Performance of elevated tanks in M_w 7.7 Bhuj earthquake of January 26th, 2001

DURGESH C RAI

Department of Civil Engineering, Indian Institute of Technology, Kanpur 208 016, India.

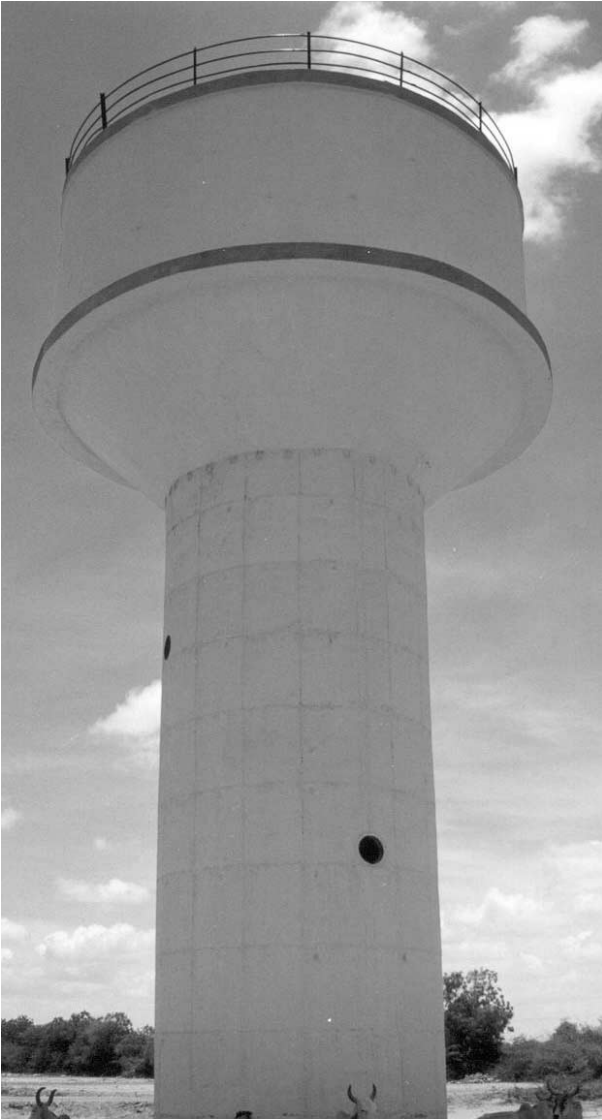
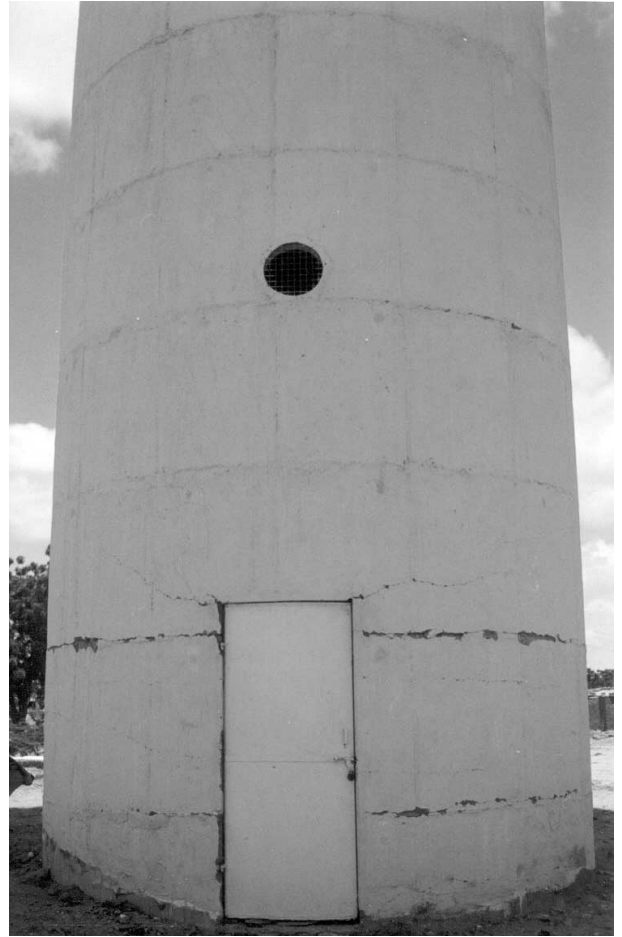
Hollow circular shaft is the most popular type of staging to support a tank container. The height of the shaft varied from a minimum of about 10 m to a maximum of 20 m whereas the shape and size of the tank container largely depended on the storage capacity and required head for the water supply. The affected tanks varied in their storage capacity from 80 kL to 1000 kL. The diameter of the staging generally increases with increase in the capacity of the tank, however, the thickness of the staging section is usually kept between 150 and 200 mm. The flexure cracks in stagings were observed from the level of the first “lift” to several lifts reaching one-third the height of the staging, as shown in figure 1. These cracks are mostly in a circumferential direction and cover the entire perimeter of the shaft. They usually appear near the edges of the form used during casting of the shaft, which appear to form planes of weaknesses along the shaft’s length. These cracks pass through the thin section of the staging and are clearly visible from inside too (figure 2).

Figure 1. 200 kL Bhachau water tank which developed circumferential cracks up to one-third height of the staging. Severe cracking at the junctions of the first two 'lifts'.

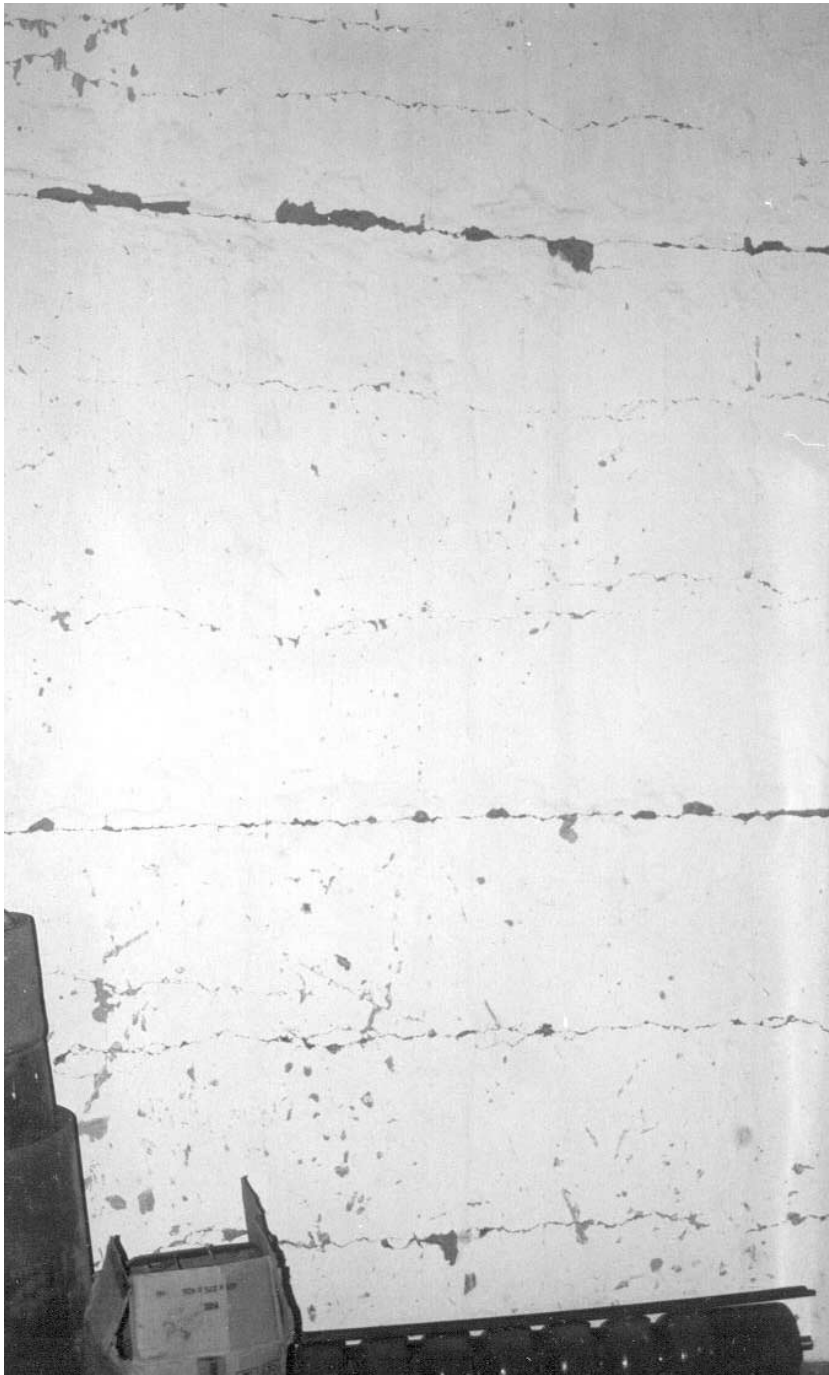
Figure 2. Cracks are 'through' the shell thickness as seen from inside the shaft of 1000 kL Anjar Nagar Palika Tank.

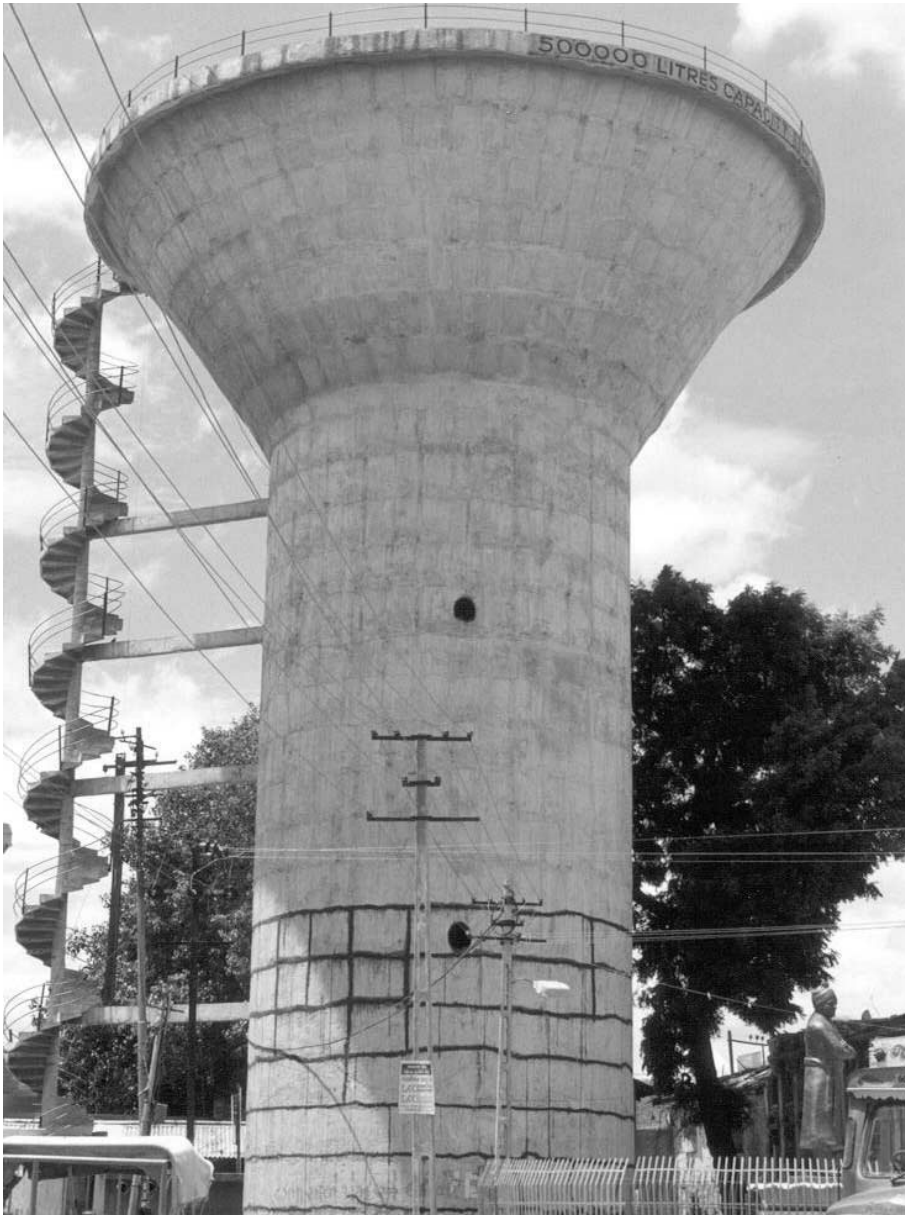
Figure 3. Flexural cracks in staging of 500 kL tank being repaired by injecting epoxy. This tank in Morbi, 80 km away from the epicenter, was empty at the time of the earthquake.

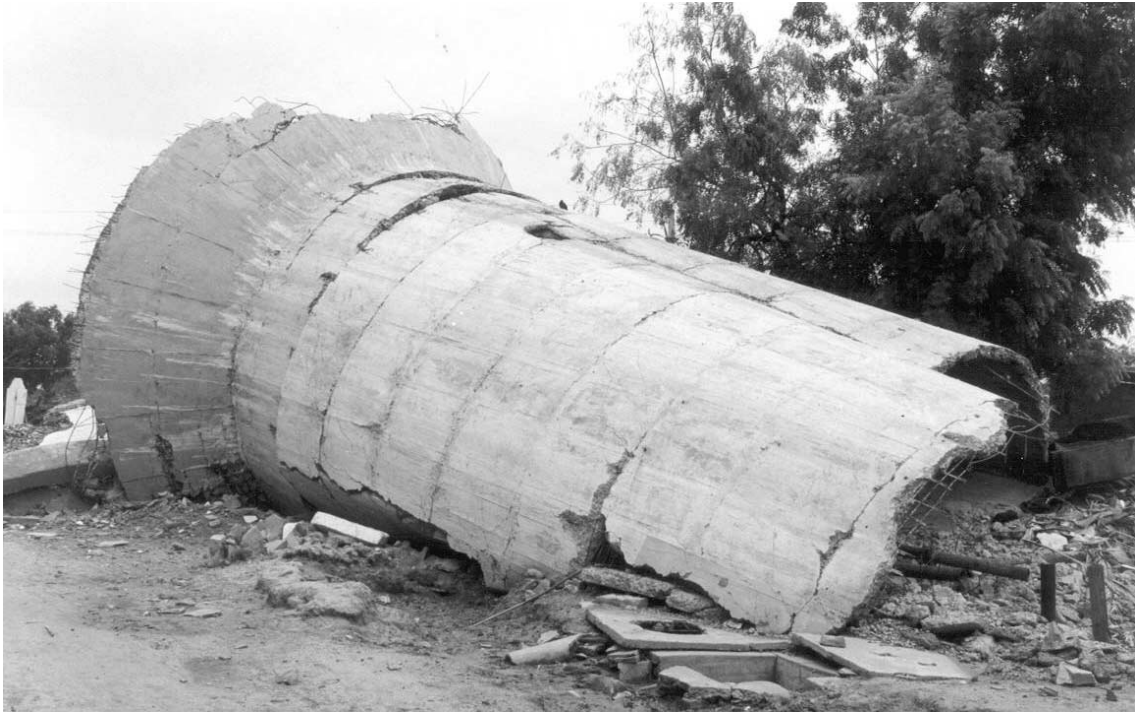
The elevated water tanks are inverted pendulum-type structures which resist lateral forces by the flexural strength and stiffness of their circular hollow shaft type staging. The section close to the ground is subjected to the maximum flexural demand. Any damage to the staging at this critical section should be considered alarming as it can seriously undermine its lateral load-carrying capacity. However, most of these tanks are being used as before. In a few cases, for example, the water tank in Darbar Garh, Morbi was repaired by injecting epoxies in the cracks, as shown in figure 3. The observed damage pattern is consistent with the expected response of these structures under lateral loads. While many water tanks escaped the earthquake with minor to severe flexural cracks, the water tank in the village Chobari in the epicentral tract did collapse (figure 4).

Figure 4. Collapsed 265 kL water tank in Chobari village about 20 km from the epicenter. The tank was approximately half full during the earthquake.

An ultimate strength analysis of the staging section of the collapsed Chobari water tank is carried out which involved the calculation of ultimate direct force and ultimate bending moment that can be resisted by the resulting stress envelope. The envelope of resistance is presented in the form of an interaction plot with the moment as the abscissa and axial load as the ordinate. The strength interaction curves were developed corresponding to factored strengths and nominal strengths as per IS:456–2000 (BIS 2000). Geometrical and material parameters used to derive the resistance envelope were:

To assess the safety of the structure, the available capacity at the critical section is compared with probable demands specified by IS:1893-1984. The ‘open’ and ‘filled’ circles in figure 9, represent factored seismic demand for empty and full tank cases according to the two critical load combinations. It is clear that the staging of Chobari water tank was probably safe for seismic forces specified by IS:1893-1984, if we ignore the possibility of poor quality construction which can not be ruled out considering its remote location. In other words, the seismic forces were indeed larger than code specified forces on the morning of the earthquake when the tank was about half full. A low seismic design force results in low flexural demand from the staging section which encourages slender stagings with thin shell sections. It is clear that damages observed in stagings of elevated water tanks once again illustrate that the IS:1893-1984 design forces are currently being underestimated by at least a factor of 3 and need an upward revision of forces immediately. In an earlier study Jain and Sameer (1993) have also pointed out this deficiency of IS:1893-1984 and advocated that the forces be increased by increasing the performance factor for elevated water tanks to 3 from the current value of 1.

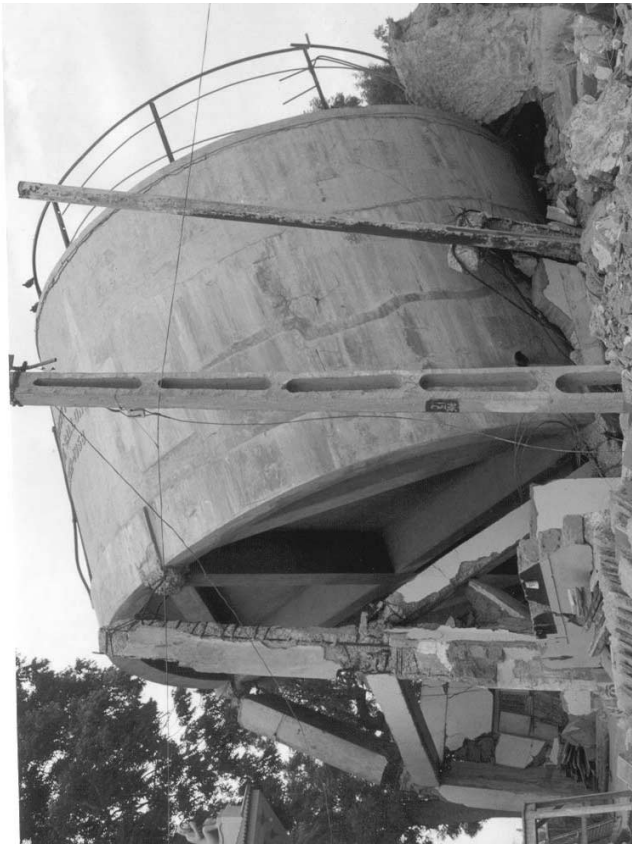
However, if the frame members and the brace-column joints are not designed and detailed for inelastic deformations, a collapse of the staging may occur under seismic overloads. Tank staging in Manfera village (figure 5) in the epicentral tract collapsed whereas severe damage to a tank in Bhachau warranted it to be torn down. Clearly, brace and column members of tanks in Manfera and Bhachau do not meet the ductility and toughness requirements for earthquake resistance. Figure 6 shows disintegrated brace-column

Figure 5. (a) Collapsed slender and weak framed stagings of water tanks in Manfera village. (b) Severe damage to similar staging required that the water tank be pulled down in Bhachau.

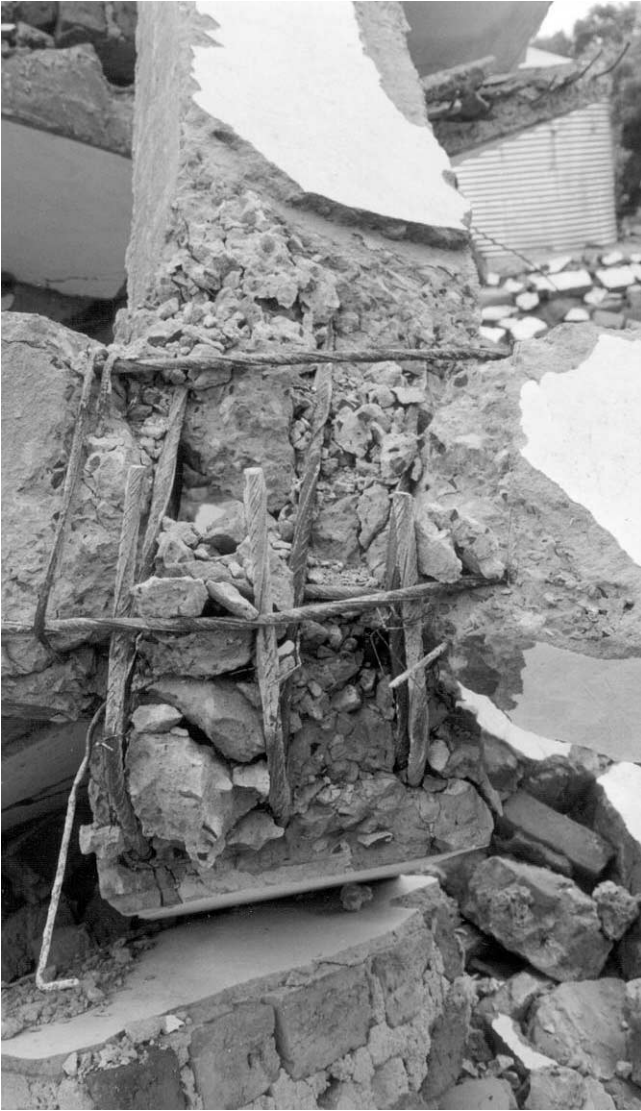
joints of the collapsed staging which is poorly detailed even for non-seismic moments. Termination of longitudinal bars in the joint region, 90° hooks for insufficient number of stirrups and poor quality of concrete are some obvious omissions leading to the failure of joints and eventually causing the collapse of the supporting frame. The collapse of the structure could have been prevented if the frame members of stagings were detailed according to provisions of IS:13920-1993 (BIS 1993a) and IS:11682-1985 (BIS 1985) which

Figure 6. Poor detailing of column-brace joints for Manfera tank.
