Performance of harbour structures in Andaman Islands during 2004 Sumatra earthquake

Goutam Mondal, Durgesh C. Rai*

Department of Civil Engineering, Indian Institute of Technology Kanpur, 208016, India

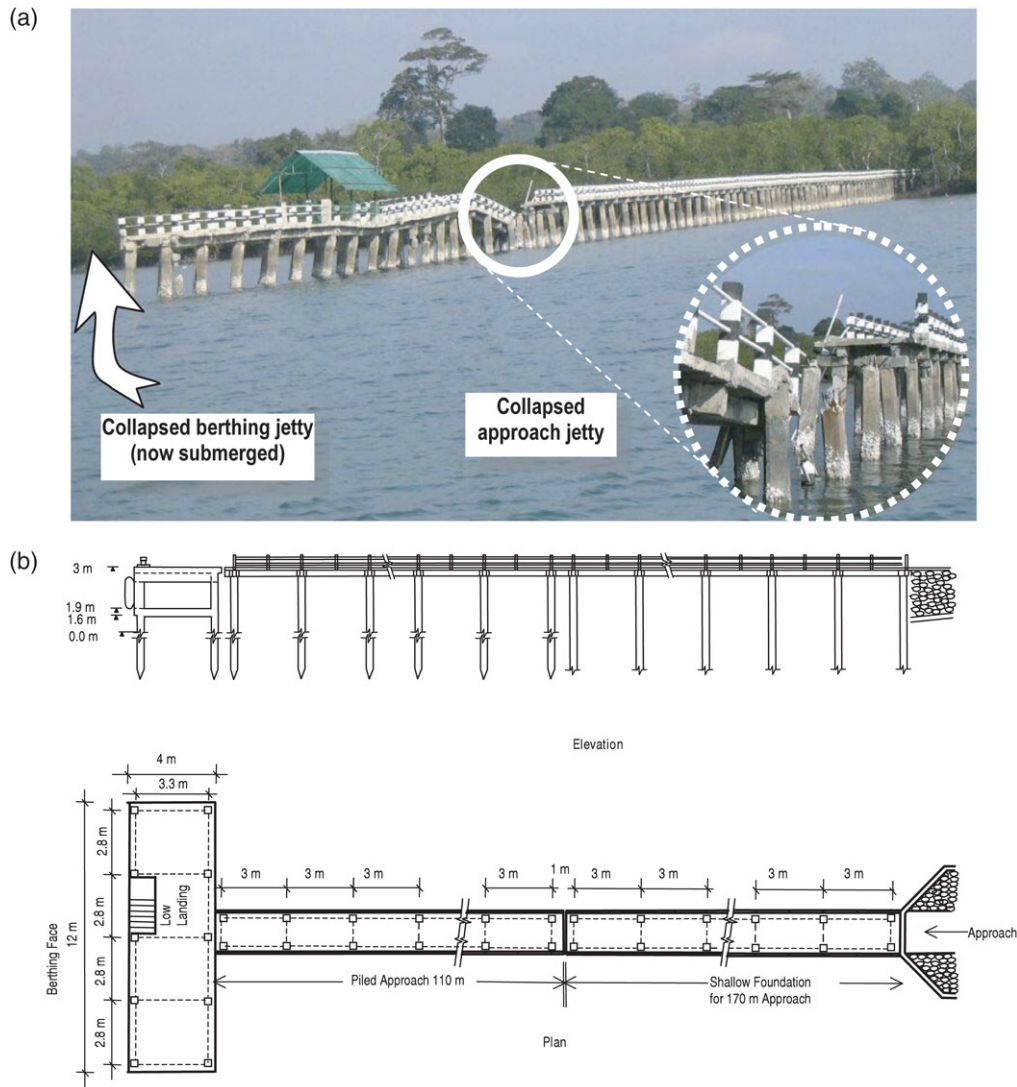
Fig. 3. Gandhinagar jetty in North Andaman: (a) Total collapse of the berthing jetty and partial collapse of the approach jetty, (b) Elevation and plan.

Jetties at Rangat Bay and Mayabandar Harbours in the Middle Andaman Islands, and at Diglipur, Sagar Dweep and Gandhinagar in the North Andaman Islands were severely affected, while Kalighat Jetty in North Andaman and Uttara Jetty in Middle Andaman sustained only minor damage (Fig. 2). Berthing jetty and a portion of approach jetty at Sagar Dweep totally collapsed during this earthquake/tsunami (Fig. 3).

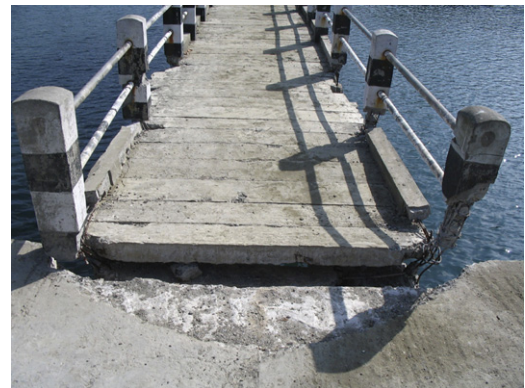
Pounding was the most common cause of damage to jetties in Andaman Islands in the 2004 Sumatra earthquake. Such damage was observed between two portions of the berthing jetties at Mayabandar as well as at Diglipur Harbours and between the junctions of approach and berthing jetties at Mayabandar, Rangat, Diglipur and Sagar Dweep (Fig. 5). Similar damage was also noticed at Diglipur Harbour in the earlier 2002 M_L 6.0 Diglipur earthquake [5,6]. The observed damage and overall performance of structures demonstrate that the structures were not designed for earthquake induced lateral displacements and forces. Such damage could have been prevented or minimized by providing devices, such as restrainer, shock absorber, connector with high damping or stiffness and energy dissipation devices, or by allowing a sufficient gap at the location of movement joints of the jetties [7–10].

Fig. 5. Pounding damage to jetties in Middle Andaman, at the construction joint of approach jetty and berthing jetty at Sagar Dweep.

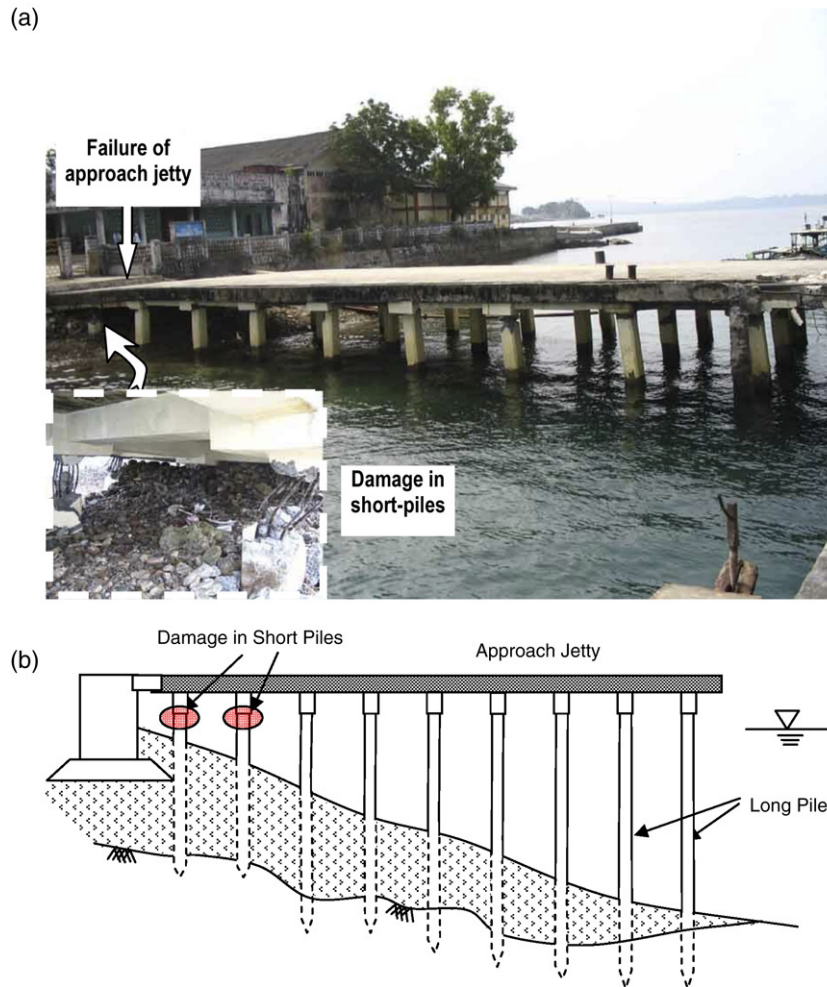
Therefore, slope in the natural and manmade embankment should be considered during design of piles. If short piles are not designed to withstand large amount of shear forces, they may get damaged severely during earthquakes. Such damage was observed in the piles of the approach jetty at Mayabandar where the approach slab fell from the ends due to damage to the short piles (Fig. 6), while little or no damage was observed in the relatively longer piles.

Fig. 6. (a) Damage in short-piles of the approach jetty at Mayabandar Harbour in Middle Andaman Islands, (b) Schematic diagram of the approach jetty.

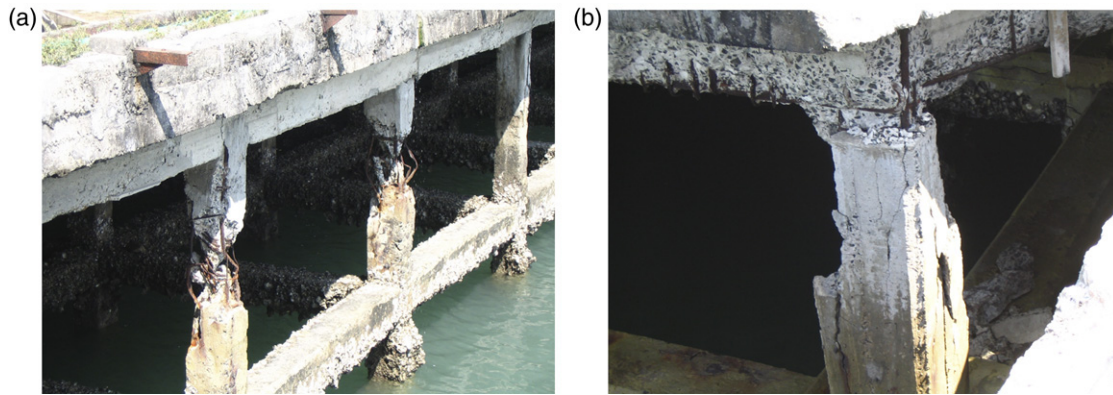
to electro-chemical reaction, chemical reaction, weathering, abrasion, scour, etc. Ingress of saline water and ocean spray corrode the reinforcement of the concrete structures if sufficient cover of reinforcement is not provided. Corrosion of the reinforcement will lead to the spalling of cover concrete exposing the reinforcement of piles and deck slabs. Corrosion of the exposed reinforcement may weaken the piles which led to severe damage to these piles during an earthquake. At Rangat Bay Jetty, corrosion of pile reinforcement was so severe that the transverse ties in some piles practically disappeared which caused severe damage to these piles during the Sumatra

earthquake (Fig. 8). Proper care and periodical maintenance is necessary for their better performance during an earthquake.

Fig. 8. Rangat Bay Harbour at Middle Andaman: (a) Severe corrosion led to damage of columns of approach jetty during the earthquake, (b) Damaged beams and piles.

periodical wetting and drying take place. Galvanized or plastic-coated reinforcing bar should be used to prevent corrosion of the reinforcement. Alkali-aggregate reaction also deteriorates concrete structures. It can be prevented by restricting the alkali content of the cement to 0.6% [12,13].

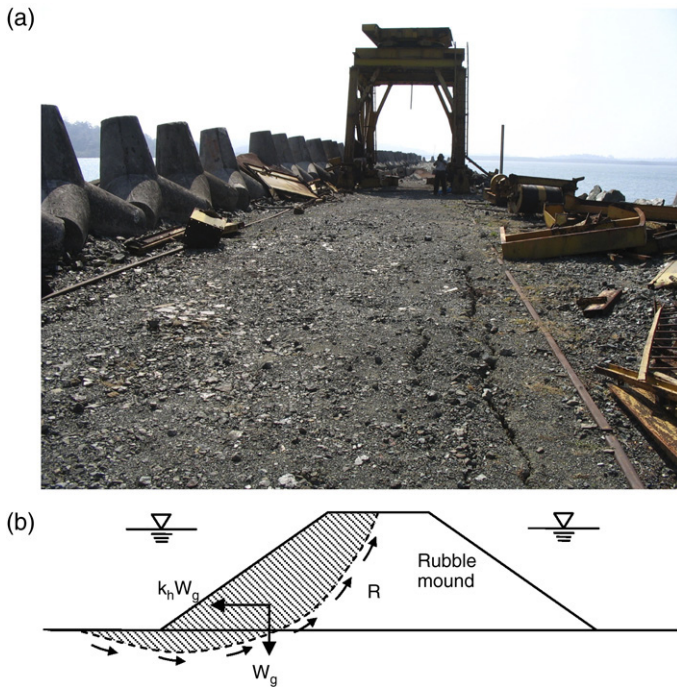
Fig. 10. (a) Longitudinal cracks on the top of the breakwater at Rangat Bay Harbour at Middle Andaman (b) Schematic diagram for pseudostatic analysis of a breakwater.

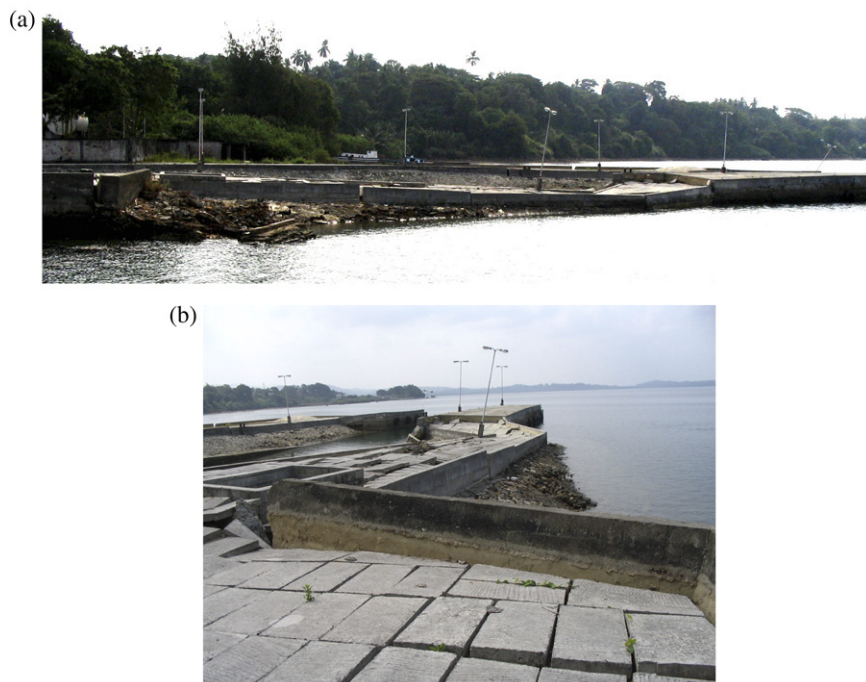
during the 2004 Sumatra earthquake [14]. Excessive ground deformation caused severe damage to the Post Office nearby Mayabandar Harbour. The approach pavement and seawall around the slipway at Mayabandar Harbour were severely damaged by liquefaction of soil (Fig. 11).

Fig. 11. (a) Liquefaction of underlying soil in the slipway at Mayabandar Harbour in Middle Andaman Islands (b) Enlarged view of the damaged slipway.

be evaluated based on standard penetration test (SPT) or cone penetration test (CPT) using empirical criteria [15,17]. Many well-established remedial methods can be used to reduce the susceptibility of soil liquefaction, e.g. compaction of sandy soil, installation of gravel columns, lowering the ground water table, etc. Installation of long piles is very effective especially for jetties or wharves since such piles are placed into denser soil at depth so that the liquefaction of the intermediate layer does not affect the structure.
