Journal of Constructional Steel Research 59 (2003) 971–994

Seismic evaluation and upgrading of chevron braced frames

D.C. Rai^a, S.C. Goel^{b,*}

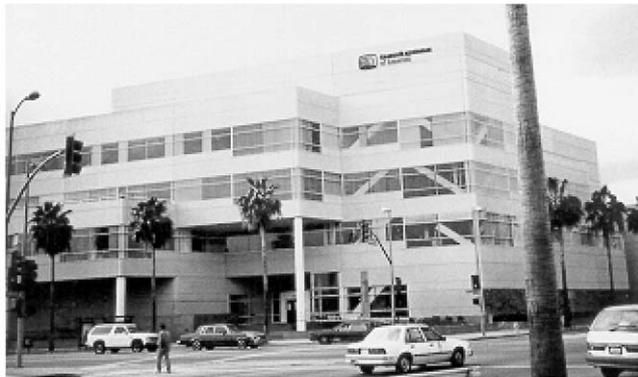
Fig. 1. (a) North-East elevation of the study building after the Northridge earthquake (b) Location of the study building, the epicenter of the Northridge earthquake and relevant CSMIP ground motion recording stations ([14]).

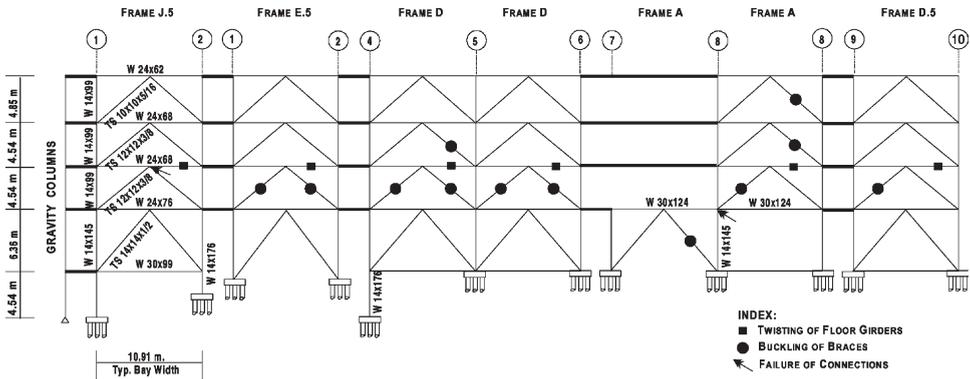
Fig. 3. Elevation of all six lateral frames of the study building in the N–S direction and location of observed damage during the Northridge earthquake.

1. Structural damage was observed in the lateral frames oriented along the N–S direction, consistent with earthquake damage observed in other buildings in the vicinity.
2. In damaged lateral frames, the failure was concentrated in the *second* story braces. Considerably less damage was observed in the other stories as shown in Fig. 3.

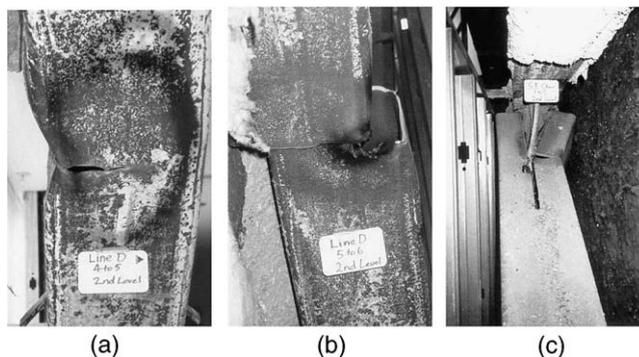
3. The main types of structural failure in the braced frames were: buckling, and fracture of tubular bracing members and some failure of brace connections. Typical failure patterns are shown in Fig. 4. Large width-thickness ratio of the tubular braces initiated the local buckling and instability following the global buckling of the braces, which led to fractures under several cyclic reversals of plastic deformations. The brace connection failures occurred due to high rotational ductility demand on the gusset plates when the braces were buckling out-of-plane. Floor beams were also laterally displaced above these buckled braces as seen in Fig. 4(c), causing considerable ceiling damage.

4. Damage to non-structural components was limited primarily to ceilings and mechanical systems in the penthouse. Ceiling damage was extensive in the upper stories above the buckled braces of the second story. However, little damage occurred in the exterior windowpanes, and the building in general was in plumb and posted with a yellow tag (i.e., limited entry but not continued occupancy) immediately after the earthquake.

Fig. 4. Typical examples of observed damage: (a) Buckled brace, (b) Fractured brace, and (c) Failed brace to girder connection and lateral displacement of girder [8].
