SEISMIC RESPONSE OF A TWICE-RETROFITTED BUILDING

David Murià-Vila, Gerardo Rodríguez, Arabella Zapata and Ana María Toro

Instituto de Ingeniería, UNAM, Ciudad Universitaria,
Apartado Postal 70-472, Coyoacán 04510, México, D.F.

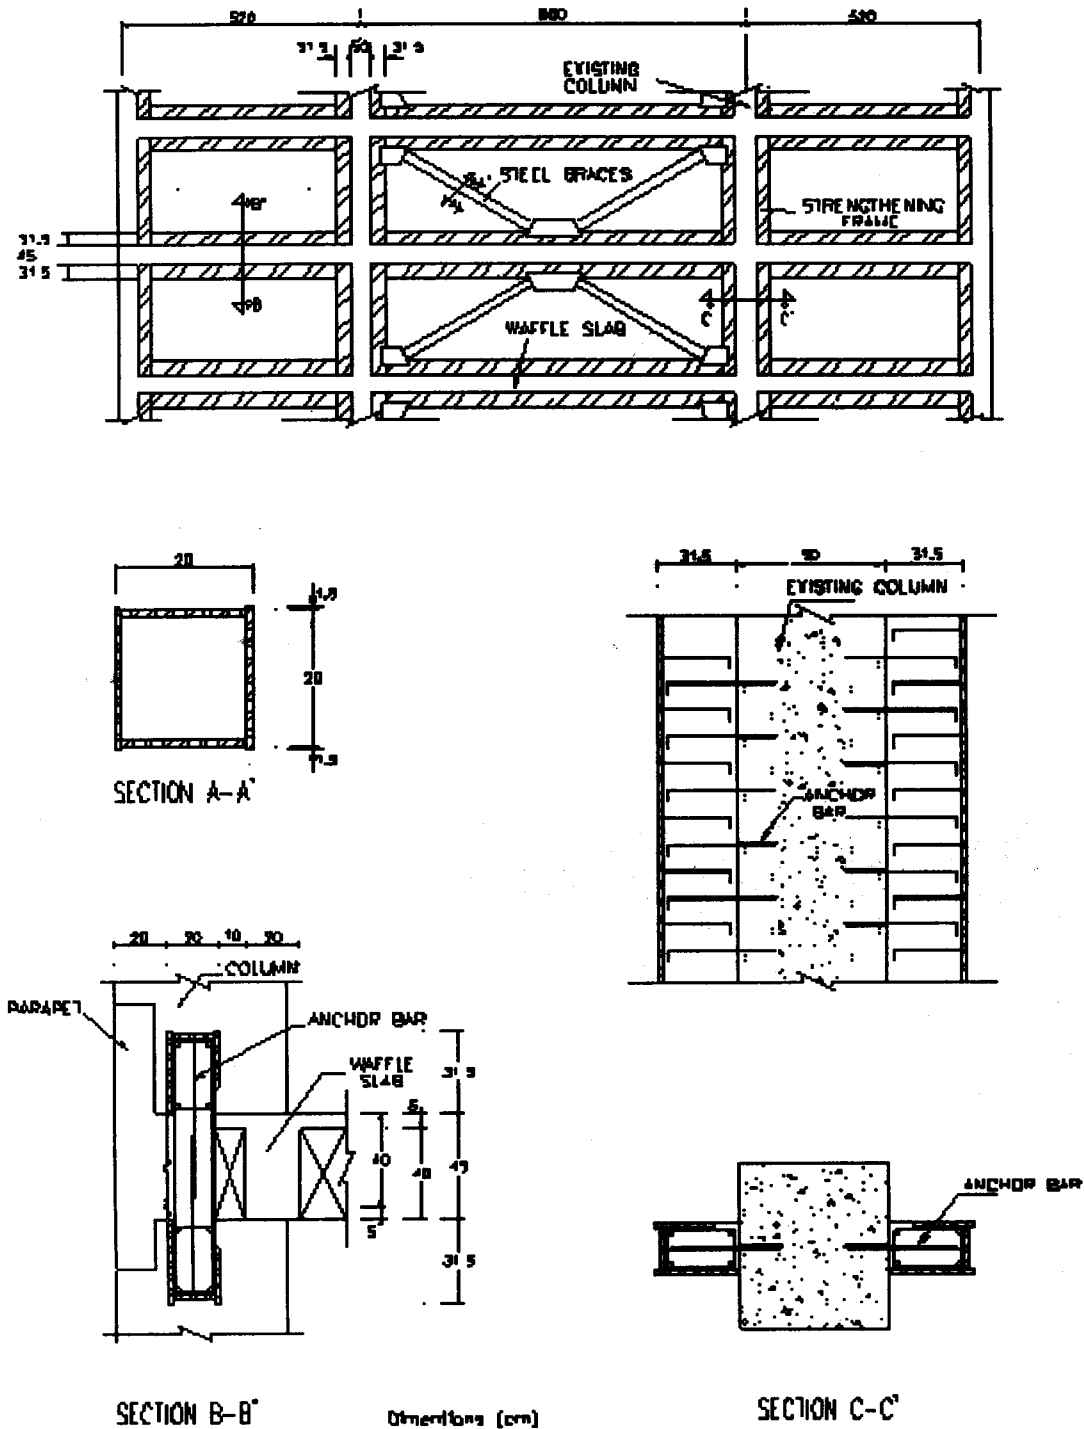
Fig. 4 Details of second rehabilitation

The December 10, 1994 earthquake (event 94-3) produced moderate damages in non-structural elements (cracking in masonry walls, as well as cracking and detachment of finished plaster and ceilings), and light structural damages (bending cracking and the perimeter sliding in concrete walls). These damages were attributable to the accumulation of the effects of previous earthquakes (mainly due to the September 1985 and April 1989 earthquakes). A light shear cracking also appeared in some columns of the parking area due to differential settlements. After the September 14, 1995 earthquake (event 95-1), more cracks in walls appeared. The bigger cracks were covered with plaster. In addition, some suspended ceiling elements fell down. The magnitude of previous settlements increased and the width of cracks in columns went up to 0.85 mm.

The deficient behaviour of the structure observed as a consequence of the moderately intense earthquakes between 1986 and 1995 led the owners to make a second rehabilitation. This time, the building was strengthened in the transverse direction (T) by steel bracing which was attached in the central bay of the exterior transversal frame through an additional steel and reinforced concrete frame. These coupling frames were put on all bays of the transversal façades. The vertical members of these frames were attached by using steel bars welded to the steel plates and glued to the concrete columns with epoxy resin through perforations. The bracing elements were square box-cross sections formed with steel plates welded to the

new coupling frames. The bracing system consisted of continuous X-bracing across two stories (Figures 1, 2 and 4).

The widths of the cracks in columns greater than 0.5 mm were injected with epoxy resin. The masonry walls with major damage were partially or totally replaced; the larger cracks were repaired with the injection of epoxy resin and then a mortar or plaster cover was applied. Moreover, an emergency steel staircase at the southwest corner of the building was built. At one end, it was supported by the building at each one of its storeys and by two steel columns at the other extreme. These steel columns were connected to two new reinforced concrete columns built over the full height of the adjoining structure.

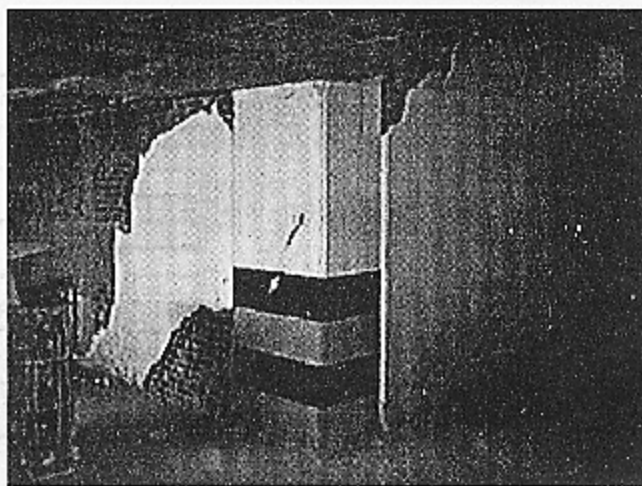
The June 15 and September 30, 1999 earthquakes, events 99-1 and 99-3 respectively, produced diverse damages in the building. On several stories, detachment of finished plaster and ceilings was observed and some suspended ceiling elements fell down. Some parapets in contact with the columns at the last garage storey showed some damage, except those with a flexible material joint. All the masonry walls were damaged (Figures 5 and 6).

Fig. 5 Reopening of cracking at basement column 2D, parking view

In two of the central columns of the basement and in the concrete wall of the foundation box corresponding to the main façade, new cracks were observed. Particularly shear cracks up to 0.6 mm width were observed at the north and south faces of columns A2 and A3. Apparently, these cracks were due to the eccentricity between the plane where the braced frames were built and the wall of the foundation box.

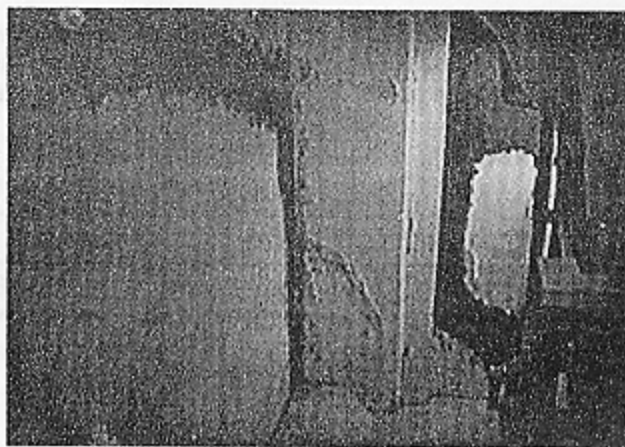
Fig. 6 Reopening of cracking at basement column 2D, stair-case view

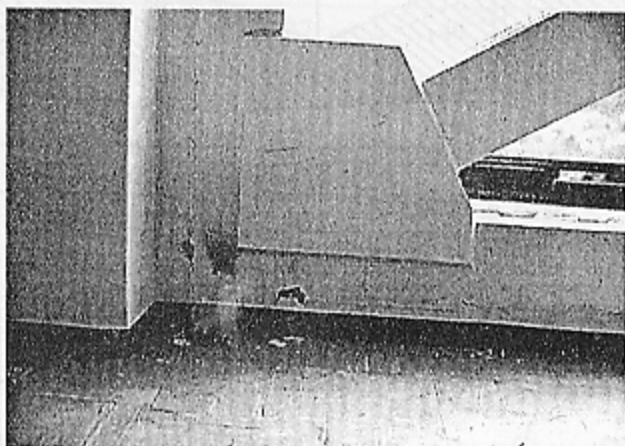
Some cracking at the perimeter of the concrete-steel and concrete-concrete interfaces between the old and new elements was detected (Figure 7). In addition, at the parking stories, light cracking, perpendicular or inclined with respect to the metallic elements, was perceived. Effects of the 99-3 event increased the number of cracks, and their widths were less than 0.2 mm.

Fig. 7 Perimeter cracking at concrete-steel and concrete-concrete interfaces between new and old structural elements

After the second rehabilitation, the deterioration in the interfaces between the new and old structural elements of the transversal façades caused a considerable observed reduction of lateral stiffness. This source of non-linear behaviour and those mentioned before contributed to the appreciable decrease of the vibration frequencies.
