Lifeline Systems in the Andaman and Nicobar Islands (India) after the December 2004 Great Sumatra Earthquake and Indian Ocean Tsunami

Lifeline systems in the Andaman and Nicobar islands performed poorly during the December 2004 Great Sumatra earthquake and tsunami. Several power stations and transmission lines were damaged by the ground shaking, affecting the electric power supply to parts of the islands. Telecommunication services were severely affected because of destruction of several telephone exchanges. These services were restored quickly by government agencies. The dams and reservoirs, which supply potable water, sustained minor damage from ground shaking. However, segmented pipelines connecting the dams and reservoirs to various storage sites broke at several places, which significantly affected the water supply for a few days. Ground shaking damaged several elevated as well as ground-supported storage tanks. Damage related to tsunami waves was substantial in the 500–1,000-m strip immediately next to the coastline. [DOI: 10.1193/1.2205874]

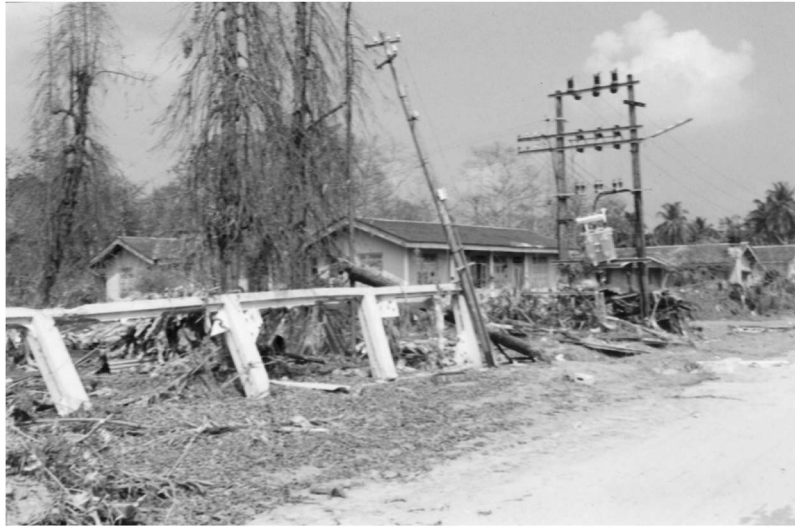
The distribution network also suffered damage. Tens of kilometers of high-tension and low-tension lines were lost. The transformers on poles were rendered inoperable after the saltwater inundated them (Figure 1). Also, the concrete poles holding the distribution lines also leaned and collapsed in some locations, thus making it difficult to restore power immediately. Several electrical poles were flooded, and several others were washed away, which disrupted the power supply (Figure 2). Since spare poles and backup power generating units were not available, the supply of electric power in many islands almost came to a halt for over four weeks.

Figure 1. General wreck of the power distribution system at Hut Bay in Little Andaman Island (photo: S. Dash).

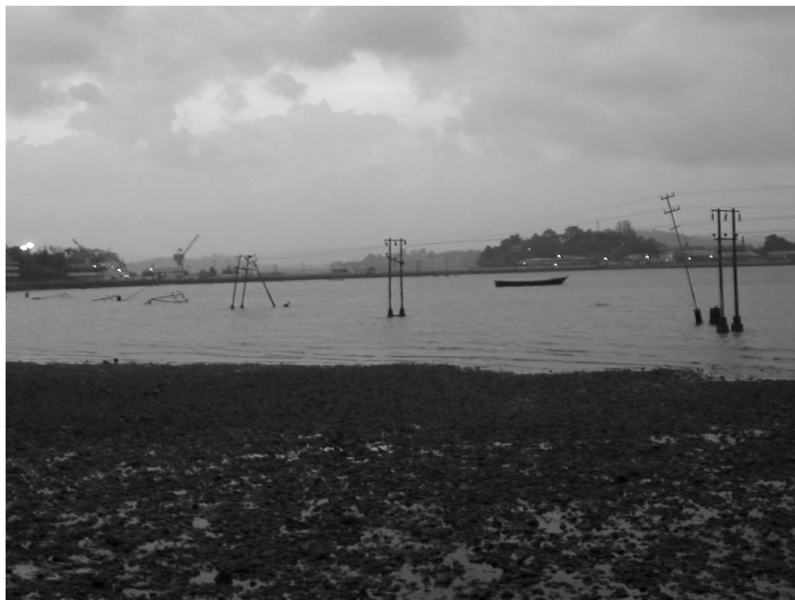
The transmission tower that carries 440 kV from Port Blair to Namunagarh was damaged and might have collapsed if the transmission line had not snapped first.

Figure 2. High-pressure tsunami waves damaged electrical poles near Haddo Wharf in Port Blair in South Andaman Island (photo: S. Jain).

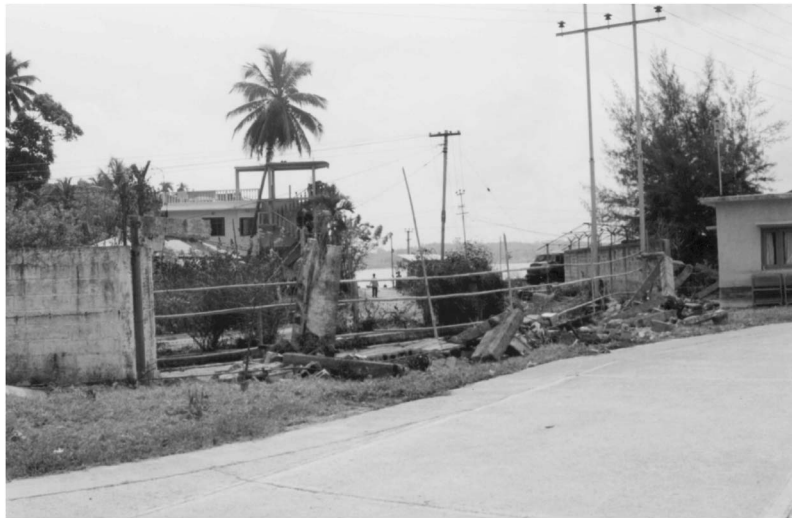
Figure 3. Collapse of the Suryachakra Power Plant masonry boundary walls at Bamboo Flat in South Andaman Island (photo: G. Mondal).

the ingress of seawater and mud in the control room of the power plant; damage included the collapse of boundary walls (Figure 3) and severe damage to mechanical and electrical equipment. Several weeks were required for restoration.

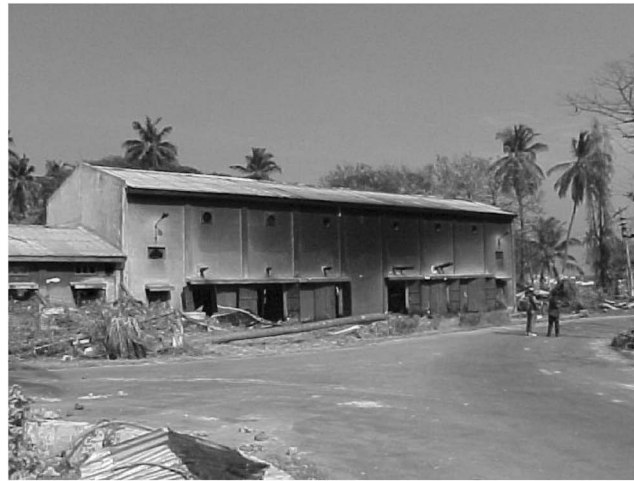
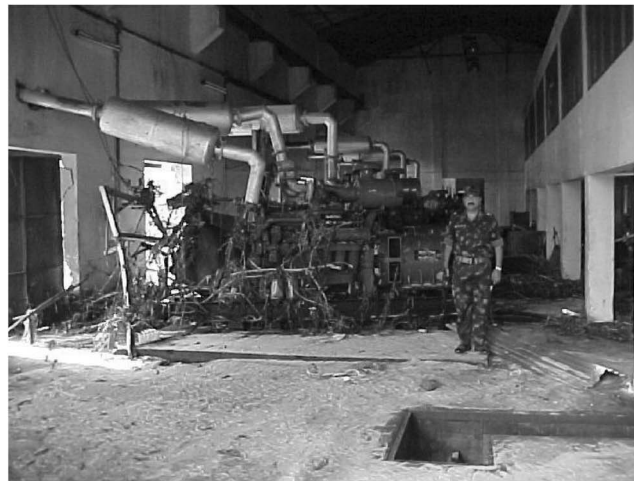
In Car Nicobar Island, diesel-based power generation was halted due to flooding of the generators with saline water and displacement of these generators from their position. They were displaced because the large pressures imposed by the giant tsunami waves had caused anchor bolts to snap (Figure 4). Also, the oil tanks of the DG sets were carried about 2 km away by the tsunami waves to the end of the military airport runway (Figure 5).

Figure 4. Electrical power generator unit at the Air Force Colony in Car Nicobar Island: (a) outside view of the building (photo: C. Murty). (b) Lateral displacement of generator sets by about 4 m (photo: S. Dash).

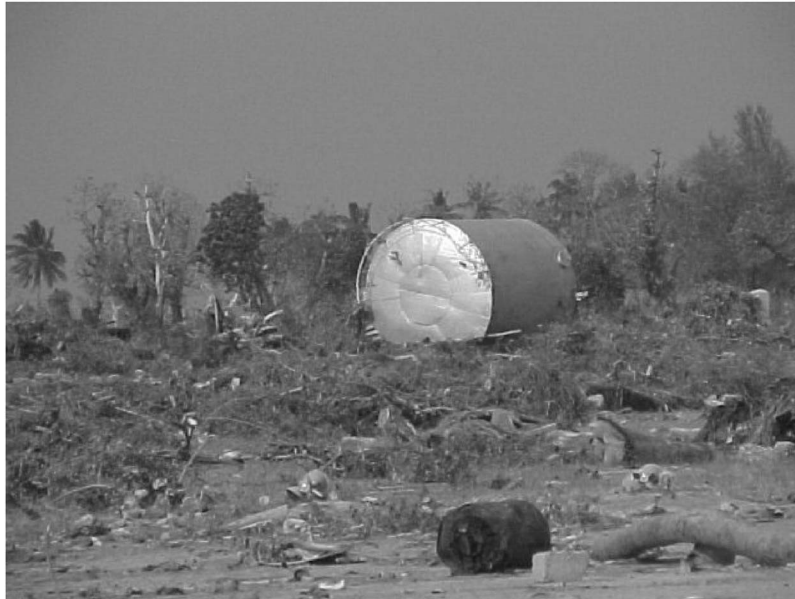
Figure 5. An oil tank of an electric power generator unit at the Air Force Colony in Car Nicobar Island was displaced by about 2 km to the end of the military airport runway (photo: S. Dash).

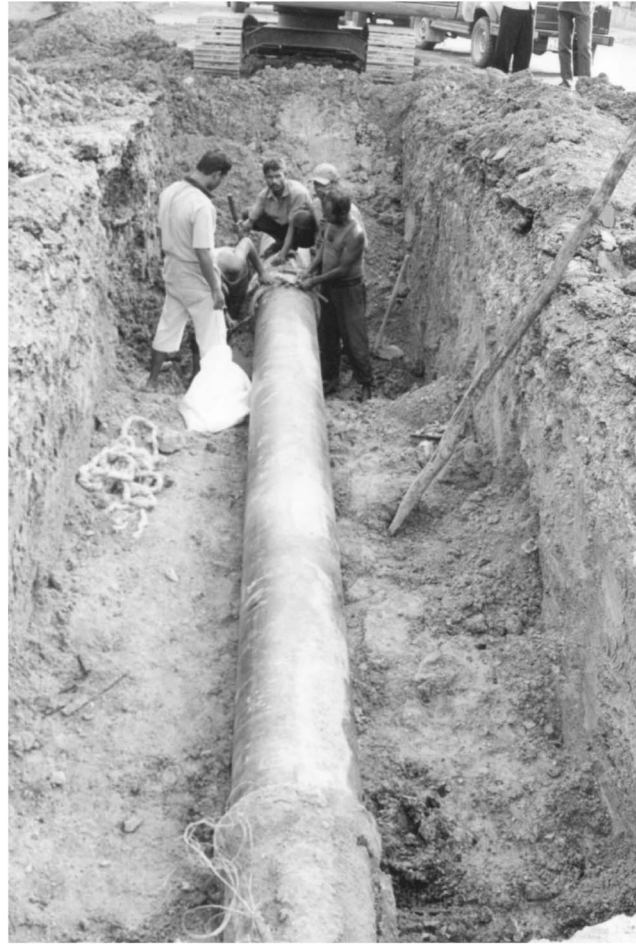
Figure 6. Damaged pipeline being attended to near the water treatment plant in Port Blair (photo: S. Dash).

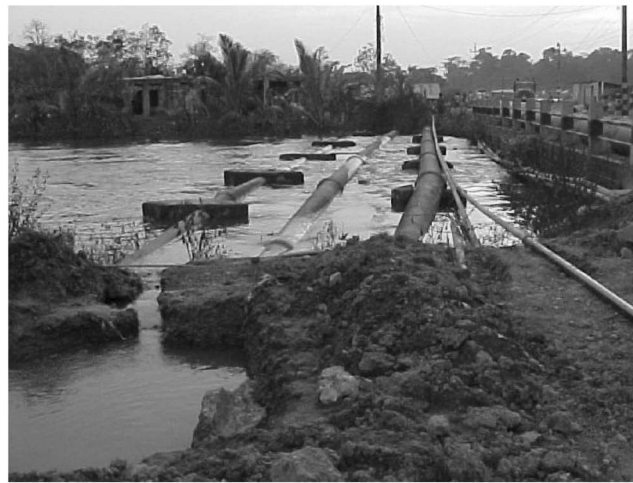
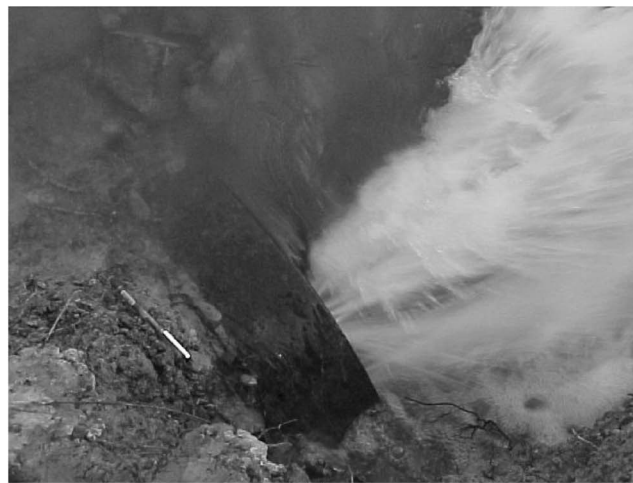
However, important damage occurred at the low-lying Lambaline area (Figure 7). The land subsided, and the seawater rose permanently in the already low-lying area. As

Figure 7. Failure of the bell and spigot joint of the pipeline in the Lambaline area near Port Blair in South Andaman Island: (a) kink in the pipeline, and (b) leakage at the bell and spigot joint (photo: S. Dash).

a consequence, the sloping ground sustained lateral spreading, which in turn caused the pipeline that rested on normal ground to displace laterally. This resulted in the opening of the bell and spigot joints of the cast iron pipe lengths. The leakage of water from these joints hampered the water supply to the city of Port Blair for over ten days.

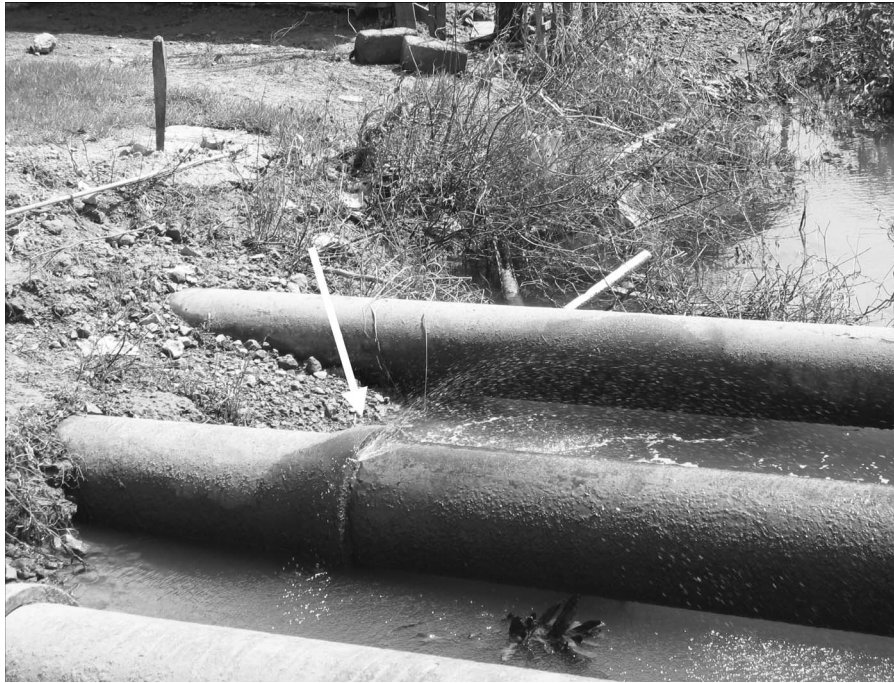
The 46-cm-diameter RC water pipelines that were laid parallel to the main trunk road in South Andaman Island were damaged as a result of ground shaking, ground settlement, and the tsunami. It is noteworthy that, six weeks after the earthquake, the pipeline was still leaking at the joints (Figure 8).

Figure 8. Water main leaking along the South Andaman Island Trunk Road (photo: M. Yashinsky).

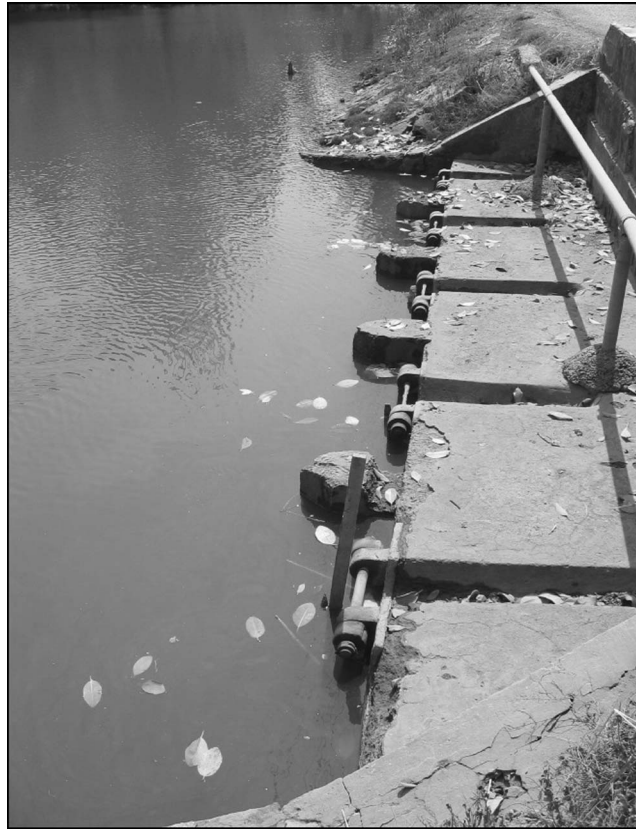
A number of sluice gates under the South Andaman Island Trunk Road were built to drain the rice fields and control the infiltration of seawater. However, during the earthquake, the tsunami overtopped the roads and broke the sluice gates (Figure 9). Moreover, the eastern part of South Andaman Island suffered tectonic subsidence as a result of the earthquake, and the land is now permanently inundated with saltwater, thus destroying the rice fields that were ready to be harvested (Figure 10).

Figure 9. Damaged sluice gates under the South Andaman Island Trunk Road (photo: M. Yashinsky).

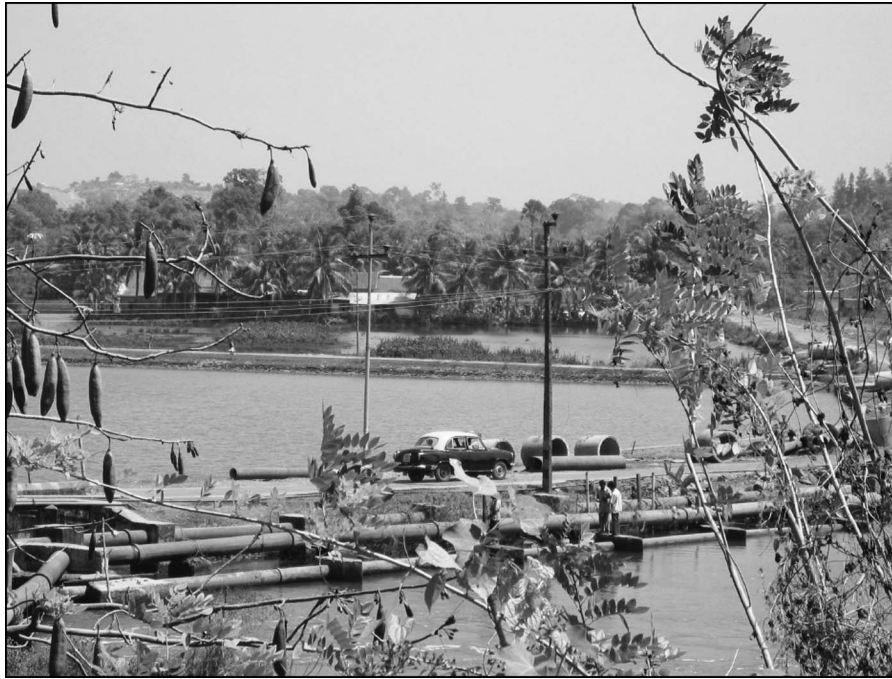
Figure 10. Fields in South Andaman Island were inundated by seawater (photo: M. Yashinsky).

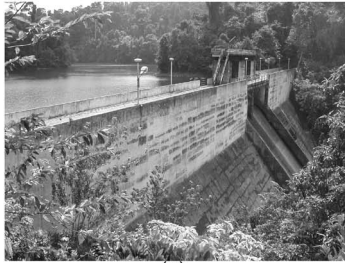
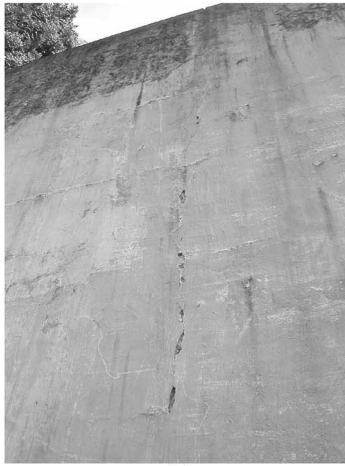
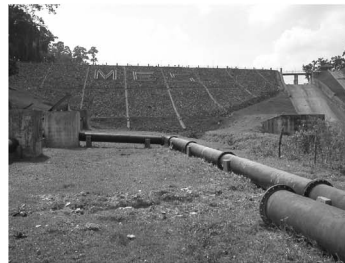
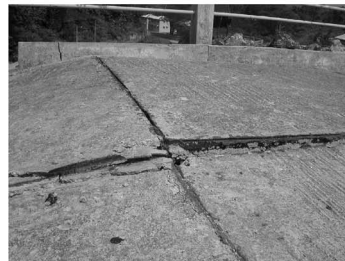
The main water source for Port Blair is the watershed behind the Dhanikhari Dam. This concrete dam (on the Dhanikhari River) was constructed during 1970–73 to supply water to Port Blair. The dam is 132 m long and 32.23 m high, with a central gated spillway having a capacity of 26,000 cu/sec. The reservoir extends to an area of $0.49 \times 10 \text{ mi.}^2$, and the storage capacity is 9,000 lakh L. On 26 December 2004, the reservoir water level was 60.60 m. Inspection of the dam revealed some minor distress to the main structure due to the earthquake (Figures 11a and 11b). Inspection of the foundation gallery showed cracking along the fifth block joint, and seepage was taking place. It was reported that, before the earthquake, the water seepage used to be pumped after every six hours. After the earthquake, this seepage required hourly pumping. After the earthquake, the main supply pipes were dislodged, and therefore the water supply to the town was disrupted. The water supply was eventually restored.

10-m-wide and 80.58-m-long left bank ungated RC-chute spillway. The earthen section has pitching of basalt blocks, both in the upstream and downstream sides. A concrete apron has been placed over the entire length of the crest. The distress is seen at the junction of the earthen section and spillway concrete. Here, the concrete apron has buckled by as much as 8 cm along the block joint (Figures 11c and 11d). The profile of the earth section otherwise does not show any deformation or distress. It was reported that, on the morning of the earthquake, the level of the reservoir (whose area is 15 ha) was quite low. But, due to the tremors, the waves in the reservoir rose so high that they splashed onto the crest portion that was about 5.6 m above the reservoir level.

Figure 11. Dams in the Port Blair area in South Andaman Island: (a) and (b) vertical cracks in the body of the Dhanikari Dam on the downstream side; and (c) and (d) buckling of the concrete apron over the crest of the Chouldari Dam at one end (photos: H. Kaushik).

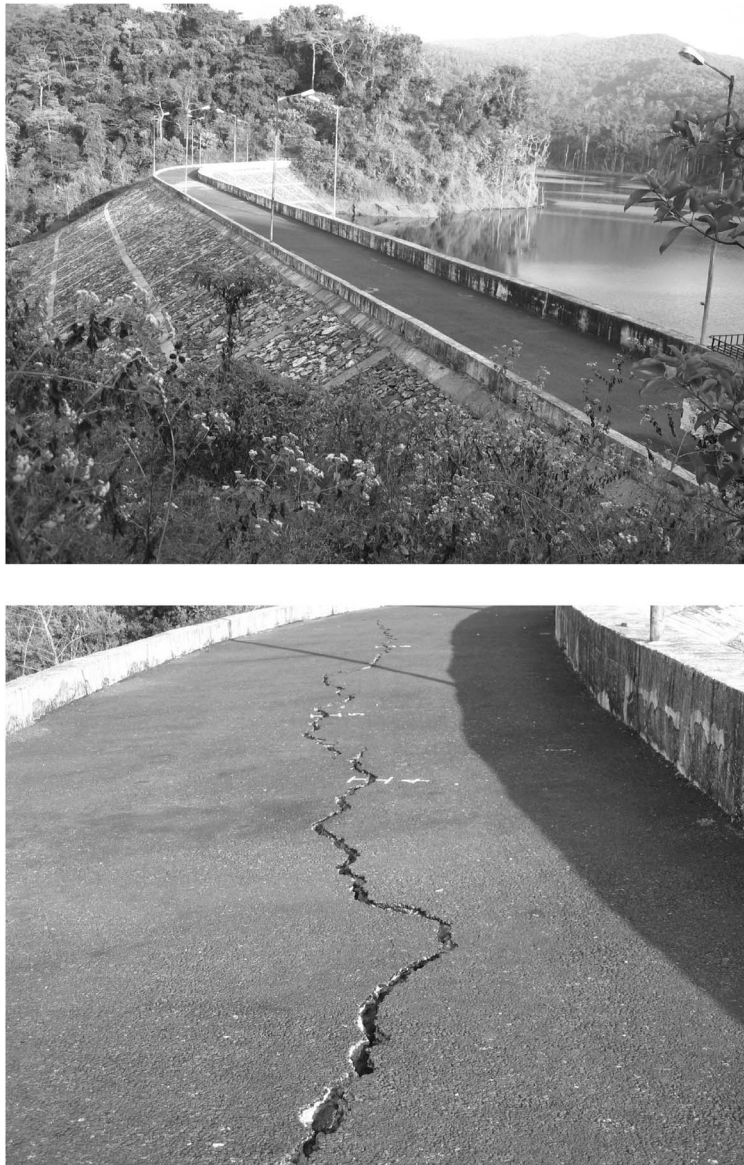
Longitudinal cracks developed at the crest of a 27-m-high, 146-m-long rockfill dam of the 5.25-MW Kalpong Hydroelectric Project near Diglipur in North Andaman Island. The cracks developed near the curved end along the axis of the straight portion of the dam (Figure 12). Movements were also noted across the block joints near both ends in the 24-m-high, 138-m-long concrete dam, and water seepage through the dam doubled after the earthquake. Misalignment of turbines caused disruption of electric generation, which was only partly restored even after ten days. The collapse of a transmission tower at Middle Strait further restricted its power distribution to North Andaman Island.

Figure 12. Longitudinal cracks at the crest of the rockfill dam of the Kalpong Hydroelectric Project near Diglipur in North Andaman Island (photos: G. Mondal).

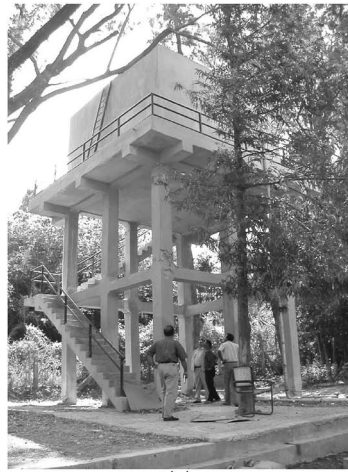
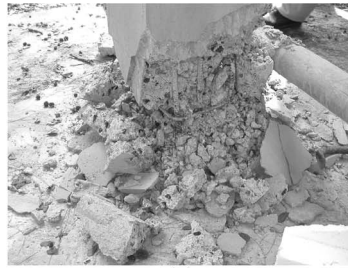
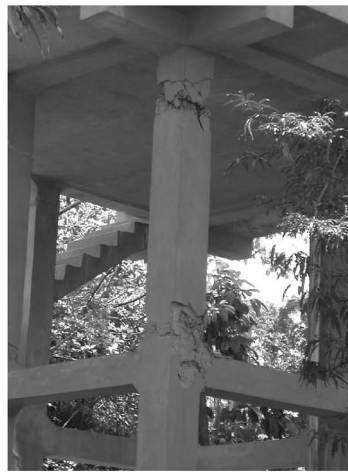
For example, an overhead water tank with a 50,000-L capacity at the converter room of the Haddo naval jetty developed plastic hinges at the bottom of all its columns and at the top in a few columns. The tank is supported on 6-m-high staging consisting of eight 300-mm square RC columns with intermediate RC beam braces at a height of 3 m. The presence of the staircase going around the staging seems to have made the tank geometry unsymmetrical, and the tank sustained torsional response. The container sustained no damage (Figure 13).

Figure 13. (a) Severely damaged RC overhead water tank at the converter room of the Haddo naval jetty. The tank container was not damaged (photo: H. Kaushik). (b) Close-up of plastic hinge formation at the bottom of one of the columns (photo: H. Kaushik). (c) A few columns also developed plastic hinges at the top level (photo: S. Jain).

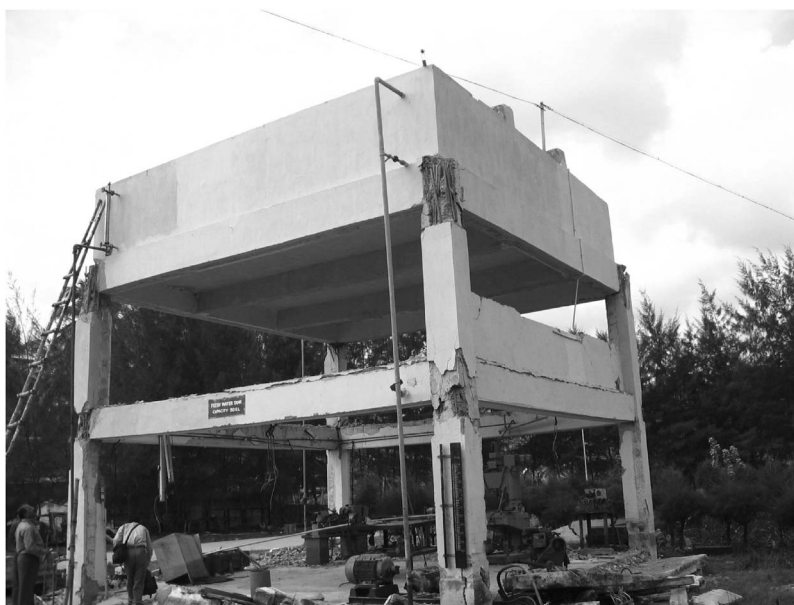
In another RC elevated water tank at the Suryachakra powerhouse in the Bamboo Flat area near Port Blair, the beam-column joints of the frame staging sustained damage,

in addition to some concrete spalling on columns at discrete locations along their height where there was very little cover (Figure 14). The space within the frame staging was made into an enclosure by adding infill walls and was being used for storage. The infill walls collapsed out-of-plane under the earthquake shaking. The damage underscores the need to (a) improve the detailing of beam-column joints in RC frames, (b) improve the quality of on-site supervision during construction, and (c) re-examine the out-of-plane stability of the masonry infill walls.

Figure 14. Out-of-plane failure of an infill wall and formation of a plastic hinge at the beam-column joint of a freshwater tank (50 kL capacity) at Suryachakra powerhouse in the Bamboo Flat area in South Andaman Island (photo: D. Rai).

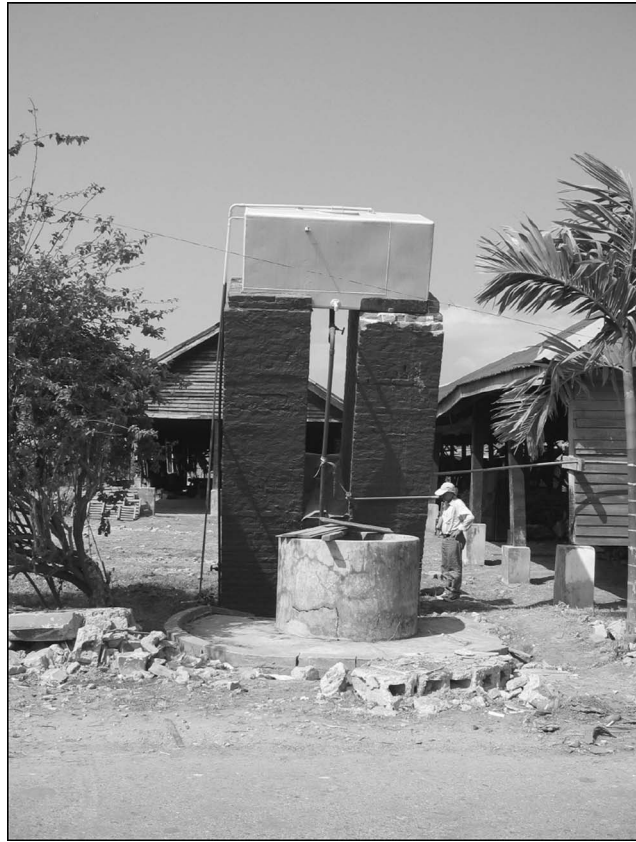
Figure 15. Elevated water tank at Port Blair, South Andaman Island (photo: R. Surrampalli).

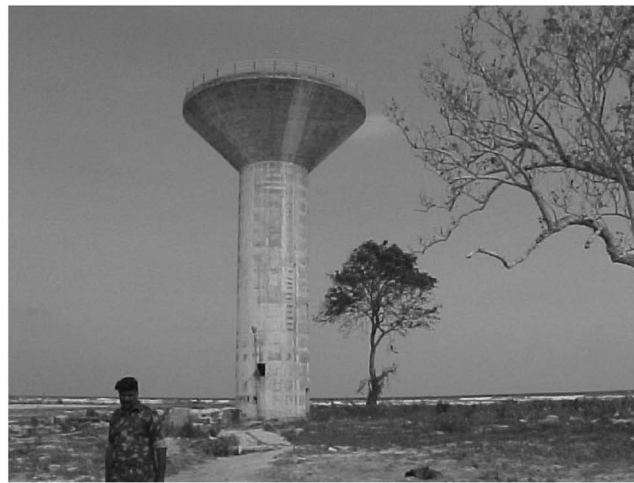
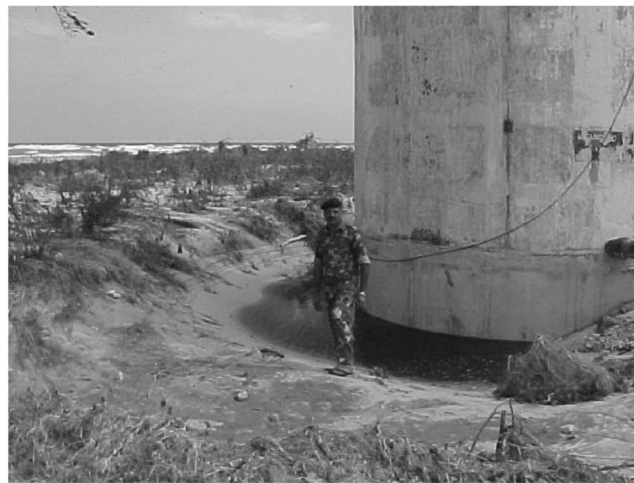
A stack-like overhead water tank at the Air Force Colony in Car Nicobar Island (Figure 16a) has cylindrical staging and rests on a pile foundation. This structure withstood the force of tsunami waves without any damage, even though it is right on the shore, owing to its hydrodynamic shape and the use of a pile foundation (Figure 16b).

Figure 16. Conical water tank at the Air Force Colony at Car Nicobar Island: (a) no apparent sign of any structural damage; (b) despite some scouring of the soil adjoining the shaft at the ground level, the scouring was not enough to cause instability of the tank (photos: C. Murty).
