FLOOD ELEVATION, INUNDATION DISTANCE AND FLOW COMPETENCE OF THE 2004 SUMATRA-ANDAMAN TSUNAMI, AS RECORDED BY TSUNAMI DEPOSITS IN THIRTEEN SHORE-NORMAL PROFILES FROM THE TAMIL NADU COASTLINE, INDIA

ABSTRACT

KEYWORDS: Tsunami, 2004 Sumatra-Andaman Rupture, Inundation Profiles, Deposits, Tamil Nadu

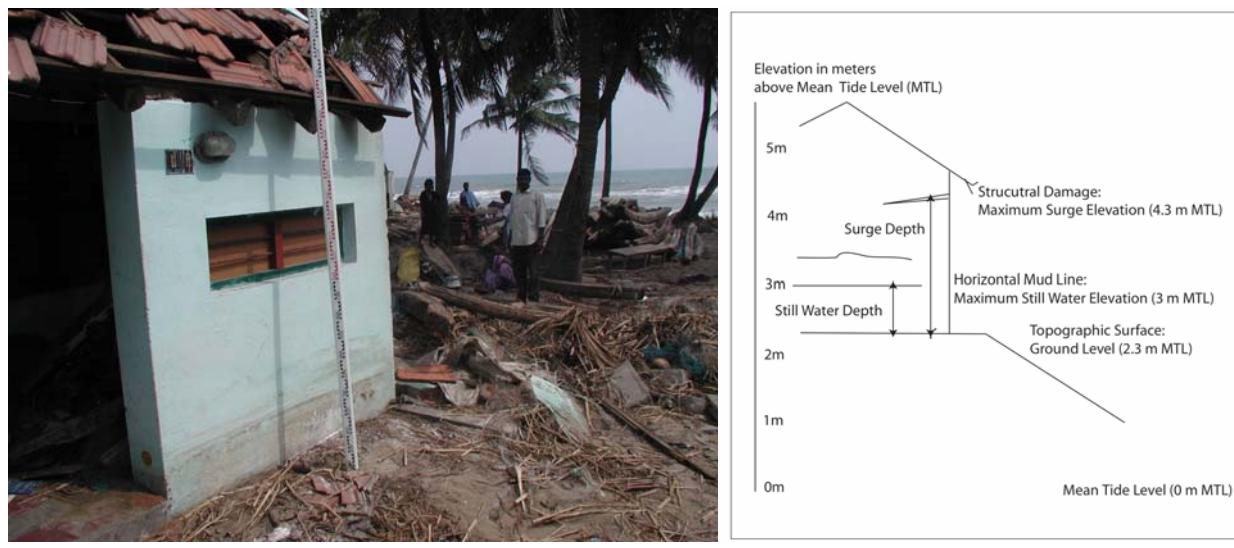
Fig. 2 (a) Photograph of proximal run-up site at profile DEVA01 (80 m position) showing mud line (maximum still-water elevation) at base of blue house, and surge damage to tile roof (maximum surge elevation) at roofline of blue house (the logs and beams that surround the house were left in place by receding tsunami water; photo view direction is towards the east with ocean shoreline in background); (b) Diagram of key tsunami flood heights taken from water, debris and/or damage marks on standing structures (the key features include calibrated MTL, topographic elevation, maximum still water elevation, maximum surge elevation, and corresponding differences of still-water depth and surge depth; measurements shown are averaged from several representative profiles in the study area)

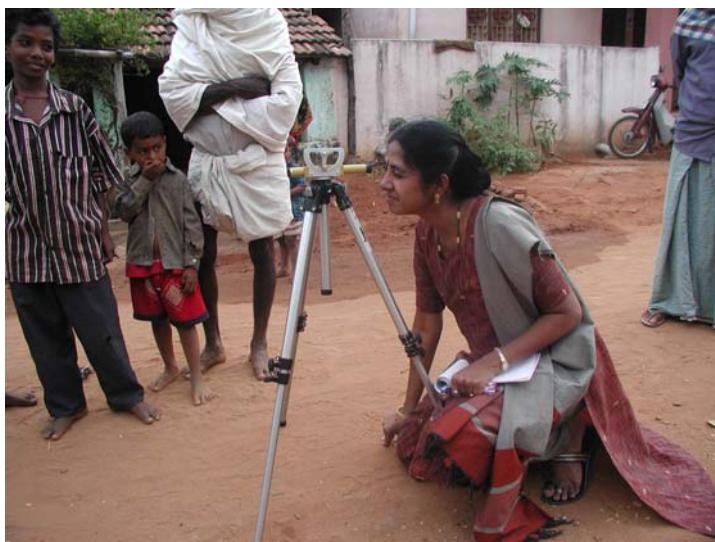
Fig. 3 Photograph of level and tripod setup on profile PERI01 (170 m position) for shooting level line from tsunami high-water deposits to beach swash zones

Elevations of high water deposits were established relative to local mean tidal level by use of profile topographic surveys. Topographic surveys were performed with a bubble-level transit mounted on a tripod and extendable stadia rod (Figure 3). Horizontal sighting distances were generally less than 100 m between level and stadia rod. Elevations were measured to the nearest centimeter. Total profile errors of ± 0.1 m are assumed for the single-sighting, single-direction, leveling surveys. Profile end points were located by 12-channel GPS (± 10 m error) using the WGS84 datum.

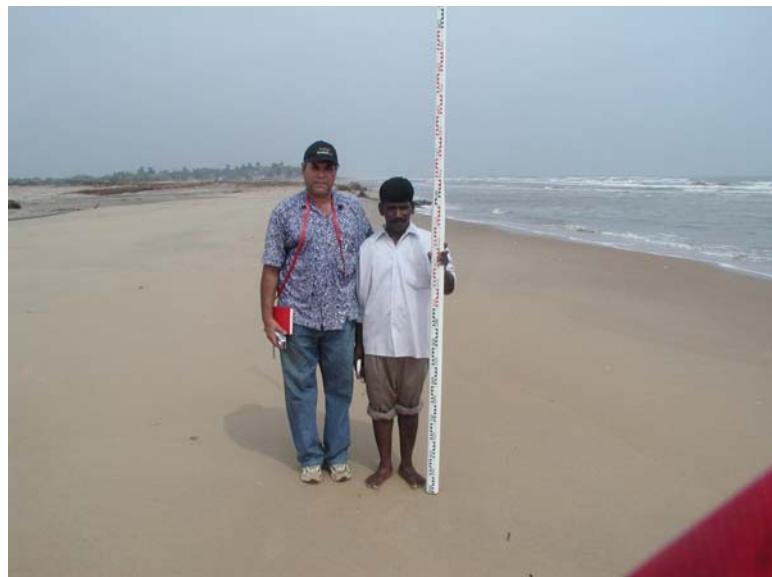
Fig. 4 Photograph of stadia rod near beach endpoint of profile NAGA01 (10 m position) with swash zone at the right (stadia rod was held at mid-swash, i.e. mean water level, to establish timed tide level during survey)

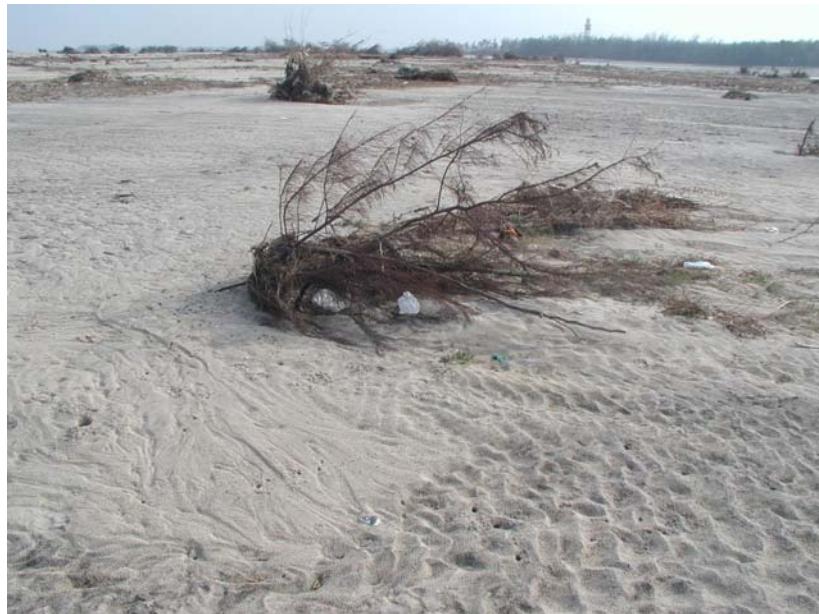
Fig. 5 Photograph of sand ripples and vegetation flop-overs that serve as indicators of tsunami flow direction, i.e., to right of figure (bearing 245° TN), at position 300 m of profile PARO01 (photograph view direction is to the south)

Flow features were recorded in eight inundation profiles (Table 2). The flow features include vegetation flop-overs, orientated beams, debris streamers around tree trunks, and sand ripples (Figure 5).

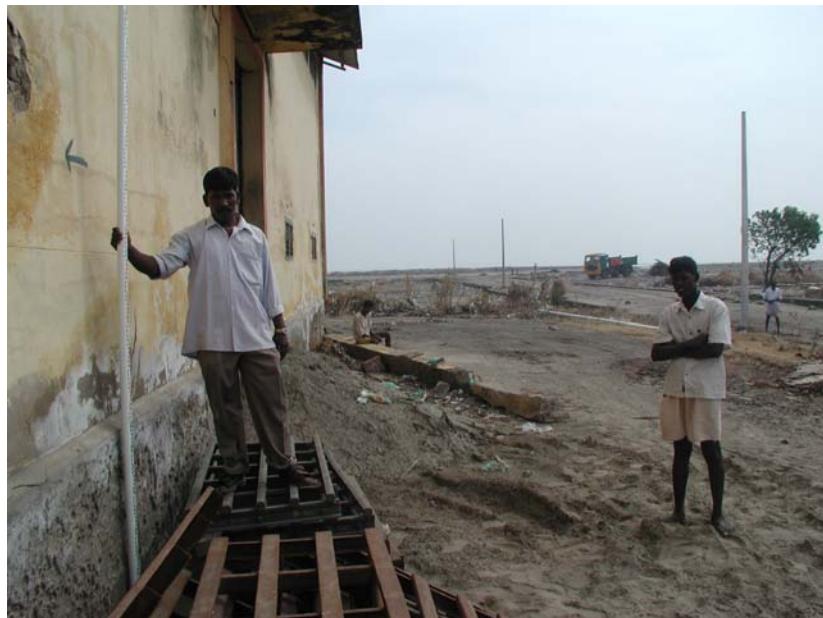
Fig. 6 Photograph of mud line at black arrow, and of flow-damaged awning at 1.2 m above the mud line, at the warehouse position 430 m in profile NAGA01 (the maximum still-water elevation, i.e. mud line, is 4.3 m MTL; the maximum surge, i.e. flow damaged awning, elevation is 5.5 m MTL; the surge elevation is confirmed by heavy debris at 5-6 m MTL in adjacent tree branches (see Figure 8); photo view direction is towards the east, with shoreline beyond view in the far background)

Maximum surge elevations were taken from sustained water levels that caused physical damage to buildings (Figure 6), and/or that left heavy debris in broken, twisted or bent tree branches. The measured elevations of maximum surge ranged from 3.8 to 6.0 m MTL in eight profiles (Table 5). Surge and splash levels varied significantly from maximum still-water elevations within some of the same profiles. In the KOVA01 profile the elevations of measured surge (+4.2 m MTL) and splash (5.6 m MTL) are substantially greater than the maximum still-water elevation (3.4 m MTL).

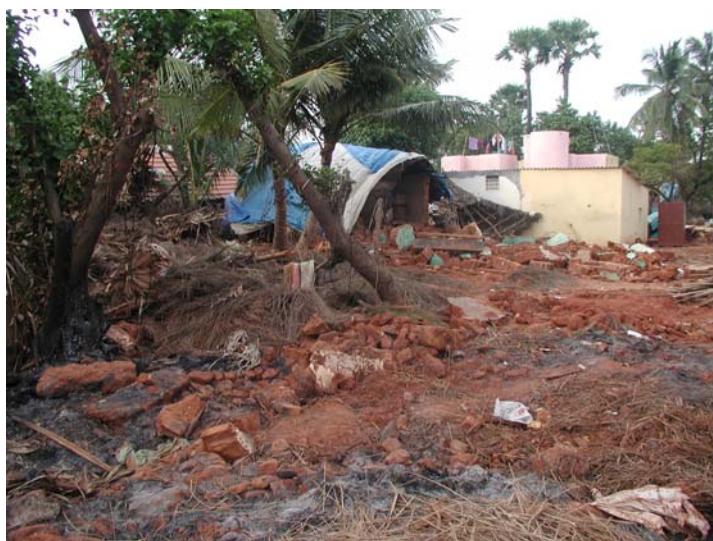
Fig. 7 Photograph of high flow competence as shown by zone of gravel (brick) mobilization in profile PERI01 (60 m) (flow direction was towards the southwest, i.e. the lower left of photo; photo view direction is towards the north)

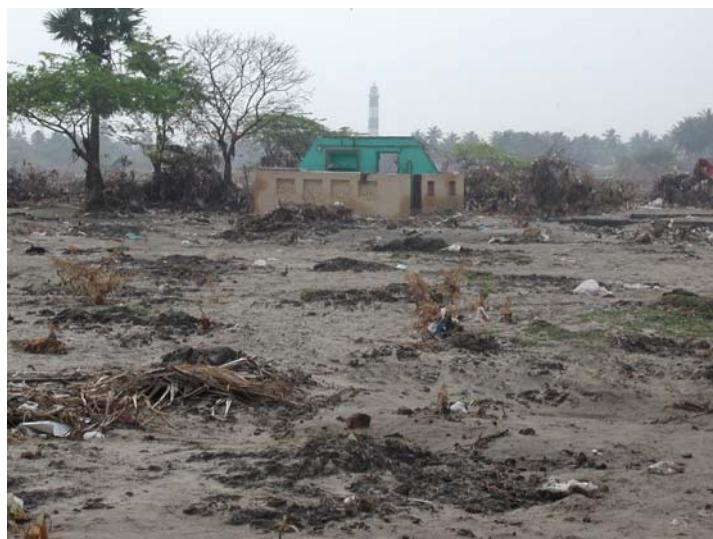
Fig. 8 Distal sand sheet deposits at 430 m position in profile (NAGA01) (computed still-water depth (2.0 m) and surge depth (3.2 m) are well established (Table 6) for this profile position (see Figure 7); inundation continued for another 370 m distance landward of this position without sand sheet deposition; Nagapattinam lighthouse is in photo background behind the collapsed structure; photo view direction is to the south)

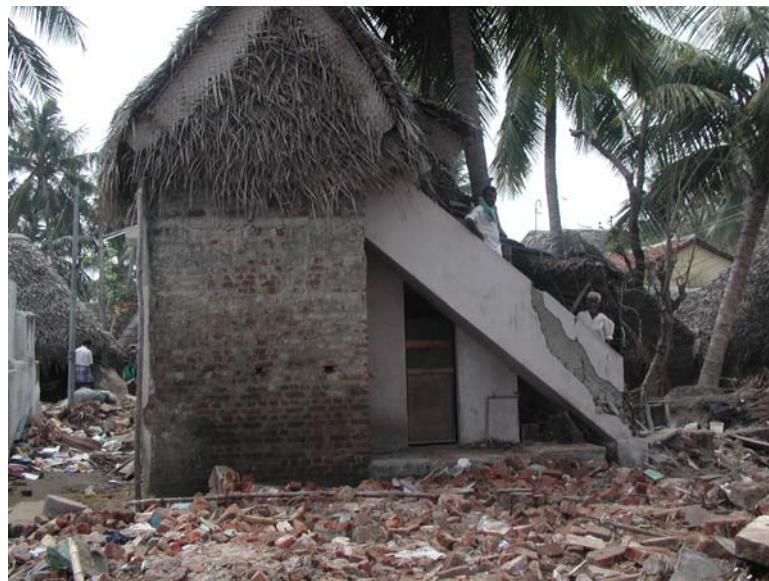
Fig. 9 Measured still-water depth (2 m) and surge depth (3 m) on a remnant standing structure in a proximal position (150 m landward of backshore) in Nagapattinam (this site is located northwest of the Nagapattinam lighthouse; rubble is from collapsed buildings adjacent to the standing structure; this neighborhood suffered substantial loss of life; photo view direction is to the south)

Most of the single story structures in the proximal settings of the surveyed profiles are only 2.5 m in height above ground surface. Surge water depths in excess of 2.0 m occurred in at least one half of the measured profiles that contained unambiguous, maximum surge water levels (Table 6). The largest, concentrated loss of life in the field area occurred in the NAGA01 locality, with a measured surge water depth of at least three meters at a distance of 430 m from the profile swash zone (Figure 6). This surge depth was greater than the height of single story residences in proximal positions. The surge depth also reached the second floor of multi-story buildings in proximal neighborhoods of Nagapattinam, located just south of the NAGA01 profile (Figure 9).

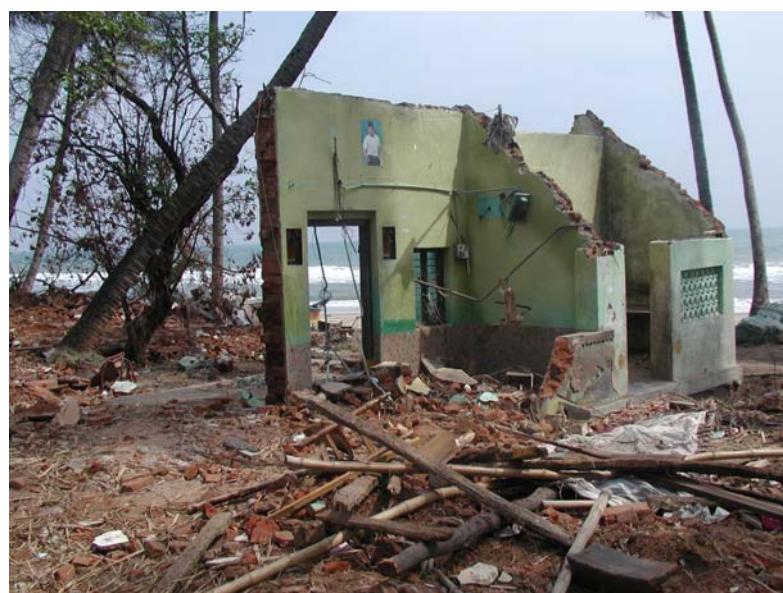
Fig. 10 Photograph of asymmetric damage and bimodal beam orientation indicating transient southwest oblique tsunami flow near profile DEVA01 (the catastrophic collapse of the trailing wall suggests that failure resulted from unbalanced internal pressures of the water-filled structure; photograph view direction is to the east; the structure is about 40 m landward from the swash zone, with shoreline visible in photo background).

Secondary shore-parallel flow was enhanced in some proximal high-gradient localities, such as profile DEVA01, where oblique surge attack (Table 2) set-up alongshore flow against a stabilized dune ridge (Figure 10).

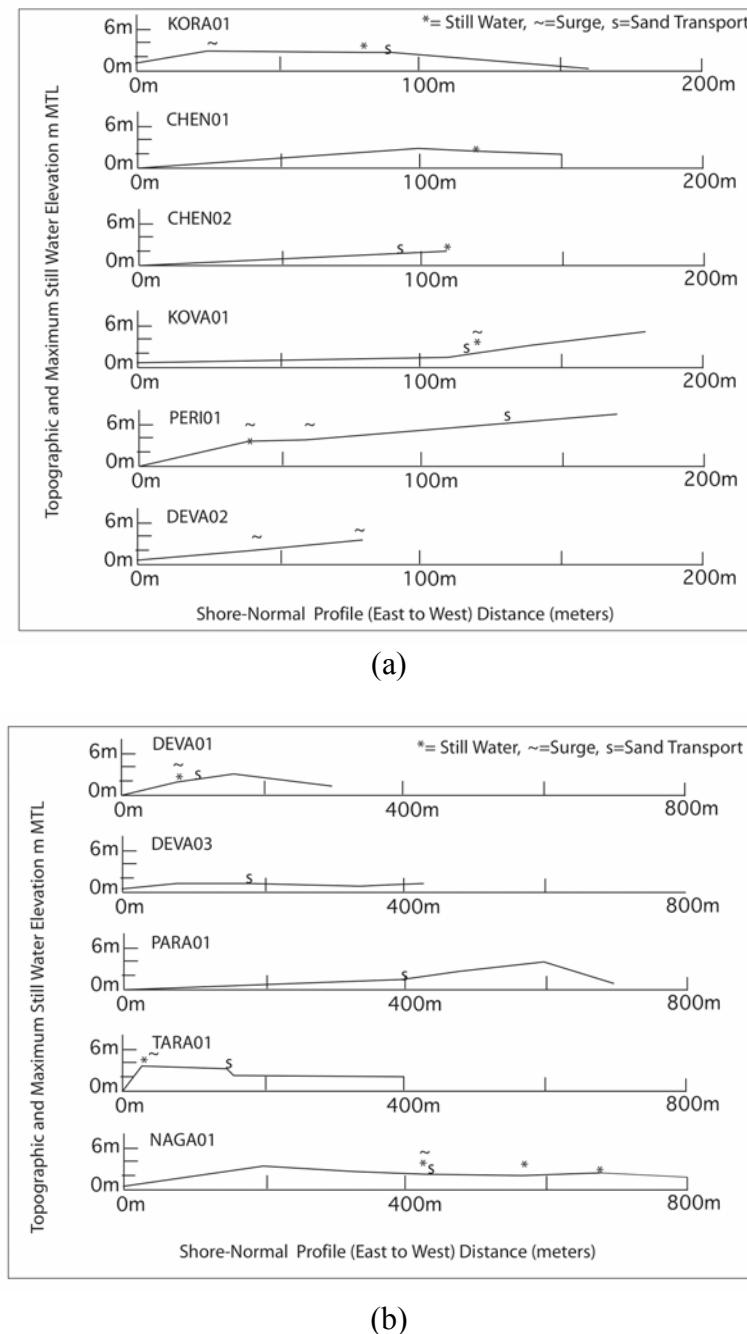
Fig. 11 (a) Shorter inundation profiles (less than 200 m distance), (b) Longer inundation profiles (greater than 300 m distance), showing topography (lines), maximum inundation distance (line terminations), and maximum still-water elevation (*), maximum surge elevation (~), and maximum distance of sand transport (s) (all distances are measured from the swash zone, i.e. zero distance, and elevation data are from Tables 3 and 5)

The measured range of tsunami flood elevation, i.e., maximum still water (2-4 m MTL), was very close to the coastal relief in SE India (Figure 11). Small differences in flood elevation and coastal topography resulted in large differences in tsunami inundation (140-840 m), and associated loss of life. Maximum still-water elevation is not correlated to local beach gradient (Table 9), so it is assumed to reflect regional forcing and effects from offshore topography. The small increase in maximum still-water elevation from the northern profiles (2-3 m MTL) to the southern profiles TARA01 and NAGA01 (4.3-4.4 m MTL) proved to be critical for life safety in the low-lying, coastal villages and cities in the Tamil Nadu region.
