## **ATHENS EARTHQUAKE OF 7 SEPTEMBER 1999: INTENSITY MEASURES AND OBSERVED DAMAGES**

### **ABSTRACT**

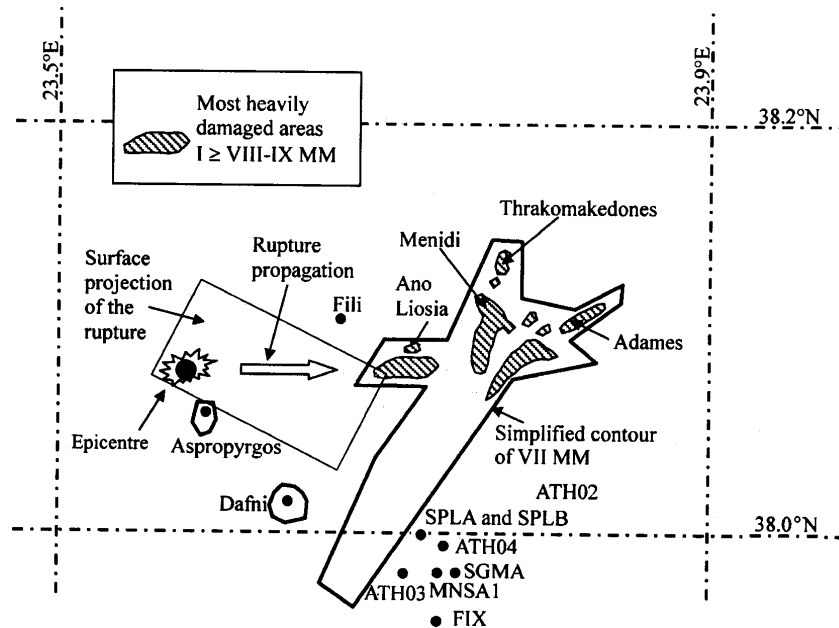
Fig. 1 Regional overview of the epicentre, meizoseismal area, isoseismal lines, and distribution of the accelerographs

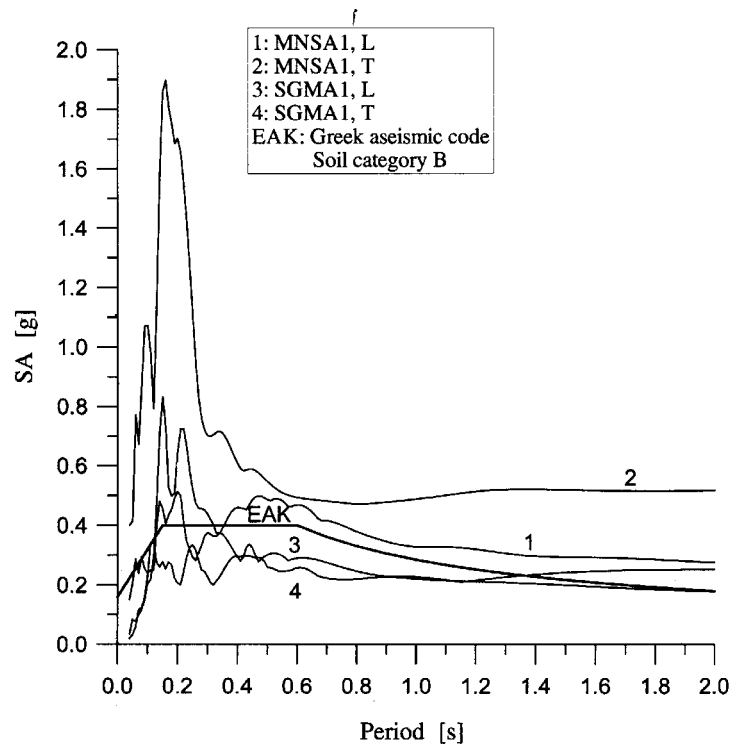
**Fig. 2** Elastic response spectra of the accelerograms 1-4 and the recent EAK design spectrum

Figures 2 to 5 show the elastic acceleration response spectra (5% damping) of all accelerograms included in Table 2, and the elastic design spectrum for the soil category B (medium soil) of the recent Greek aseismic code (EAK-2000). These figures expose the variations in spectral values, although the epicentral distances are comparable for all the examined records. This fact points to the evidence of the influence of the local conditions on the strong ground motion. It can be observed that the numerical values of the response spectra of several records are greater than the values of the design spectra, especially in the low period range.

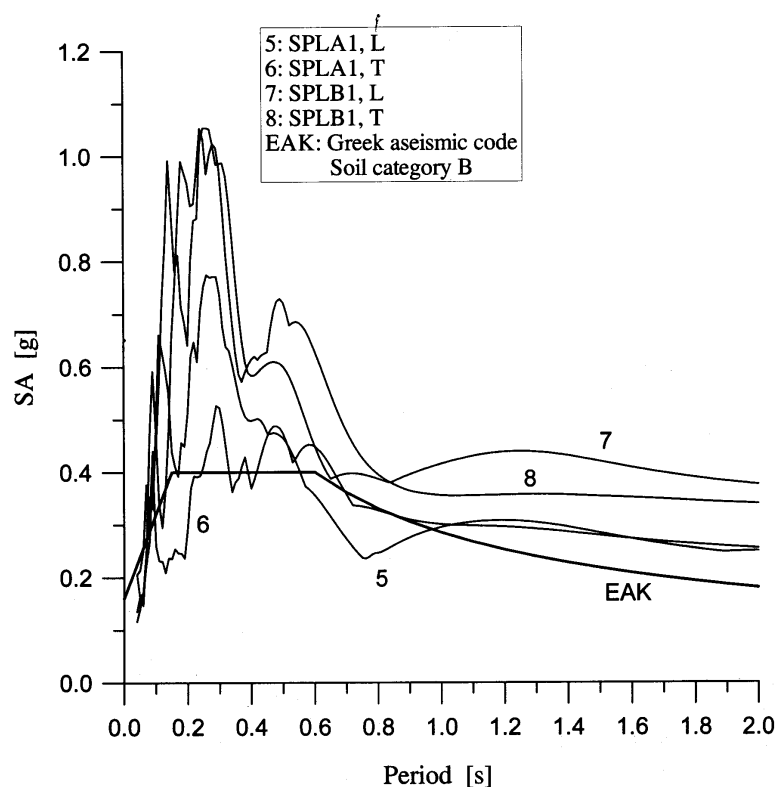
Fig. 3 Elastic response spectra of the accelerograms 5-8 and the recent EAK design spectrum

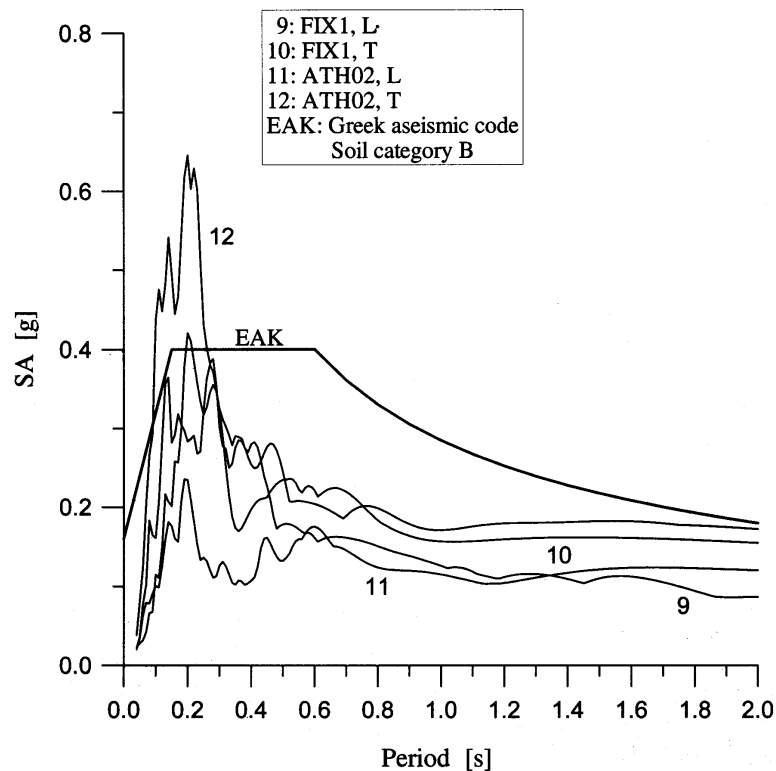
Fig. 4 Elastic response spectra of the accelerograms 9-12 and the recent EAK design spectrum

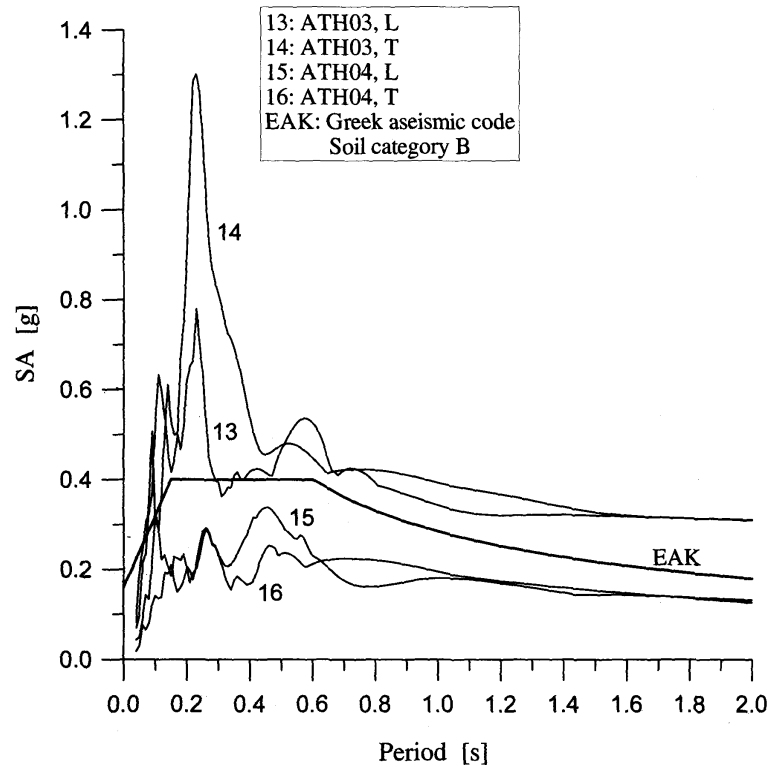
Fig. 5 Elastic response spectra of the accelerograms 13-16 and the recent EAK design spectrum

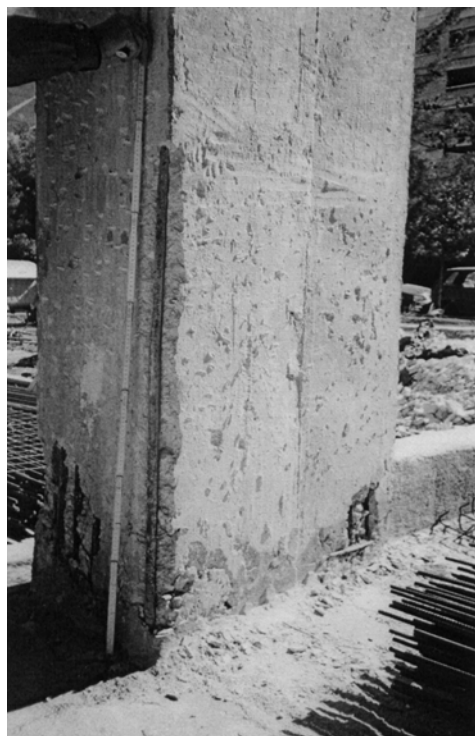
Fig. 6 Exposed column reinforcement bar without stirrups

Figure 6 shows insufficient stirrups at the bottom of a column, at the soft ground floor of a 10-storey reinforced concrete building. Stirrups are absent up to a height of 1.20 m. Figure 7 presents an exposed reinforcement anchorage hook without stirrups at the base of a column. Figure 8 shows a buckled longitudinal reinforcement bar of a column. All these figures underline the absence of stirrups in critical regions.

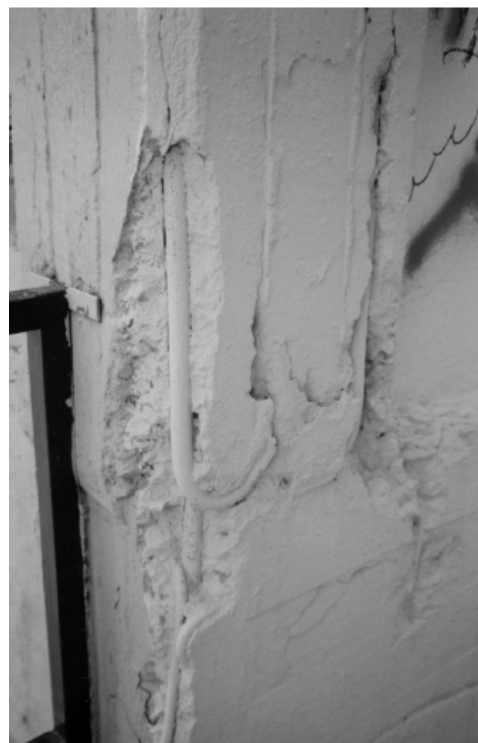
Fig. 7 Exposed anchorage hook without stirrups at a column

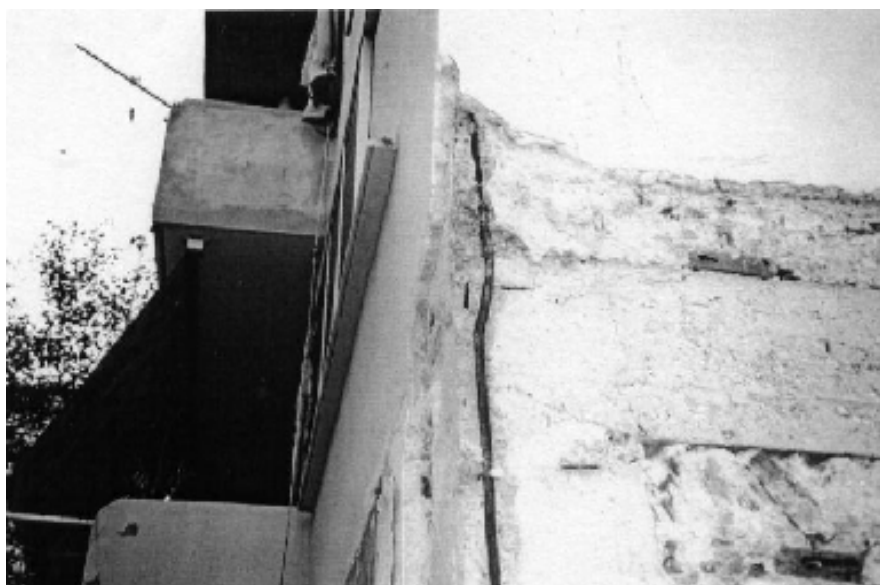
Fig. 8 Buckled reinforcement bar and minimal stirrups

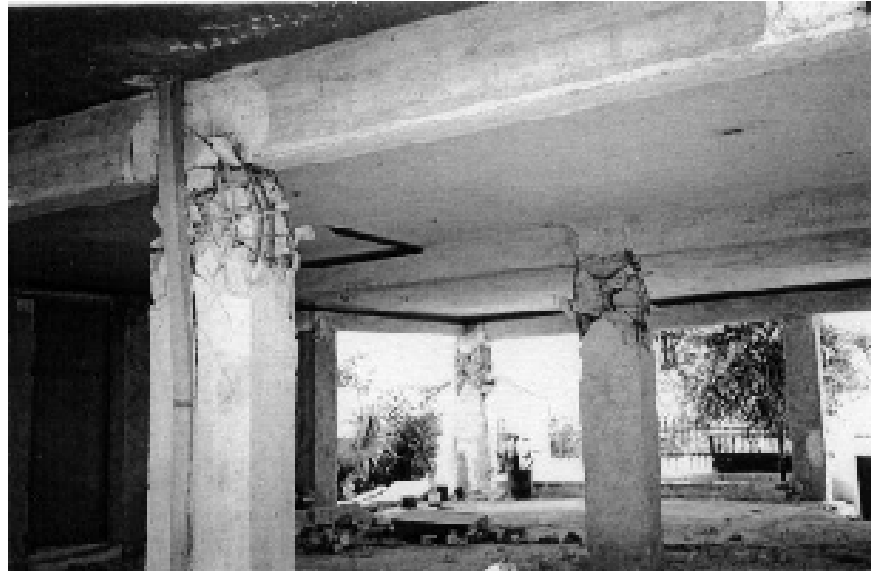
Figure 9 shows damages at the top of columns due to inadequate reinforcement. The columns were placed in the soft ground floor of a reinforced concrete building. Soft storeys frequently led to minor or heavy damages, up to the point of collapse. Figure 10 shows column damage in a soft storey, and the reinforcement deficiency is obvious. An x-shaped crack on a reinforced concrete wall is presented in Figure 11. It is placed at the soft ground floor of a building. A very common observed failure is the x-

Fig. 9 Damaged beam-column joint in a soft first storey

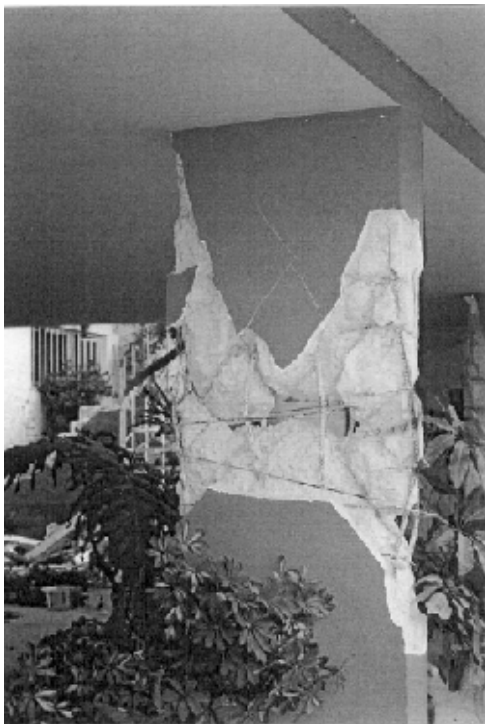
Fig. 10 Failure of column in a soft first storey

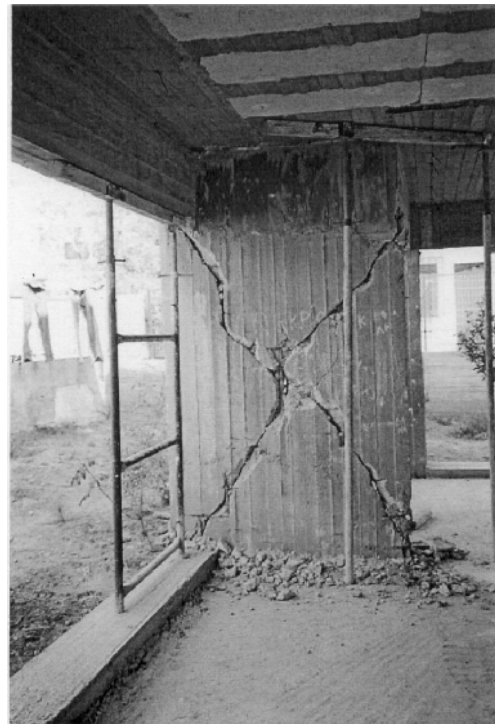
Fig. 11 X-shaped shear crack on a reinforced concrete wall

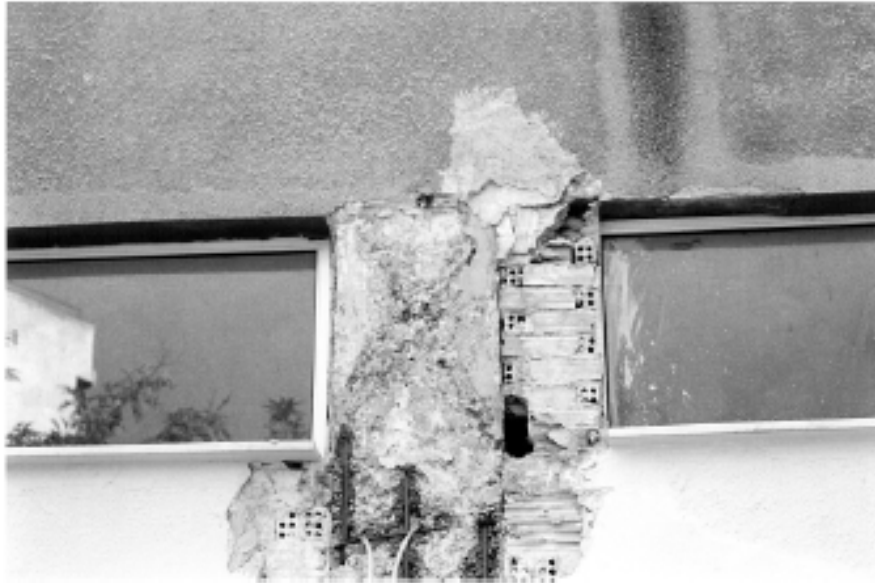
shaped crack in short columns, as shown in Figure 12. In addition, Figure 13 presents a shear crack in a short column due to insufficient confinement. Figure 14 shows the partial collapse of a staircase, due to short anchorage length of the longitudinal reinforcement. The mid-part building collapse presented in Figure 15 was caused by short anchorage length of the longitudinal reinforcement of the mid-part beam. Figure 16 shows the partial collapse of a building, initiated by the failure of a column at the soft ground floor.

Fig. 12 X-shaped crack in a short column

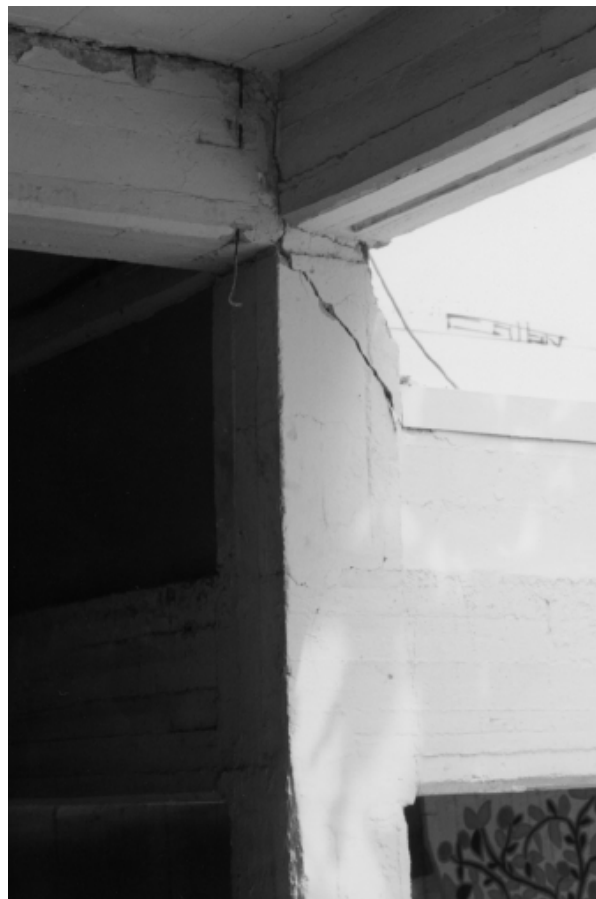
Fig. 13 Shear crack in a short column

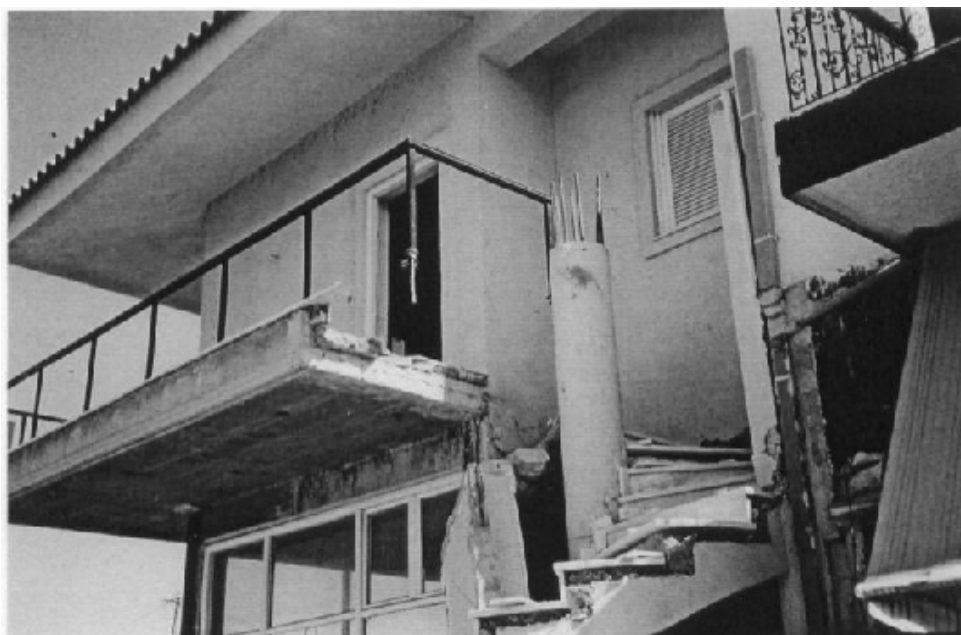
Fig. 14 Partial collapses of a staircase

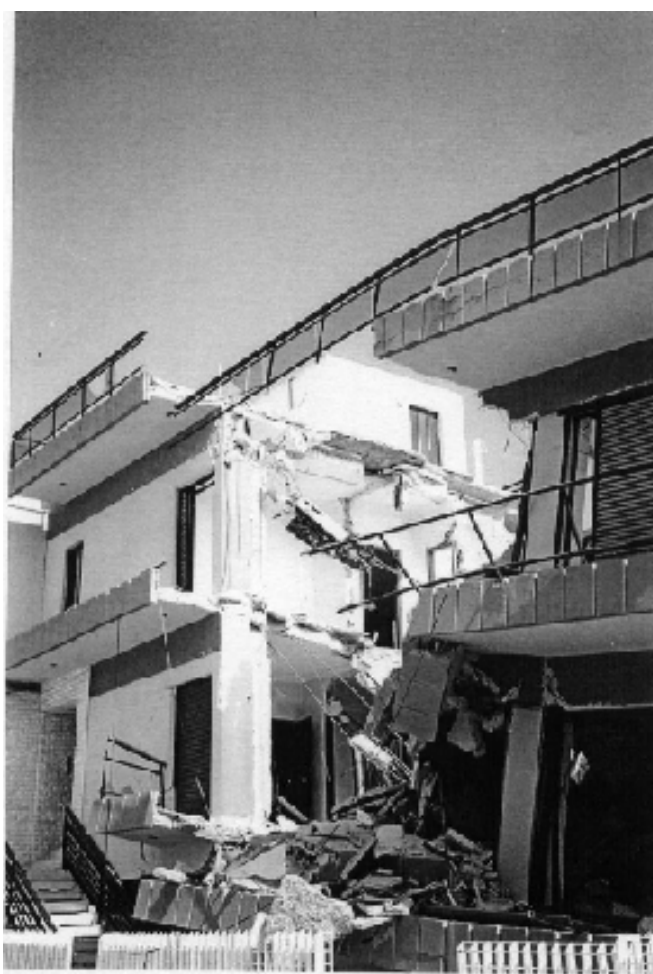
Fig. 15 Collapse of the middle part of a building

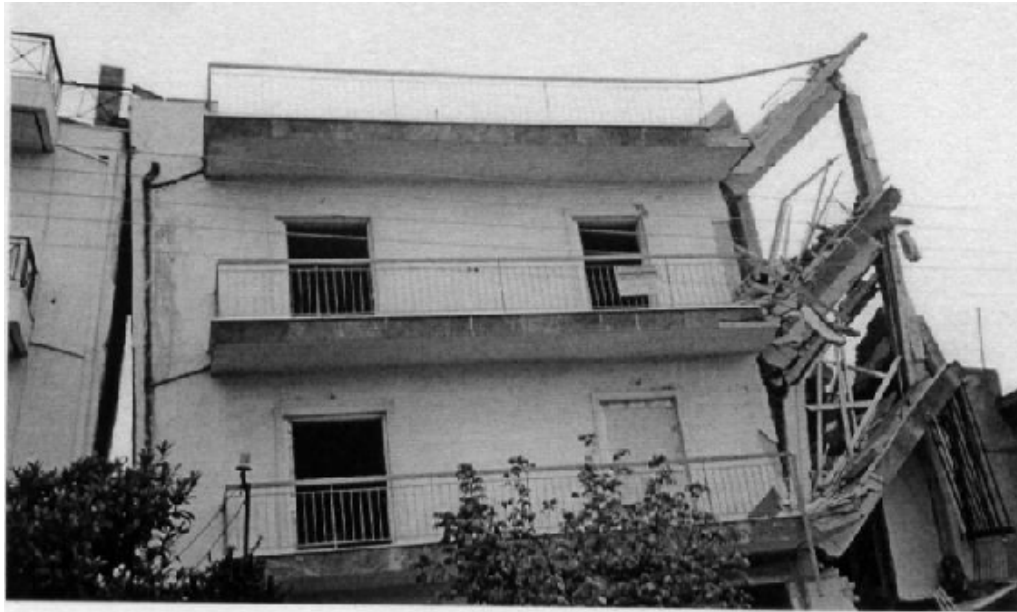
Fig. 16 Partial collapse of a reinforced concrete building

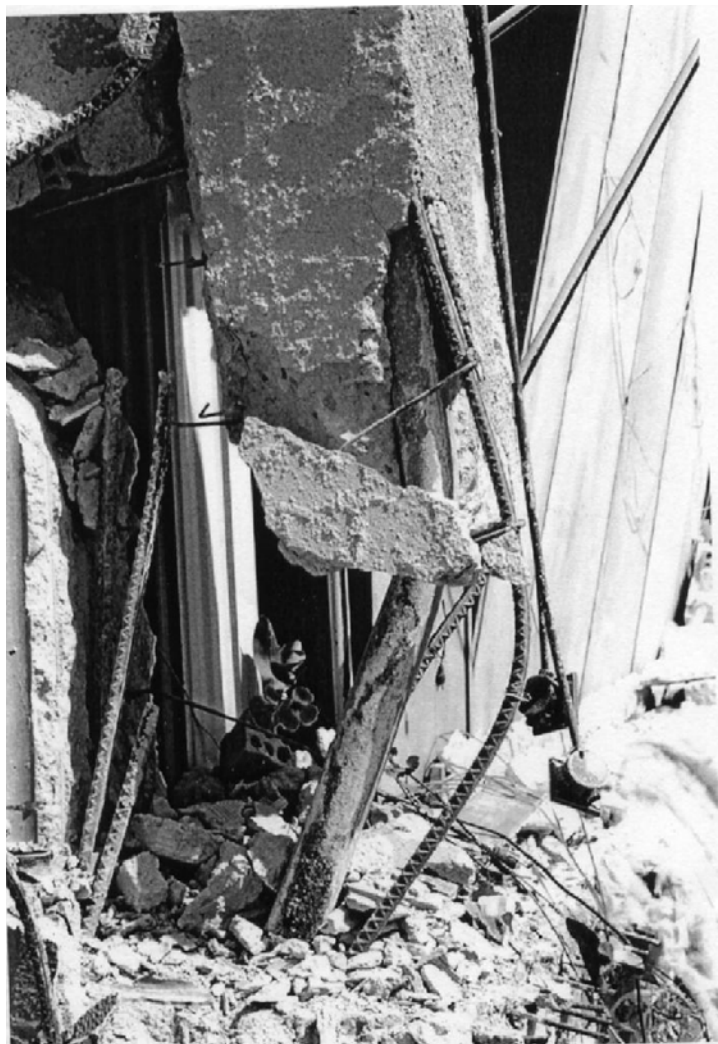
Unexpected installations put into structural components led to damages. For example, Figure 17 shows a drainage pipe built into a collapsed column. Poor stirrup reinforcement can also be observed. Moreover, Figure 18 shows an electrical cable installation built at the top of a column, which decreases the column strength in a potential plastic hinge region. Figure 19 shows hooks of longitudinal wall reinforcement of a 10-storey reinforced concrete structure, terminated just above the floor slab. It is obviously an inadequate anchorage of wall-reinforcement. In the same building, large gaps due to improper concrete pouring and compacting were observed, as shown in Figure 20.

Fig. 17 Pipe for drainage put into a column

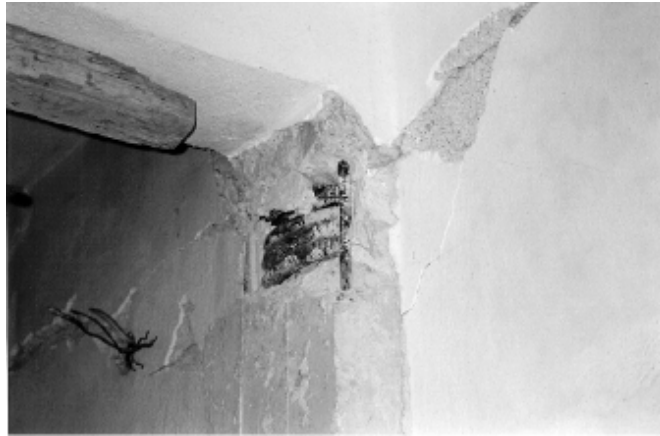
Fig. 18 Electrical cable installation put in a column

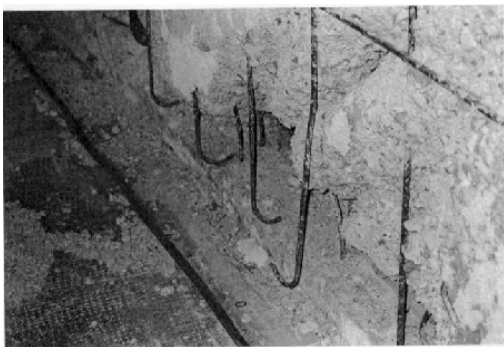
Fig. 19 Inadequate anchorage of a wall-reinforcement

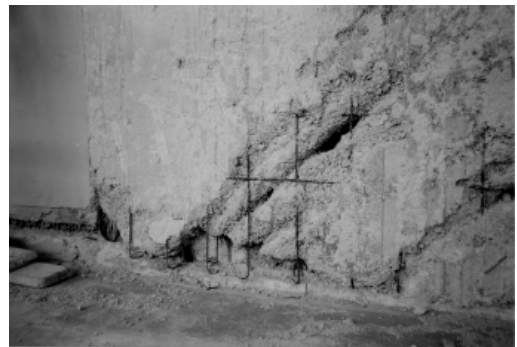
Fig. 20 Large gaps due to improper concrete pouring and compacting

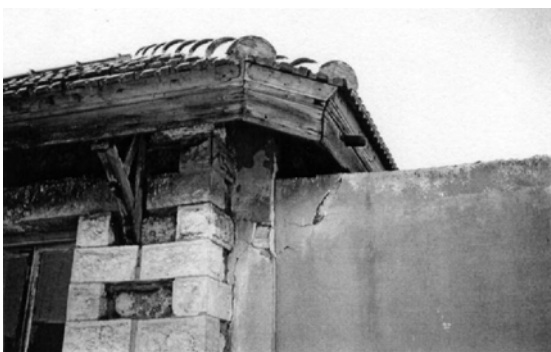
Pounding effects among adjacent structural elements or buildings led frequently to damages. For example, Figure 21 shows damage caused by pounding between a stone masonry and a reinforced concrete structure. In addition, a beam failure caused by pounding between the beam and the column next to it, is shown in Figure 22. It points to shear failure in a short beam. Furthermore, deficiencies in the construction of gaps also led to damages, as is shown in Figure 23. Here, a reinforced concrete column and wall are separated by an improper expansion gap. In addition, Figure 24 exposes a simulated expansion gap. Here, the columns were initially built together. After that, an electrical cutting machine has cut a 5 cm deep gap. During this process, the stirrups have also been cut. Moreover, the gap was filled with polystyrol material to simulate a properly constructed gap. Frequently observed damages were x-shaped cracks in masonry infill walls, as shown in Figure 25. Figure 26 shows a collapsed roof parapet, lying at the playground of the school.

Fig. 21 Damage due to pounding of adjacent building

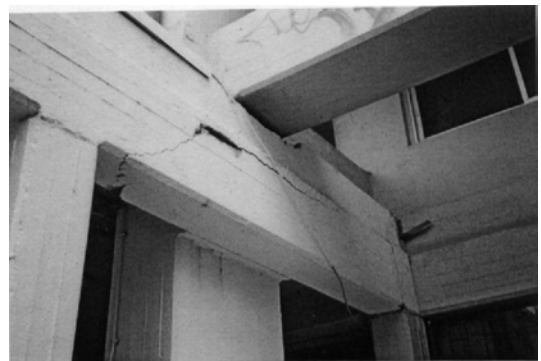
Fig. 22 Failure of a beam due to pounding

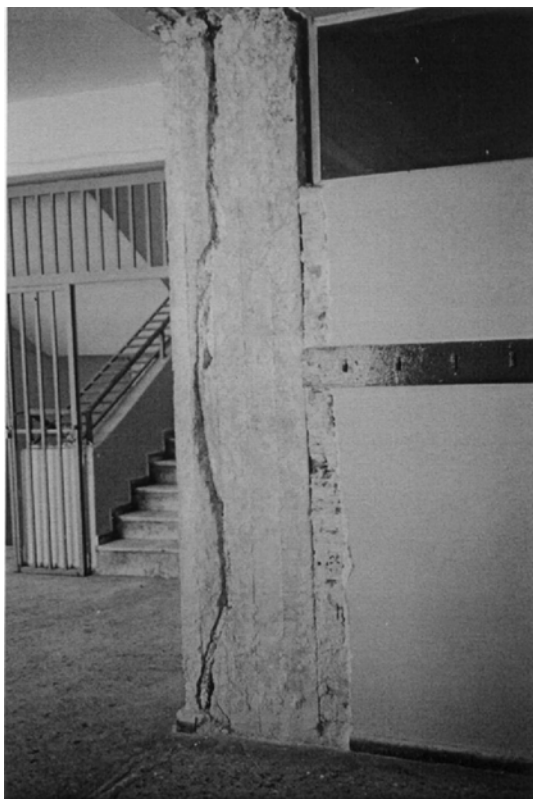
Fig. 23 Improper construction of a gap

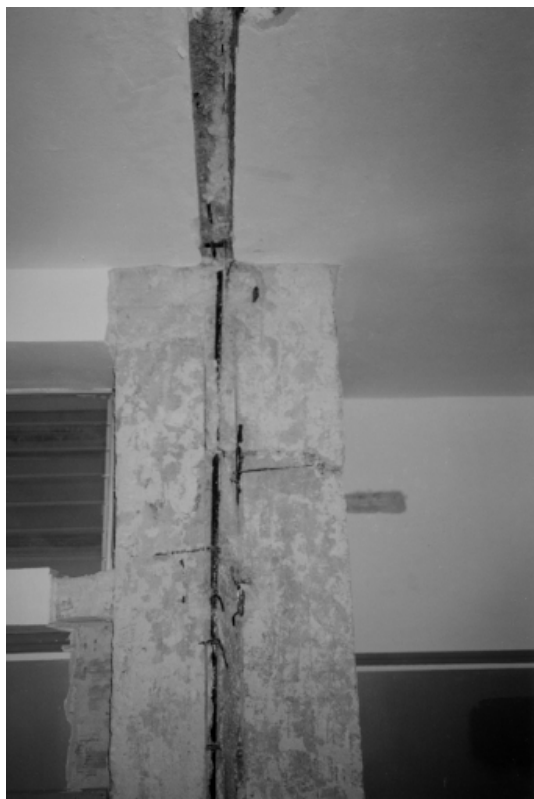
Fig. 24 Damage in a simulated expansion gap

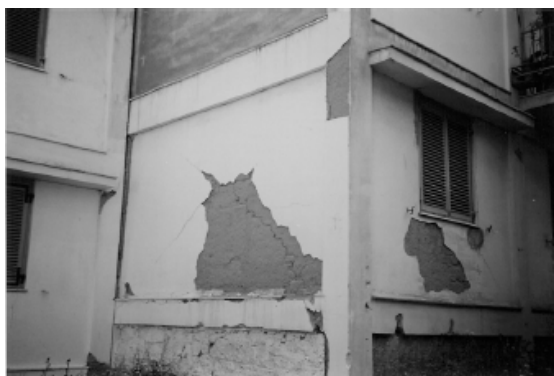
Fig. 25 Masonry failure with x-shaped cracks

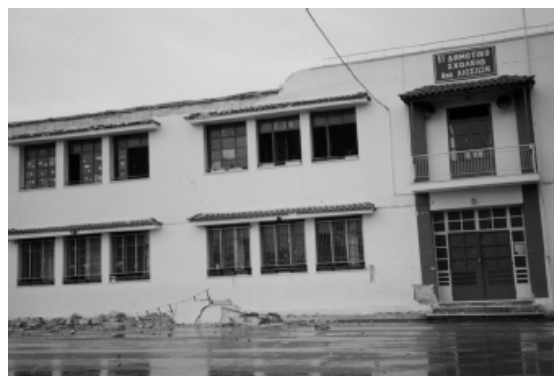
Fig. 26 Collapse of a roof parapet

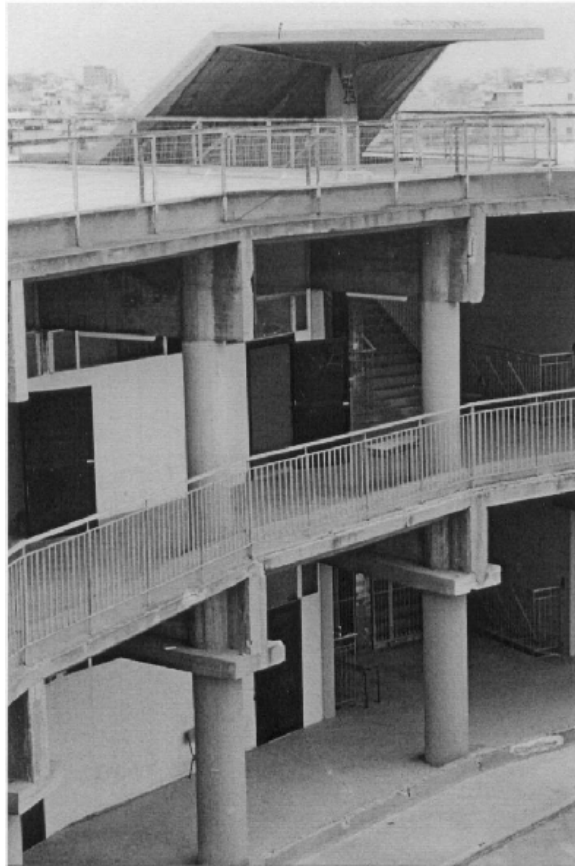
During the post-earthquake inspection process, several deficiencies were observed in the architectural design of buildings. As examples are presented first, a weak column and strong beam system, as shown in Figure 27. Plastic hinges may appear at the columns, which is an undesirable phenomenon during seismic excitation. Secondly, a long cantilever beam system (up to ten metres) is used for sun protection, as shown in Figure 28. In the latter case, additional mass is added to the dynamical system of the building. Furthermore, because it was built at the beginning of 1960's, there is a reason to believe that no special design considerations were made to resist seismic vertical vibrations. Although no significant damages were found on those buildings, the architectural deficiencies can be protagonists in a future earthquake.

Fig. 27 A weak column and strong beam system

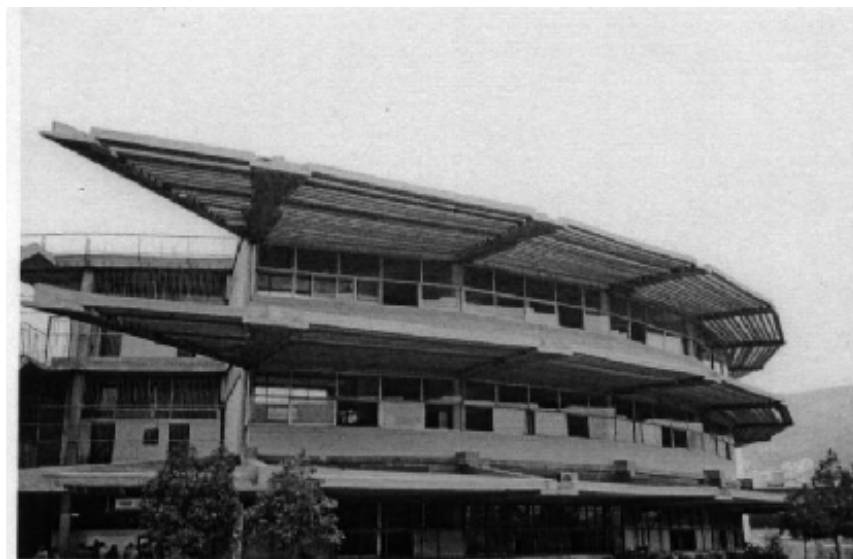
Fig. 28 A long cantilever beam system
