ANALYTICAL STUDY OF LIVING ENVIRONMENT IN THE TSUNAMI-AFFECTED AREAS OF TAMIL NADU, INDIA

Vasudha A. Gokhale
Dr. B.N. College of Architecture
Karve Nagar, Pune-411052

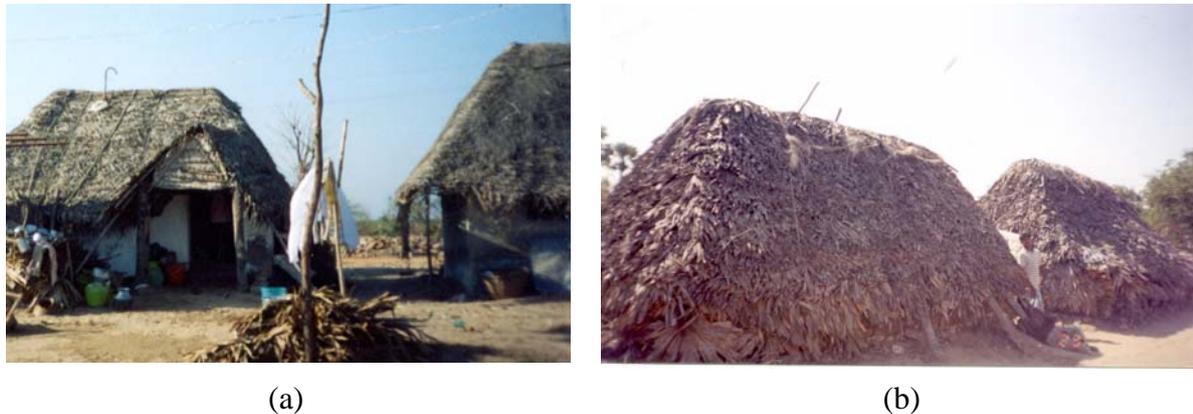
Building stock along the coast generally consists of non-engineered and semi-engineered constructions, built with locally available materials like mud, coconut thatch, bricks, wood etc. A typical fishermen hut is a small unit consisting of 1-3 rooms. It has small openings with wide overhanging roof to face the severe climate, and consists of a living space and a semi-covered cooking space, the floor of which is finished with cow dung coating and mud to provide a cool and soothing environment inside. The thatched roof is often tied with coconut ropes (Figure 2).

Fig. 2 (a) Typical fishermen hut in Tamil Nadu, (b) A typical fisherman hamlet

Very shallow foundations, not more than 900 mm deep, and 150 to 300 mm high plinth are some of the characteristic features. The houses belonging to rich families are made of bricks, finished with mud or cement mortar, and are covered with a tiled roof. Room sizes vary from 10 to 15 square meters. Another type of dwelling is a brick building with mud or cement and sand mortar. Pitched roofs are often covered with locally available mud tiles placed on wooden rafters and purlins. Majority of tsunami-hit areas consisted of rural houses, which were totally ravaged. Many reinforced cement concrete framed buildings faced partial collapse and non-structural damage; here, the extent of damage was attributed to the dashing of floating objects to the structures, faulty architectural configuration, and poor structural strength of the structures because of lack of maintenance and aging. Tables 1 and 2 show the materials generally used for construction in the tsunami-affected areas of Tamil Nadu (BMTPC, 1997).

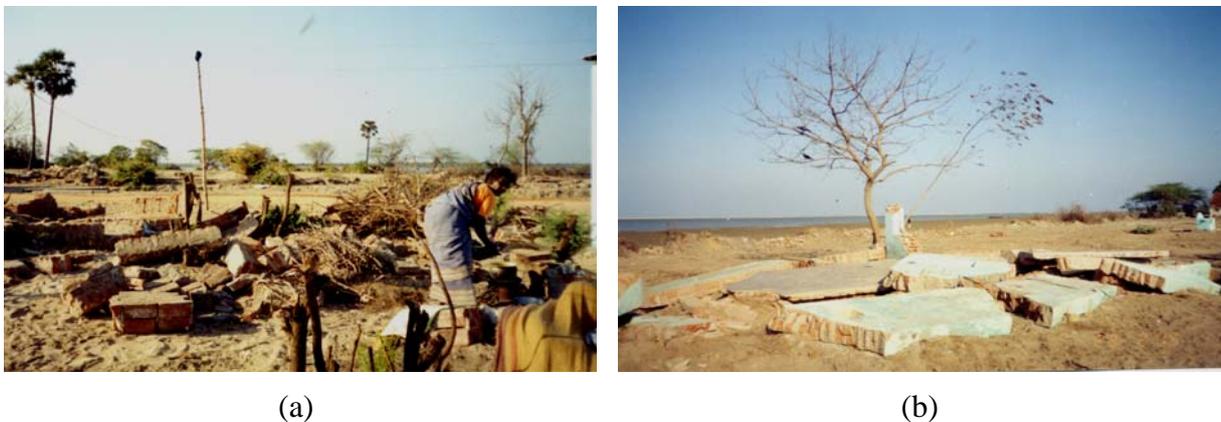
The tsunami exposed the vulnerability of the fishing community on the Tamil Nadu coast. Almost all non-engineered huts were washed away, while semi-engineered houses faced heavy damage in many villages along the coast (Figure 6).

Fig. 6 (a) A totally ravaged hamlet in Cuddalore, Tamil Nadu, (b) Total collapse of a semi-engineered house in Muzhukuthurai, Tamil Nadu

It was observed that in addition to the total absence of a disaster warning system and the unawareness of the inhabitants, there are many factors concerning architectural development (Christopher and Elsseser, 1982), which resulted in the catastrophic failure of building stock and the subsequent loss of life and property (Dowrick, 1972). Waves rose up to 6 meters and reached the second floor of houses in many places. A large number of fishing villages were totally ravaged (Table 3).

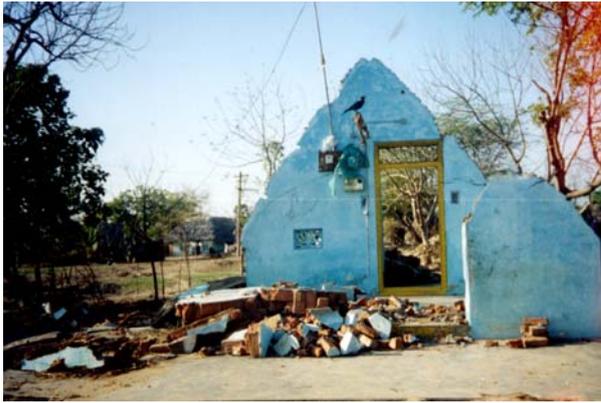
Many semi-engineered structures, which were located near the coast, were seriously damaged. Brick walls with substandard mortar failed and collapsed (Figure 7). Living areas located within a distance of 2.5 km from the coastline remained flooded for a considerably long period of time, and rescue operations were difficult in the worst affected areas like Nagapattinam, Cuddalore and Kanyakumari. The debris carried away by the waves caused a number of problems in areas not directly hit by the tsunami (Figure 8).

Fig. 7 A collapsed semi-engineered house at Muzukuthurai, near Pichvaram

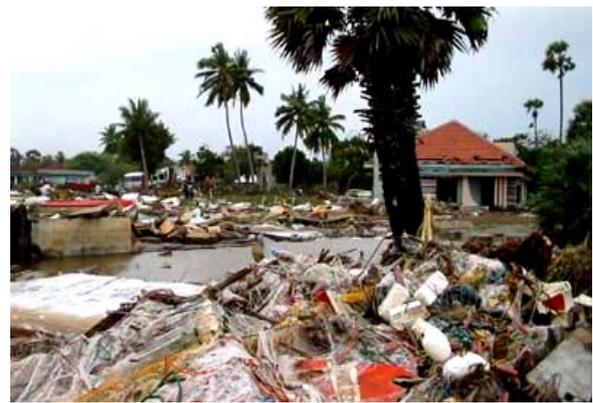
Fig. 8 Debris collected in front of an undamaged house

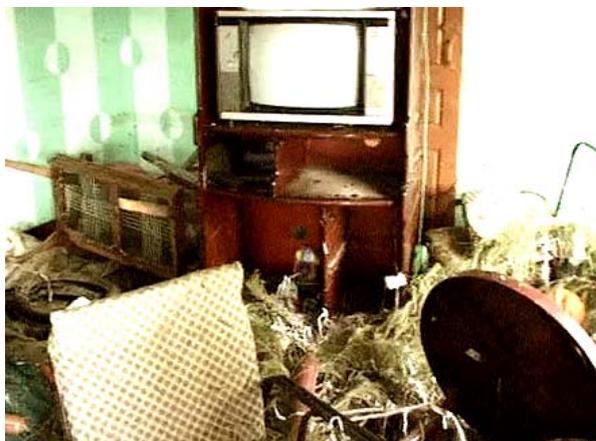
In areas about 1 to 2 km away from the coast water entered inside and resulted in moderate damage. In a large number of semi-engineered houses, walls facing the tsunami collapsed and all the furniture was washed away with the inhabitants (Figure 9). Water entered the villages and blocked the accesses, thus trapping many people inside their houses. This phenomenon resulted in panic and increased the extent of damage to the living environment in the affected areas (Figure 10).

Fig. 9 Destruction to house interior

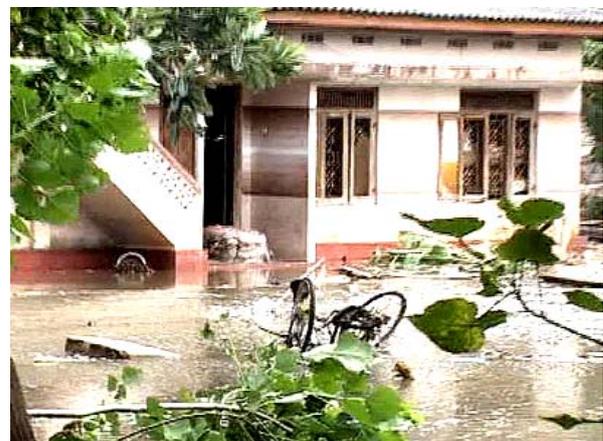
Fig. 10 Blocked access in a well-built residential unit

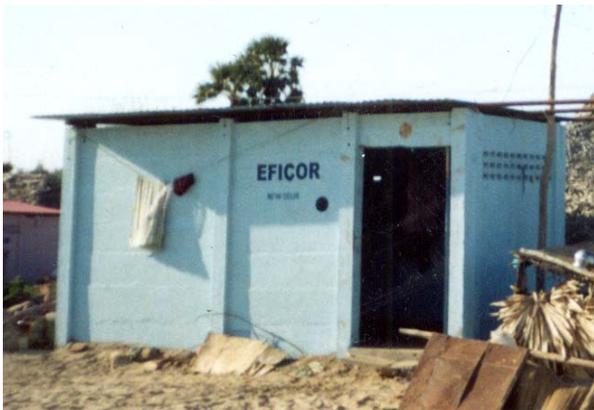
Many temporary shelters, designed without considering the severe heat and space requirement have failed to serve the purpose (Figure 11). A box-like temporary house made of Ferrocete walls (walls constructed with steel mesh and cement concrete) and very thin roof have resulted in inside temperatures rising to 30-50°C, which is much higher than the desirable temperature. Absence of adequate openings for light and ventilation have created highly uncomfortable and unhygienic indoor environment.

Fig. 11 A small-sized temporary shelter without adequate provision for light and ventilation

Tamil fishermen community which is largely conservative and used to living in a joint family system, having 6-8 family members on an average, refused to live in small 2.5×3.0 m size temporary shelters, because the space was not enough to provide shelter for the family. The survival of victims in the absence of space for cooking and washing became difficult. Many open tent-like shelters failed to provide a feeling of security to the victims who were in a state of trauma (Figure 12). It has been observed that many rehabilitation projects consisted of shelters made of locally available materials like coconut mats and thatch roof in addition to modern materials like polythene or galvanized iron sheets. They proved successful in providing the required physical comfort (Gokhale, 2002) because of the insulation provided with the use of coconut-thatched roof.

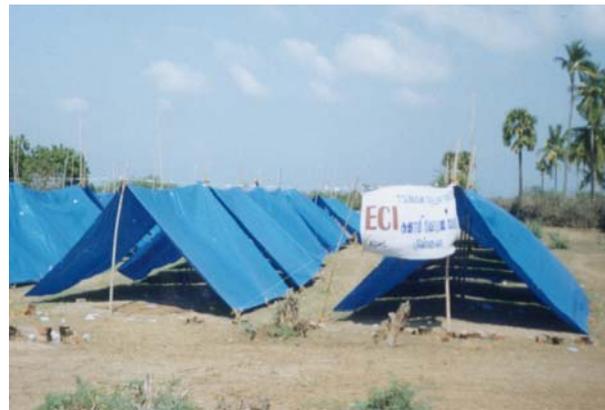
Fig. 12 Empty temporary shelters in Pichvaram
