Performance of elevated tanks in M_w 7.7 Bhuj earthquake of January 26th, 2001

DURGESH C RAI

Department of Civil Engineering, Indian Institute of Technology, Kanpur 208 016, India.

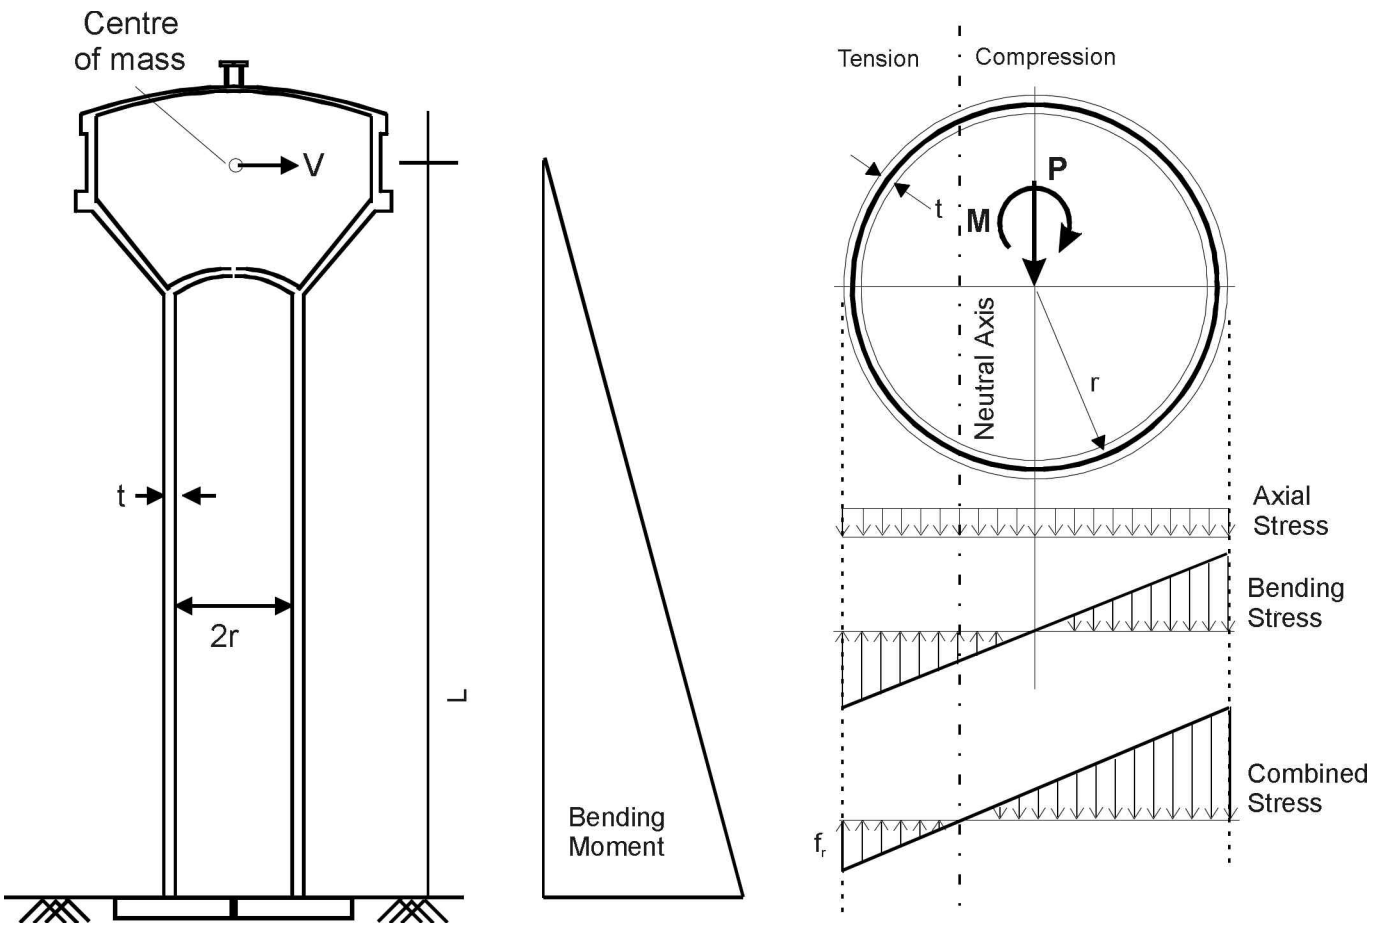
As shown in figure 7 due to lateral seismic forces on tank structures, the maximum moment occurs at the base of the staging and for circular shaft type staging the points on the outer fibers of the staging section are subjected to maximum bending stress. The critical stress for design is obtained by combining this maximum bending stress with the uniform axial compression stress due to the weight

of the tank structure. For the section to crack, it is necessary that the combined stress at outer fibers exceeds the tensile strength of the concrete, f_{cr} . Assuming thickness of staging t to be much smaller in comparison to the radius of staging r , and ignoring the small percentage of shell reinforcement, the expression for the moment which will cause cracking, M_{cr} , can be obtained by equating combined stress at outer fiber to the tensile strength of concrete, i.e.,

Figure 7. Stresses developed in shell staging.

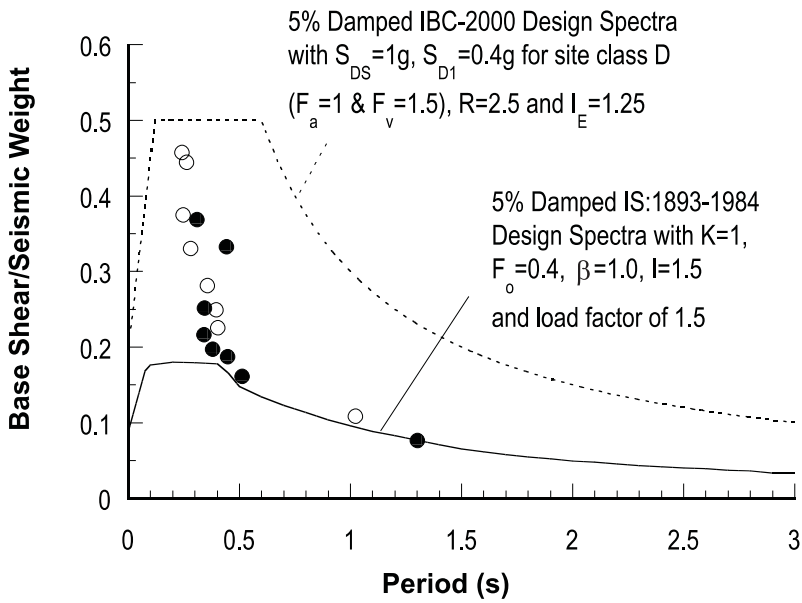
In figure 8, the available shear strength in stagings of the affected tanks is compared against the lateral strength required by IS:1893-1984 (BIS 1984) in the Seismic Zone V, the highest seismic zone in which most of the affected tanks are located. For a sample of eight tanks, the provided lateral strength against tensile cracking of staging was either equal or larger than the code required strength and maximum overstrength being as large as 170%. In other words, the stagings do meet or exceed the strength requirements of IS:1893-1984. However, they will be considered seismically deficient due to inadequate lateral strength capacity by International Building Code (IBC 2000) under similar seismic exposure conditions.

Figure 8. Comparison of available shear strength against tensile cracking of eight tanks with base shear strengths required by IS:1893-1984 and IBC 2000 codes, respectively. Open circles represent tank-empty condition while full circles represent tank-full condition.

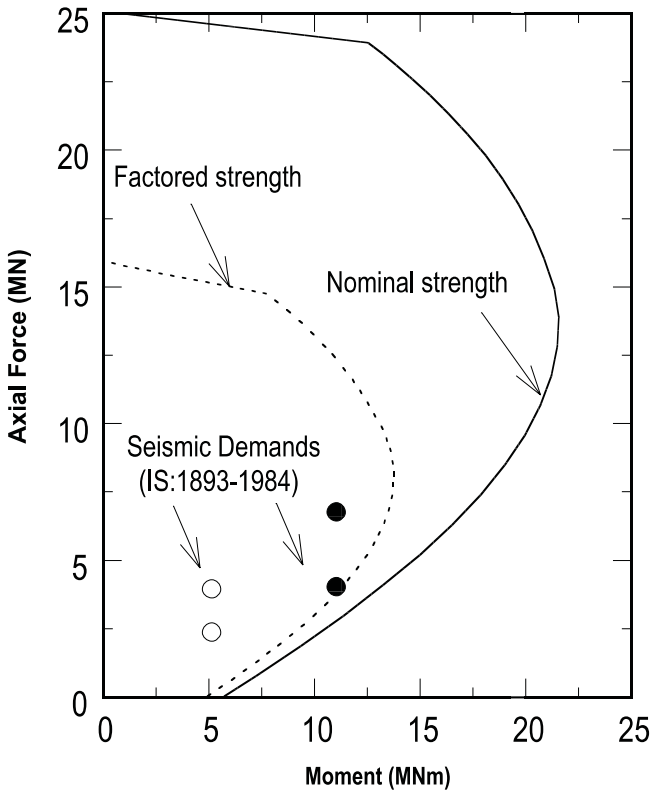
To assess the safety of the structure, the available capacity at the critical section is compared with probable demands specified by IS:1893-1984. The ‘open’ and ‘filled’ circles in figure 9, represent factored seismic demand for empty and full tank cases according to the two critical load combinations. It is clear that the staging of Chobari water tank was probably safe for seismic forces specified by IS:1893-1984, if we ignore the possibility of poor quality construction which can not be ruled out considering its remote location. In other words, the seismic forces were indeed larger than code specified forces on the morning of the earthquake when the tank was about half full. A low seismic design force results in low flexural demand from the staging section which encourages slender stagings with thin shell sections. It is clear that damages observed in stagings of elevated water tanks once again illustrate that the IS:1893-1984 design forces are currently being underestimated by at least a factor of 3 and need an upward revision of forces immediately. In an earlier study Jain and Sameer (1993) have also pointed out this deficiency of IS:1893-1984 and advocated that the forces be increased by increasing the performance factor for elevated water tanks to 3 from the current value of 1.

Figure 9. Envelope of factored and nominal strengths (interaction diagrams) for staging section near the base of the Chobari tank and demands expected for tank-empty and tank-full conditions.
