Performance of harbour structures in Andaman Islands during 2004 Sumatra earthquake

Goutam Mondal, Durgesh C. Rai*

Department of Civil Engineering, Indian Institute of Technology Kanpur, 208016, India

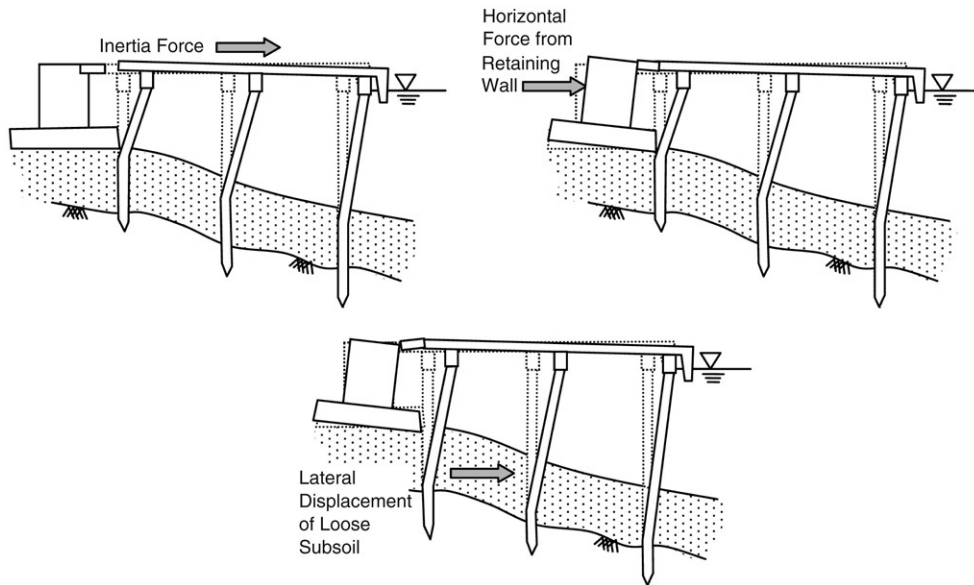
During ground shaking, the response of pile-supported wharves is influenced by complex soil–structure interaction. Typical failure modes depend upon lateral displacement of the deck due to inertia force relative to the ground displacement (Fig. 4). Major features of observed damages of jetties or wharves along with their remedial measures can be described as in the following:

Fig. 4. Failure modes of pile supported jetty.

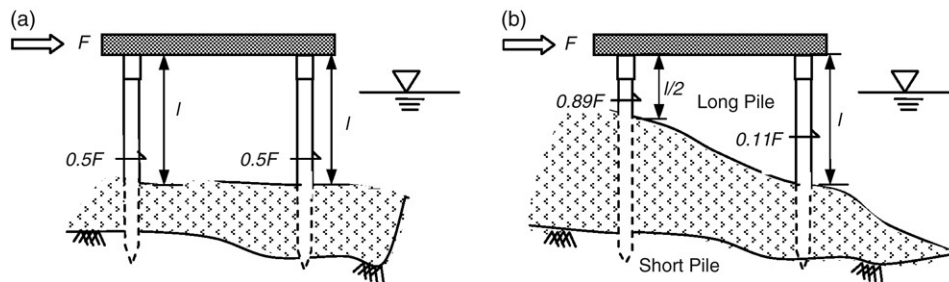
proportional to their bending stiffness. For example, if a wharf is supported on two piles having same properties and if unsupported length of one pile is reduced by half, the pile will be eight times stiffer for lateral loads and as a result it will attract 78% more lateral load than the other pile (Fig. 7). Often this fact is ignored and all piles of varying lengths are assumed to carry the same amount of lateral loads. As a result, the shorter piles are easily overwhelmed by the additional lateral loads.

Fig. 7. Schematic of short-pile effect in jetty (a) Design condition (b) Service condition.

Therefore, slope in the natural and manmade embankment should be considered during design of piles. If short piles are not designed to withstand large amount of shear forces, they may get damaged severely during earthquakes. Such damage was observed in the piles of the approach jetty at Mayabandar where the approach slab fell from the ends due to damage to the short piles (Fig. 6), while little or no damage was observed in the relatively longer piles.

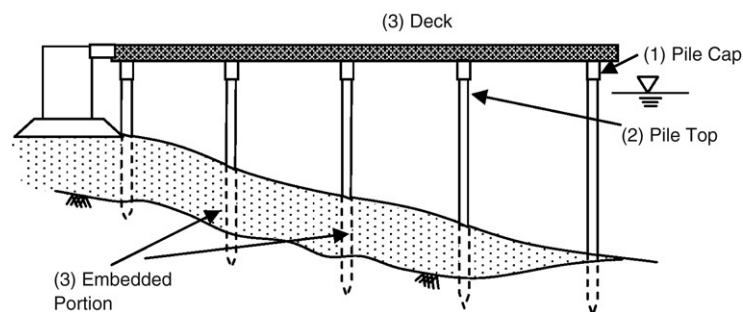
Fig. 9. Preferred sequence for yielding of pile supported jetty depending on ease of restoration.

A part of the berthing jetty at Diglipur Harbour sunk due to pile failure underneath. Failure of piles over the portion embedded in the soil is not desirable since it is difficult to restore. With respect to the ease of restoration and repair, the preferred sequence for yielding of a pile-supported wharf is pile cap, pile top and deck and embedded portion of the pile (Fig. 9). The connection between the wharf deck and retaining wall should be such that it can safely withstand displacement from the retaining wall and it should also be easily repairable.
