Journal of Constructional Steel Research 59 (2003) 971–994

Seismic evaluation and upgrading of chevron braced frames

D.C. Rai^a, S.C. Goel^{b,*}

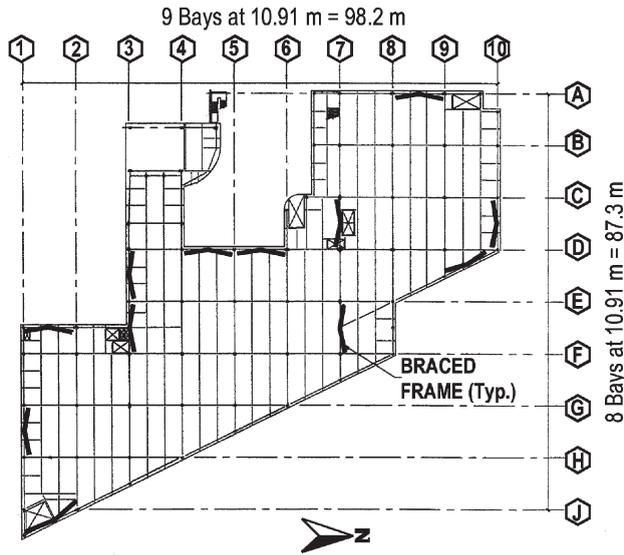
Fig. 2. Framing plan of the first floor of the study building [8].

The lateral load resisting system consists of six braced bays oriented along the two principal directions of the building, as shown in Fig. 2. However, two frames J.5 and D.5 are at an angle with the principal N–S direction. The elevation and member sizes of a typical lateral braced frame are shown in Fig. 3. The foundation consists of both spread footings and drilled piers, where the latter type is used for all columns resisting seismic overturning. Soil investigations indicated that the site is located on a medium to very dense alluvial cohesionless soil, which can qualify as UBC S_2 type soil.

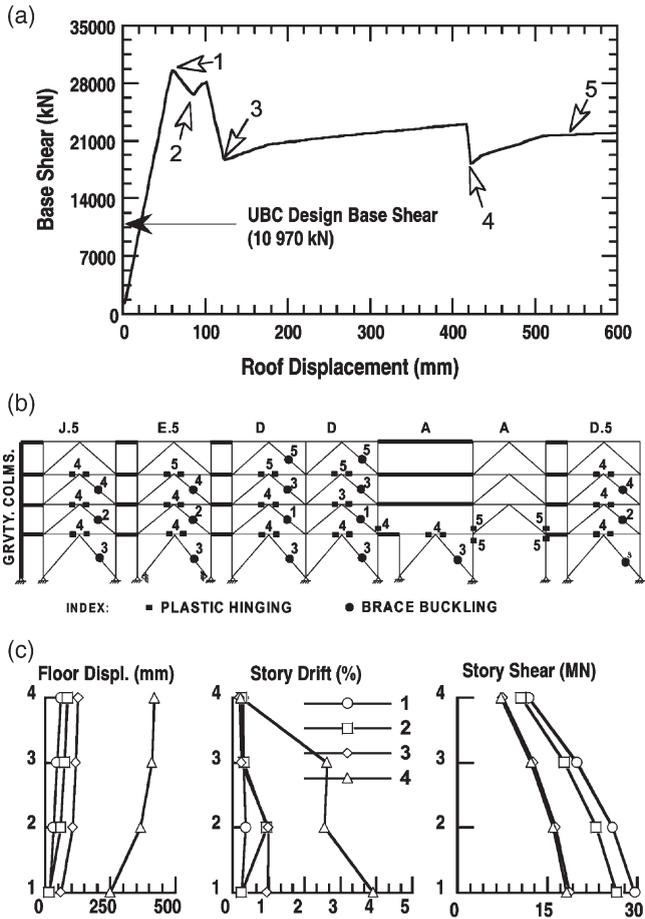
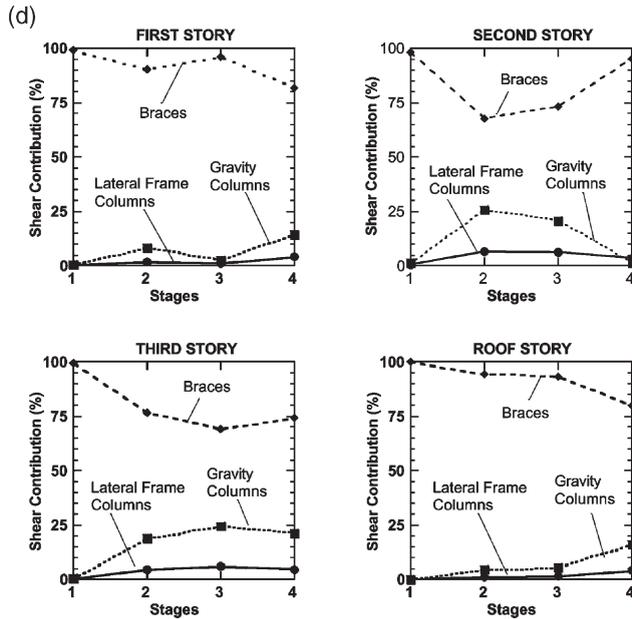
Fig. 5. Pushover analysis of 2-D model (a) Load-displacement curve (b) Force and deformation quantities at various stages of incremental loading (c) Location and sequence of inelastic activities and (d) Variation of story shears resisted by columns at various stages.

The base shear–roof displacement response of the 2-D model is shown in Fig. 5(a). The response is identified by five major events, each representing the occurrence of certain inelastic action in the frame and is illustrated in Fig. 5(b). Inelastic action began with the buckling of braces in the second story with significant loss of strength and stiffness. The next drop in strength and stiffness is noted when braces in the upper stories start buckling. The lateral strength of the frame increases with further redistribution of loads but drops again at the occurrence of plastic hinging of floor beams where chevron braces intersect. In a given story, with the compression braces buckled and the load carrying capacity reduced, the unbalanced vertical loads cause additional flexural demands on the floor beams. This unbalanced force is large enough to cause plastic hinging in the floor beams of lateral frames. Some column hinging in the second story is also observed as resistance demands shift to the columns.

The distribution of floor displacement, story drift, and story shear over the height of the frame is presented in Fig. 5(c) as they change through various stages of the incremental lateral loading. As can be seen, concentration of damage first began in the second story and then progressed to the first story followed by the third story. Deflection responses increased rather rapidly between stages 3 and 4 when plastic hinges in the floor beams were developing.

The shear forces resisted by the columns of lateral frame and gravity frames at various stages of loading are shown in Fig. 5(d). The contribution of columns to total shear is negligible when the structure is elastic, but it increases as the braces buckle, especially for the second and third story columns. The columns carry about 30% of the total shear following the brace buckling in a given story. Lateral and gravity columns as “non-considered” and redundant elements in CBF system can participate in a significant manner in resisting lateral loads following the strength loss due to brace buckling. This inherent characteristic of CBF system should be recognized in the design process.

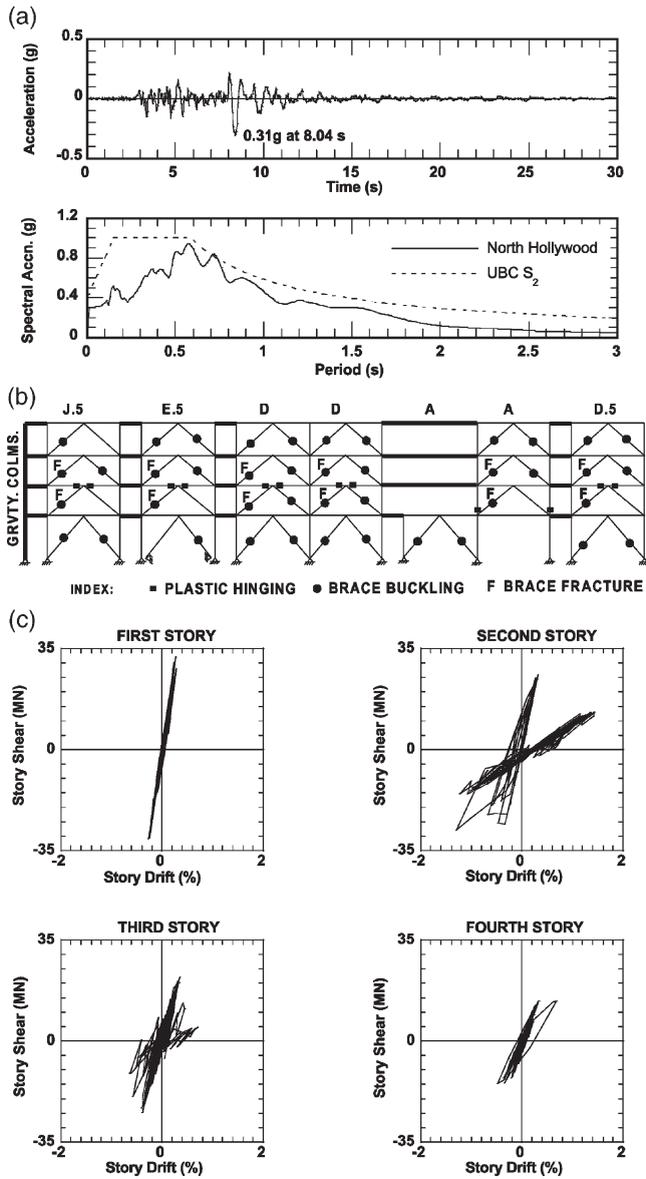
Fig. 6. (a) North Hollywood accelerogram (PGA = 0.31 g) and its acceleration spectrum compared with the UBC 94 S₂ spectrum and (b) Predicted inelastic activities and (c) Hysteretic behavior of the N-S lateral frames.

A reasonable agreement between the predicted inelastic activities (Fig. 6(b)) and the observed damage (Fig. 3) was obtained. In the northern part of the building, the first story columns of the braced frame A were subjected to large shear forces in the absence of braces and developed plastic hinges. All frames throughout the model

suffered buckling and fracture of braces in the second story, as observed. The model also predicts damage in the second floor beams, which agrees with the observed twisting of beams, and extensive ceiling damage. The model also predicts buckling of braces in the first and the upper stories, however, such damage was only observed in the frame A. The analysis clearly shows the vulnerability of the upper stories.

The hysteretic responses, in terms of story shear and drifts, for all stories are shown in Fig. 6(c). It is clear that the first story behaved nearly elastically despite the buckling of braces indicating that inelastic deformations were small, whereas all upper stories experienced large inelastic excursions and suffered permanent lateral displacement. Significant reduction in the stiffness of the second story is obvious following the brace buckling and beam hinging. The story drift is concentrated in all stories above the first story, which varies from 1.43% for the second story to 0.67% for the top story. The base shear reached a maximum value of 31 897 kN, which is about three times the UBC design base shear and is close to the peak lateral resistance of 29 601 kN as obtained by the pushover analysis.

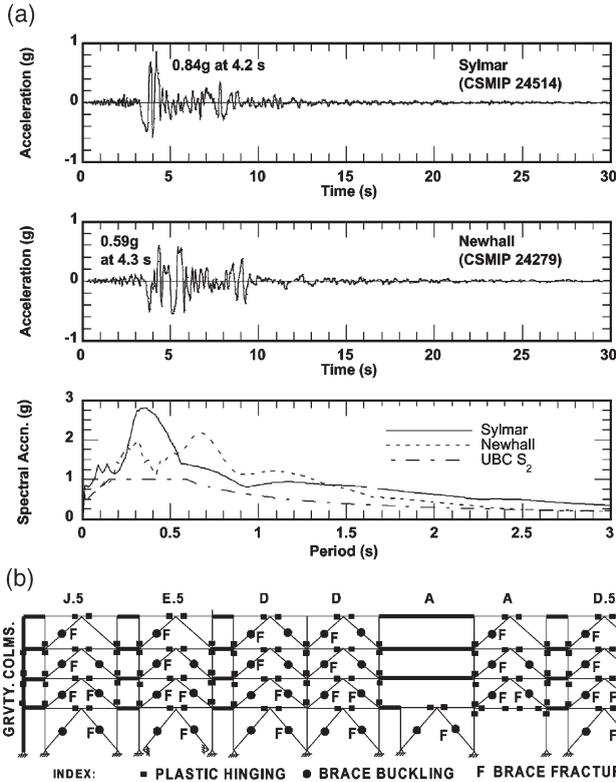
Fig. 7. (a) Characteristics of Newhall (CSMIP Station 24279) & Sylmar accelerograms (CSMIP Station 24514) and (b) Predicted inelastic activities in N-S lateral system for the Sylmar accelerogram.

The N–S component of ground motions, their acceleration and response spectra are shown in Fig. 7(a). The peak ground accelerations are 0.59 and 0.84 *g* for Newhall and Sylmar, respectively. The peak horizontal ground velocities are significantly large; 1.30 m/s for Sylmar and 0.94 m/s for Newhall. The spectral acceleration of these motions is well above the UBC design spectrum for all the periods. The spectral power of the Newhall motion peaks at a period of 0.69 s, which is very close to the fundamental period (0.72 s) of the undamaged structure.

For the Newhall motion, story mechanisms formed in the first and second stories. Most of the braces in these stories buckled and fractured, floor beams formed plastic hinges where the chevron braces meet, and columns formed plastic hinges throughout the second story, resulting in a complete collapse mechanism. The damage is more widespread for the Sylmar motion in which complete story mechanisms developed for all four stories and the whole structure formed a collapse mechanism as shown in Fig. 7(b).

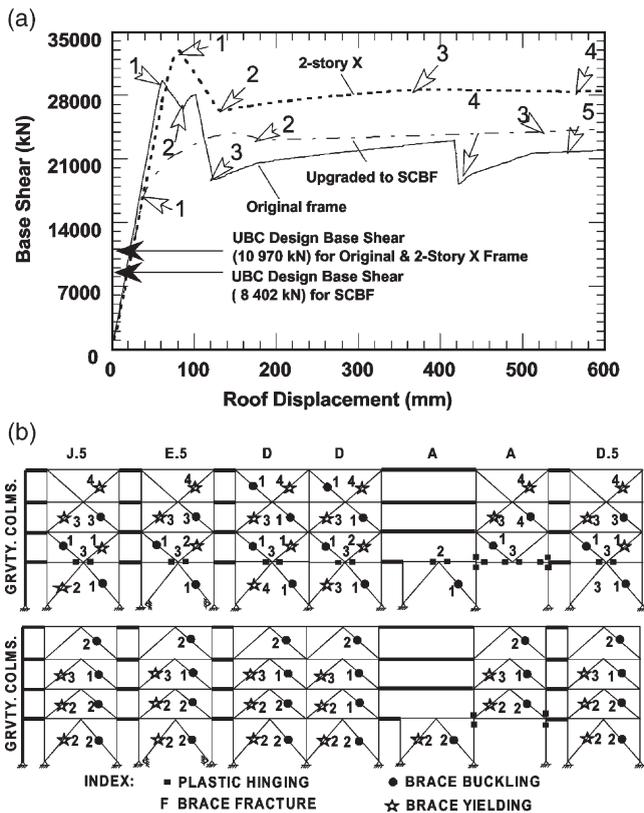
Fig. 8. Pushover analyses of upgrading schemes (a) Comparison of the base shear vs roof deflection curves (b) Sequence of inelastic activities in the lateral frames with braces arranged in the 2-Story X pattern and upgraded to SCBF.

and brace buckling occurred in the first and third stories. With further displacement, the lateral strength continued to decrease as the compression force of buckled braces decreased and reached the lowest value of 26 366 kN at a roof displacement of 132.1 mm. After that, redistribution of forces to the upper stories led to a gradual increase in the base shear, which reached a near constant value of 28 747 kN following the hinging of the second floor beams and yielding and buckling of the third story braces.

As seen in Fig. 8(b), for the special chevron frame, the inelastic action began with buckling of braces in the first story at a roof displacement of 38.1 mm and base shear of 16 752 kN. The frame continued to resist more lateral load, but with significantly reduced stiffness between events 1 and 2 as seen in Fig. 8(a). At the second event, the braces in the bottom three stories buckled and the first story braces reached their tension yield capacity. The load-displacement curve is nearly flat as all the braces have buckled and yielding of the upper story braces continued. At this stage, the frame can be considered to have reached its ultimate capacity of 23 550 kN, which is about 2.8 times its design base shear.

The inelastic (static) pushover analysis of the two upgrading schemes, i.e., changing to a 2-story X configuration and redesigning as SCBF, was conducted. The concrete filling of tubular braces enhances the fracture life measured in terms of cyclic inelastic excursions and its effect on load-deformation behavior can't be seen in a pushover analysis. The base shear versus roof displacement curves are shown in Fig. 8(a) and sequence of inelastic activities in frame members are shown in Fig. 8(b), for 2-Story X and SCBF upgraded frames. The 2-story X frame had a slightly lower stiffness than the original chevron frame due to the distribution of overturning forces in the columns. The first inelastic activity was noted in the second story of Frame D. The frame reached a maximum capacity of 32 929 kN at a roof displacement of 81.3 mm despite an early occurrence of inelastic actions. However, at this stage, the first major change in the strength and stiffness of the frame occurred when most of the braces in the second story reached their buckling and tension yield capacities

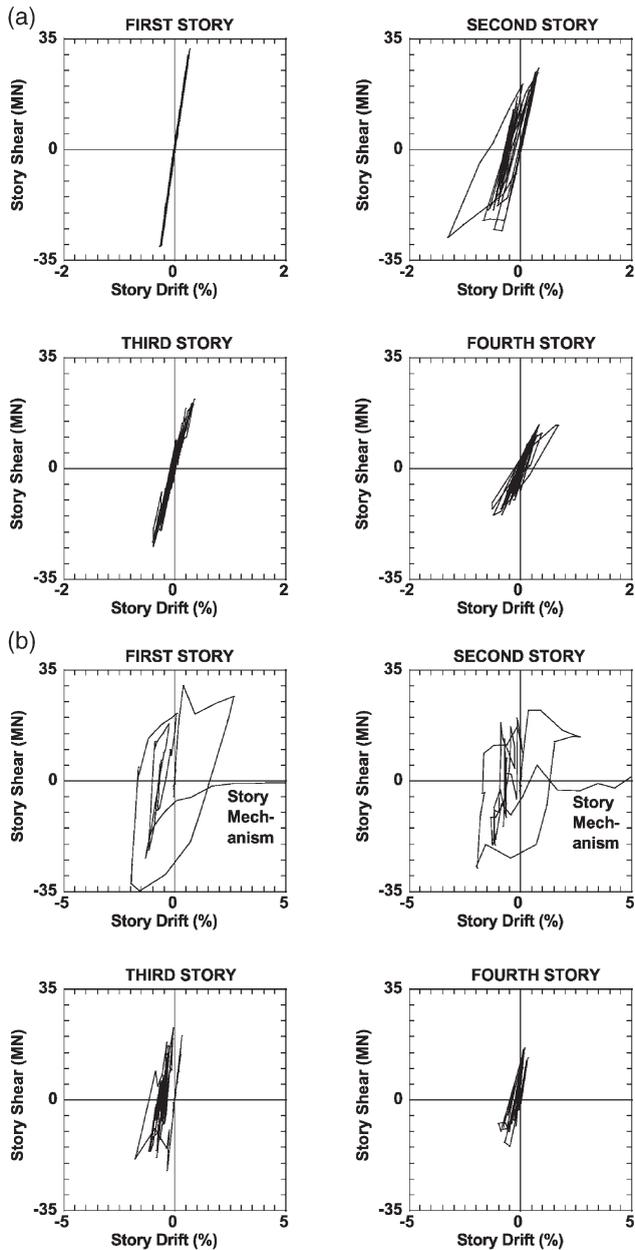
Fig. 9. Hysteretic behavior of the lateral frames with existing tubular braces filled with concrete for the (a) North Hollywood and (b) Sylmar accelerograms.

The fracture of braces was completely eliminated with concrete filled tubular braces for the North Hollywood accelerogram, which is in contrast to the fracture of several hollow braces in the second and third stories of frames as shown in Fig. 3. The overall spread of inelastic activity, in general, did not change and the second story received the maximum amount of damage. However, there was a general reduction in the ductility demands. For the more severe Sylmar ground motion, only one-third of all braces exceeded their fracture life and developed story mechanism only in the first story, unlike the hollow braces, which developed story mechanism in all stories. Plastic hinging of the first and second story floor beams and first story columns was also observed.

Significant improvements in the hysteretic behavior of frames were noted with concrete filled braces. For the North Hollywood motion, the absence of brace fractures clearly improved the hysteretic response of the bottom three stories, especially the second and third stories which suffered extensive brace fracturing with hollow braces, as can be seen by comparing Fig. 6(c) with Fig. 9(a). The response of the top story is very much unchanged as the brace ductility demands were not too high in this story. Similar trends of improved hysteretic response were observed for the upper stories for Sylmar (Fig. 9(b)) and Newhall ground motions. However, the first two stories developed story mechanisms and this upgrading scheme did not change the overall response in any significant manner for the severe ground motions.

One inexpensive and simple way to reduce the effect of the width-thickness ratio of hollow tubular braces is to fill in plain concrete to increase their fracture life (ductility). The equivalent width-thickness ratio of such a concrete filled tube section is given in Ref. [15]:

The fracture life of the concrete filled tubular members is calculated by replacing the width-thickness ratio in Eq. (1) with the equivalent web-thickness ratio given by Eq. (2). The fracture life of the braces of the study building increased about 1.32–1.76 times that of the hollow brace members.

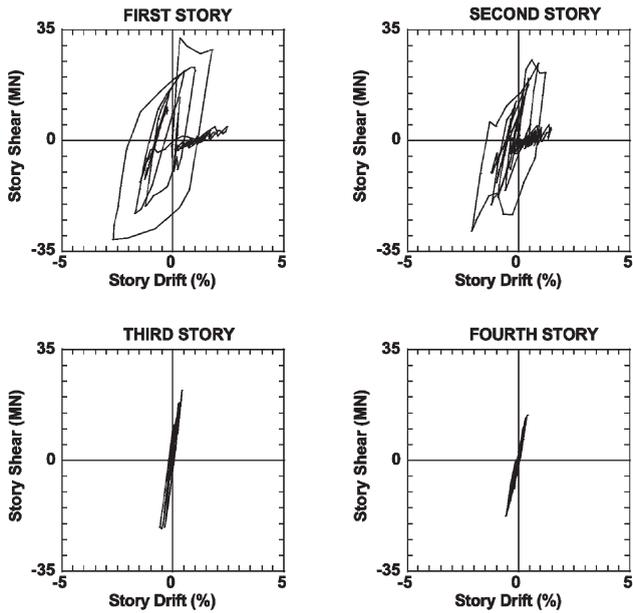
(a) 2 story X

Hysteretic behavior of the 2-story X lateral frames showed significant improvement over the chevron configuration, as shown in Fig. 10(a). For the Sylmar accelerogram, a stable hysteretic response was observed for the lower stories, and the upper stories behaved almost elastically except for buckling of a few braces. The superiority of the 2-story X configuration is obvious when comparing Fig. 10(a) with the hysteretic response of the chevron configuration shown in Fig. 9(b).

The second upgrading scheme utilizes a different configuration of bracing members to eliminate or minimize the formation of plastic hinges in the floor beams. Braces arranged in the 2-story X are considerably superior to the chevron system, as long as braces are ductile enough to prevent fracture. This scheme performed satisfactorily even for a severe ground motion such as the Sylmar. This upgrading scheme, along with methods to enhance the brace ductility, is very effective for ensuring an acceptable response to most seismic events. Although this scheme is somewhat disruptive to the occupants of the building during upgrading work, only half of all stories will be seriously affected.

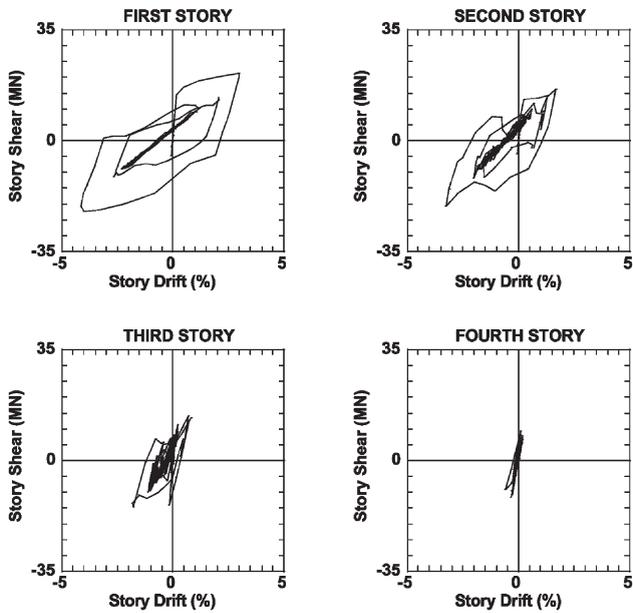
(b) SCBF

As expected with the lateral frames upgraded with a *strong beam–weak brace system* (SCBF), the inelastic activity was confined mainly to the braces, even for the Sylmar motion. A few plastic hinges were observed in the columns of the soft story of Frame A. The hysteretic behavior of SCBFs is shown in Fig. 10(b). The distribution of inelastic deformation and energy dissipation is consistent with those of properly designed regular frames with a dominant fundamental mode, i.e., maximum seismic demands for the first story, smaller demands for the upper stories, and minimum for the top story.
