SEISMIC RESPONSE OF A TWICE-RETROFITTED BUILDING

David Murià-Vila, Gerardo Rodríguez, Arabella Zapata and Ana María Toro

Instituto de Ingeniería, UNAM, Ciudad Universitaria,
Apartado Postal 70-472, Coyoacán 04510, México, D.F.

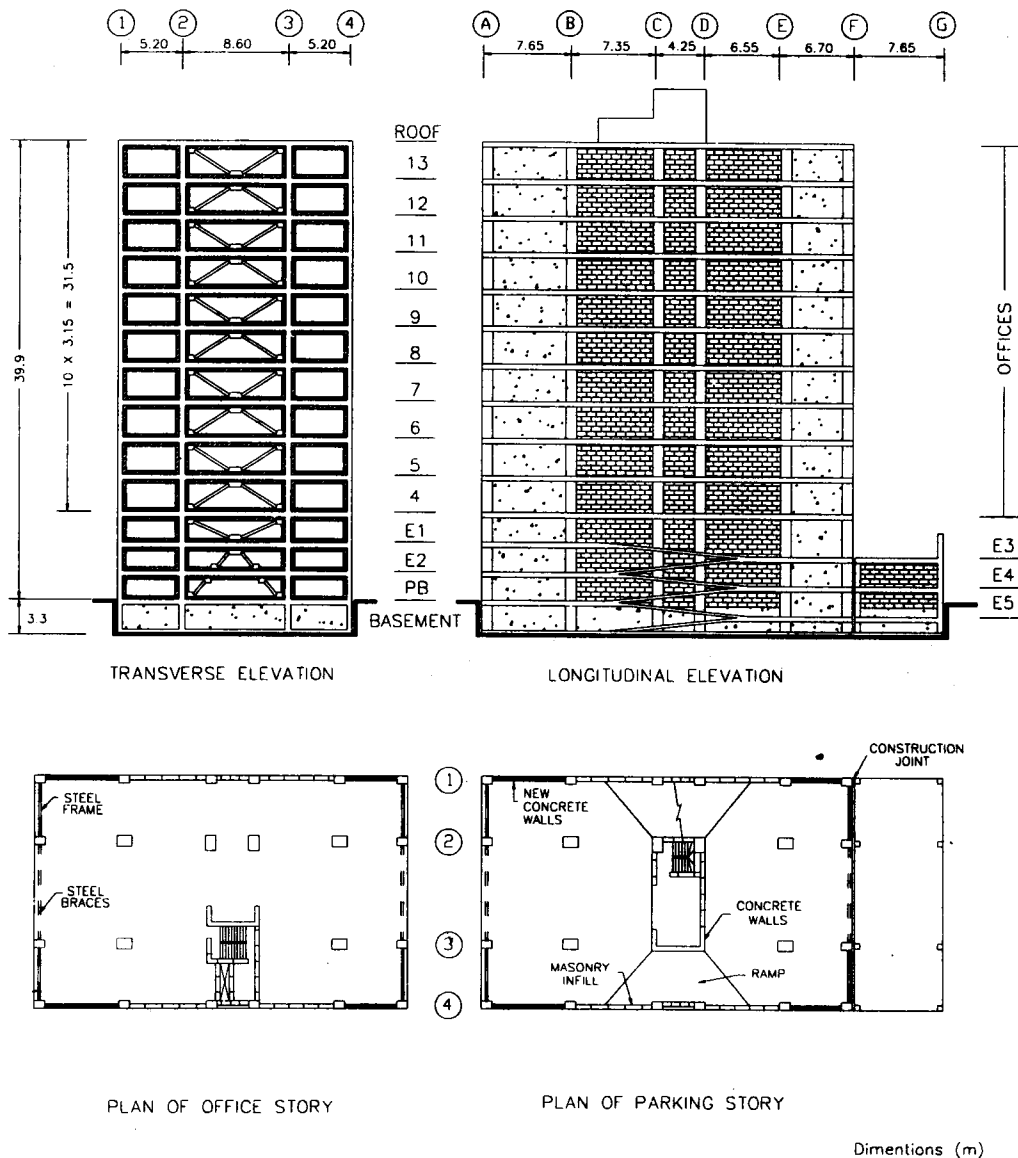
Fig. 1 Elevation and plans of building

Since it is located in the Mexico City area where the greatest damage was observed during the 1985 earthquake, and because large vibrations are expected due to its flexibility, the Jal building was selected among 50 candidates for study. This was built in 1981 using the Mexico's Federal District Constructions Code (RCDF, 1976). It is a 14-storey reinforced concrete structure occupied by offices, except for the first four stories, which are used for parking. The building has a small three-level adjoining structure, separated by 150 mm from the main structure and attached at the base. Originally the structure consisted of a waffle flat-plate (450 mm thick) on rectangular columns with a box-type masonry wall around the staircases, a small core of concrete shear walls around the elevator shaft, and masonry infill walls in the end frames of the longitudinal direction (L). The detailing of the reinforcement does not comply with present requirements for ductile structures, especially regarding the transverse reinforcement in columns and in slab-column joints. Figure 1 shows a schematic view of the structure.

The building was then strengthened in 1986 by adding infill concrete walls in the L direction connected to the original structure only through the upper slab. The sections of the interior columns were jacketed with new reinforced concrete without any modification to the foundation (Figure 1). The masonry walls were merely covered with plaster, and the cracks of the slabs were not repaired.

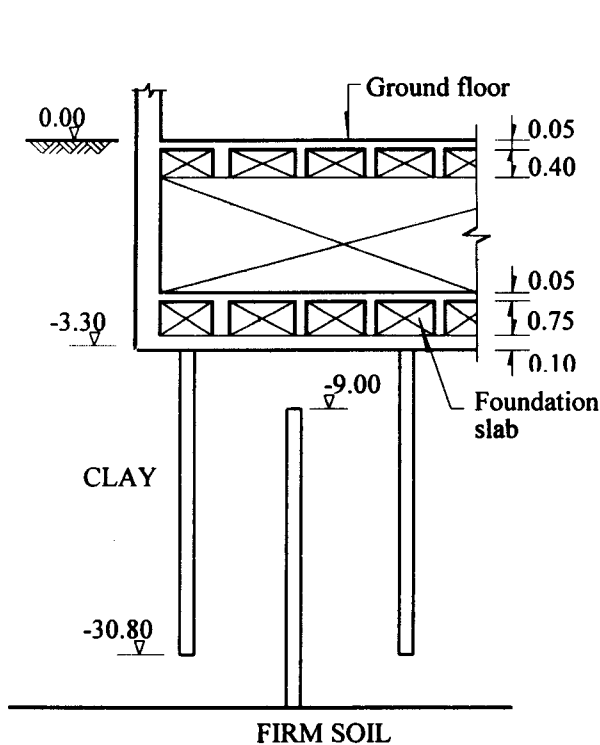
Fig. 2 Vertical cross-section of the building foundation

The foundation consists of a concrete slab on friction piles, driven according to a rather peculiar solution, as shown in Figure 2. The so called A-piles are fixed to the foundation slab and driven into the clay soil without reaching the firm layers. B-piles are driven down to the firm layer but are separated from the foundation. The weight of the building is assumed to be supported by the lateral friction of the piles and partially transferred from the A-piles to the B-piles, thus avoiding a foundation failure while at the same time allowing the building to sink following the areal settlement of the ground.

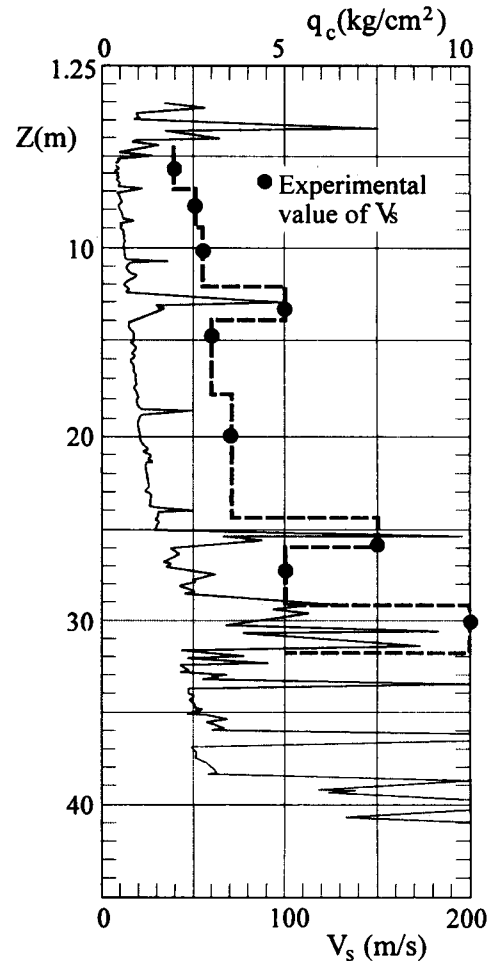
Fig. 3 Shear wave velocity (V_s) profile and cone penetration resistance (q_c) at the building site

front of it, where a field (surface) station was placed. Also, at the field site, a selective sampling and seismic cone testing (SCT) was executed. Figure 3 shows the soil profiles at the building site. In general terms, under a crust of about 5 m, the upper soft clay deposits extend to a depth of 29.5 m, followed by a 3 m thick intermediate firm layer. The lower clay layer extends from 32.5 to 38.5 m depth, followed by the so-called deep firm deposits. The shear wave velocity profile, determined from the SCT tests, is also shown in this figure.

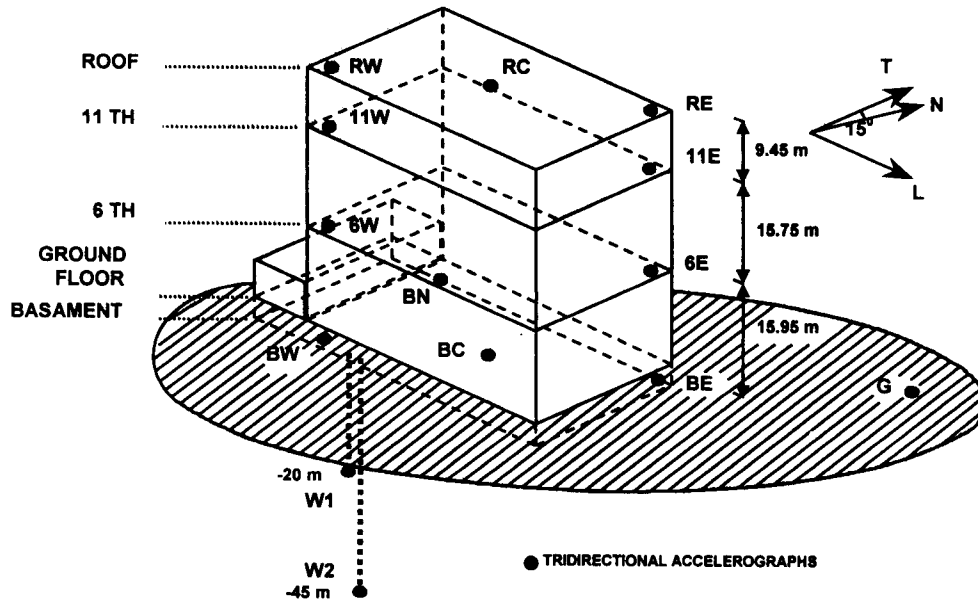
Fig. 8 Overview of the building instrumentation

The building was instrumented with a 14-accelerograph network. Eleven accelerographs were placed into the building, whereas the remainder were located on the ground. The field station instrument (G) was located about 50 m away from the building (Figure 8).

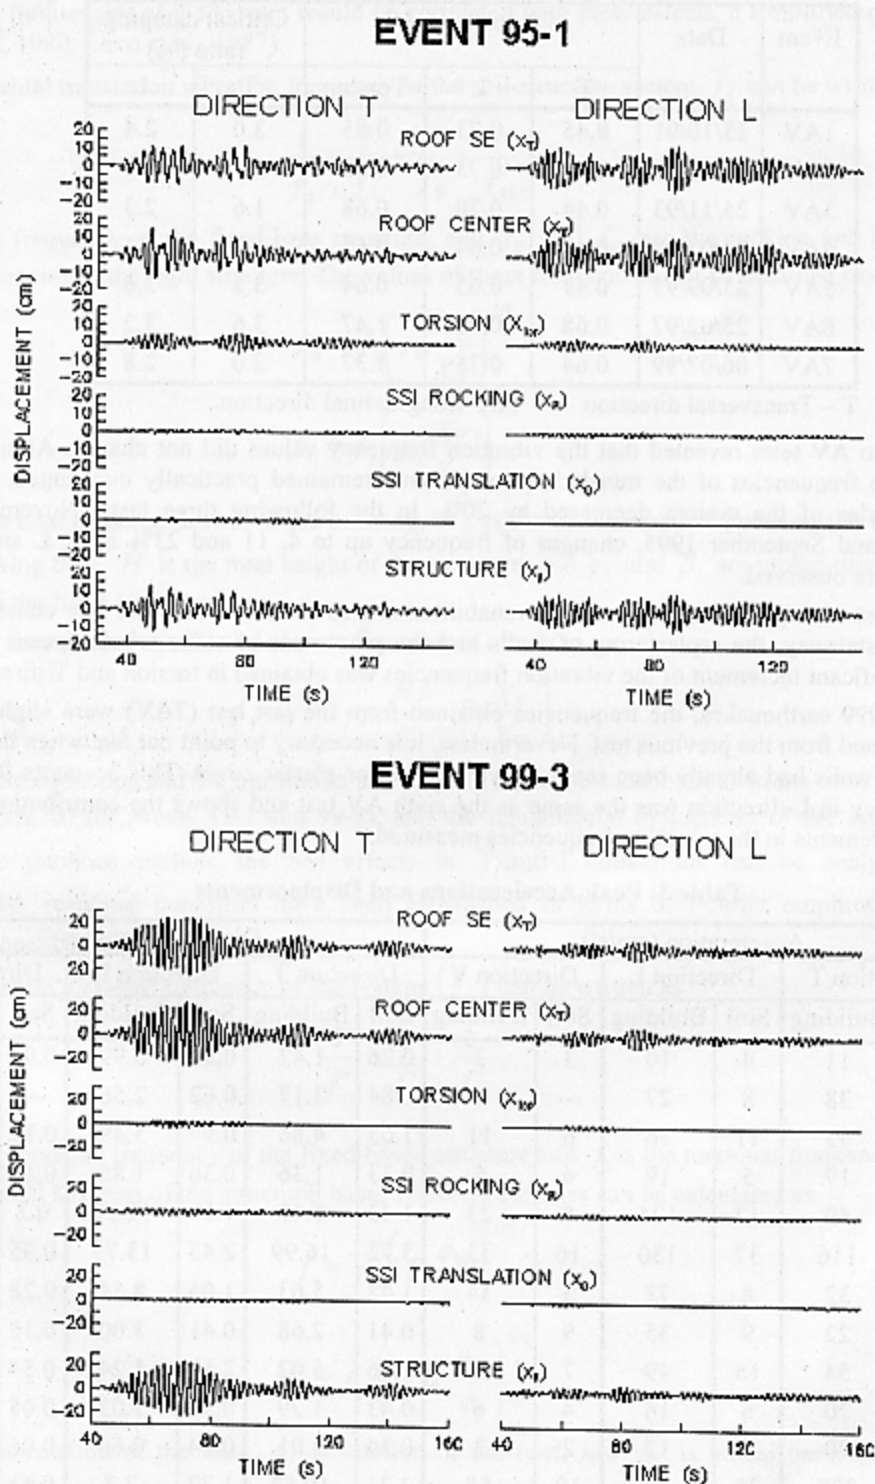
Fig. 10 Time-histories of displacements at roof level, with contributions of different sources deformation, calculated for events 95-1 and 99-3

Figure 10 shows the case of the 95-1 and 93-3 events. In this figure, time-histories of the total displacements (x_T) at the centre and at one corner of the roof level in the T-direction are shown, along with the contributions to these displacements, due to rocking and translation at the base plus the torsion. The torsional motion (x_{tor}) was derived from the differences between the horizontal movements at roof corners. The rocking motion (x_R) was calculated by the product of building height and angle of base rotation, assuming that the base is rigid for out-of-plane bending. The angle was derived from the vertical motions recorded in the corners of the basement level. Base translation displacement (x_0) was computed by subtracting that at the field site instrument (G) from that at the basement (BC). Finally, displacements due to the flexibility of the structure (x_F) were obtained by subtracting from the motion at the roof (RC) those obtained from base rocking and translation.

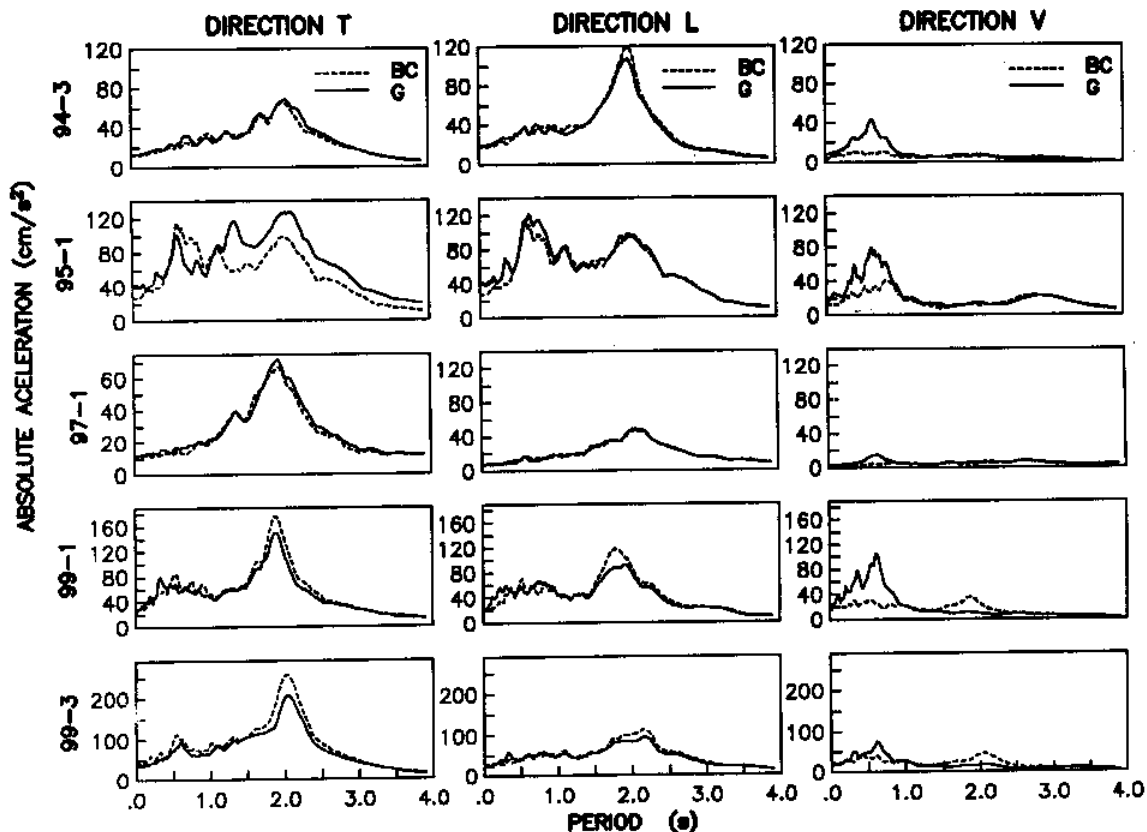
Fig. 11 Response spectra from the basement centre (BC) and from field site (G)

Response spectra, for 5% of critical damping, were calculated with the records of the field site and the centre of foundation in site BC. In Figure 11, for the greatest intensity events, the spectra of the three components (T, L and V) of these two measurement points are compared.

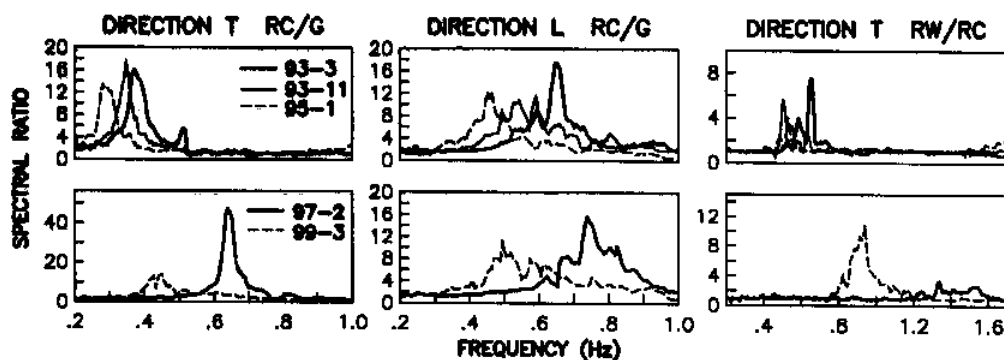
Fig. 12 Estimated transfer functions between the motions at roof centre and at field site (RC/G), and between the corner and the roof centre (RW/RC)

Figure 12 shows some estimated transfer functions obtained to illustrate the variations of the frequencies of three principal modes. The shapes of the curves and the intervals of maximum ordinates vary from one event to another. Furthermore, for some events, more than one significant peak appeared around a modal frequency. Therefore, the system exhibited non-linear behaviour even during seismic intensities considered as low or moderate.

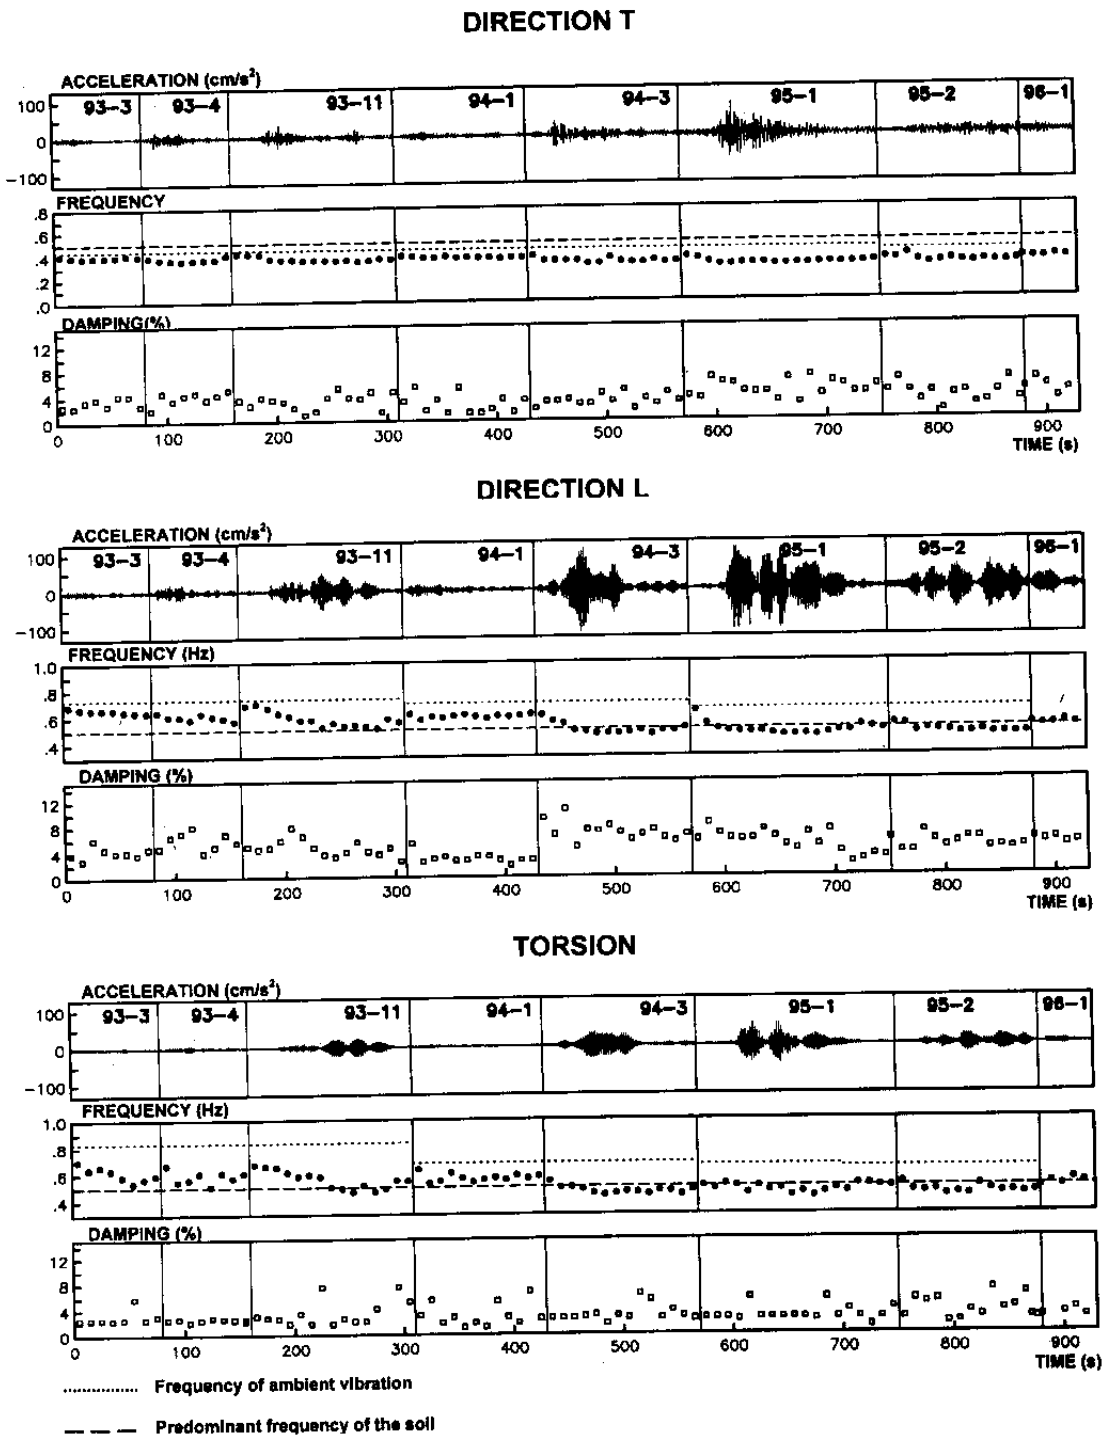
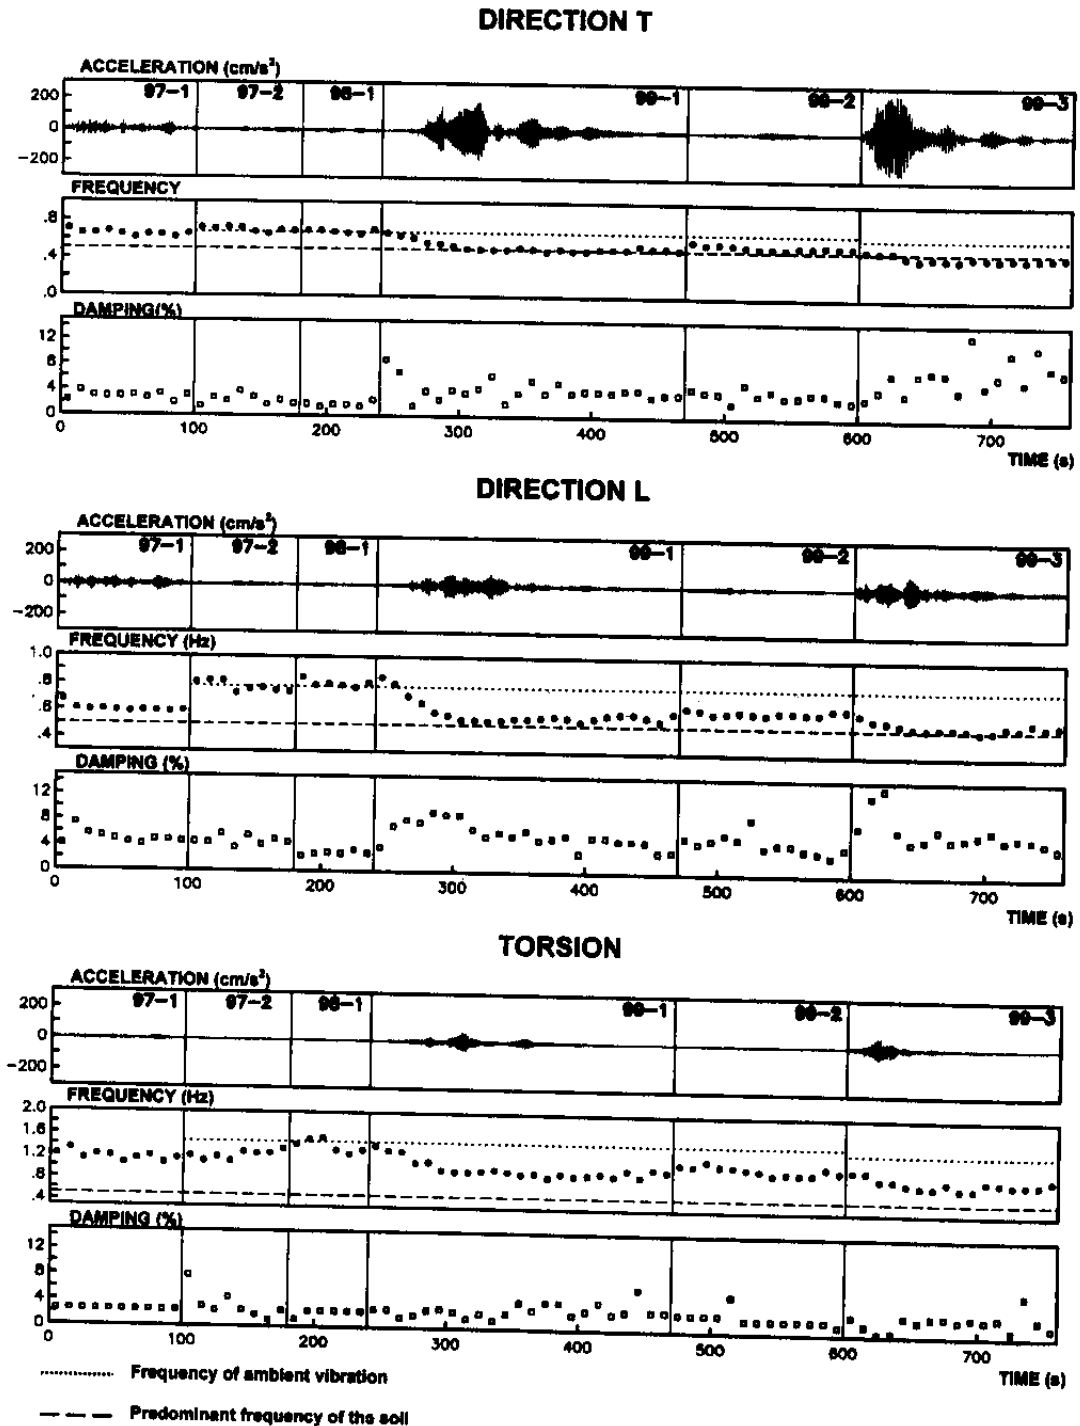
Fig. 13 Acceleration time-history recorded at RC site and time-variation of the dynamic properties of the events before the second rehabilitation

Fig. 14 Acceleration time-history recorded at RC site and time-variation of the dynamic properties of the events after the second rehabilitation

Figures 13 and 14 show accelerograms recorded at a point located on the roof. The first modal frequency (dot) and damping (rectangle) are plotted versus the time corresponding to the middle of each window. The horizontal line represents the AV frequencies and the predominant frequency of the soil. It can be seen that values along the duration of each earthquake have an amplitude-dependence on the input motion. In the intense phase of the event, the major reduction of frequencies occurred, and after this phase of the most significant events, a partial recovery of the values of the frequencies was observed.

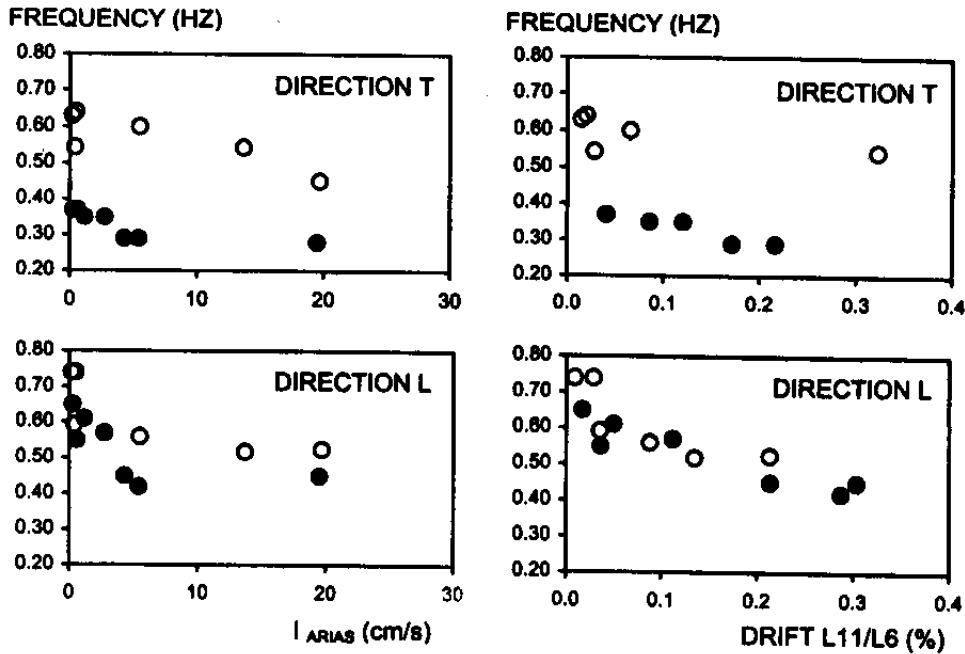
Fig. 15 Arias intensity (I_{Arias}) and inter-story drift variation of soil-structure system frequencies (• before the second rehabilitation, ◊ after the second rehabilitation)

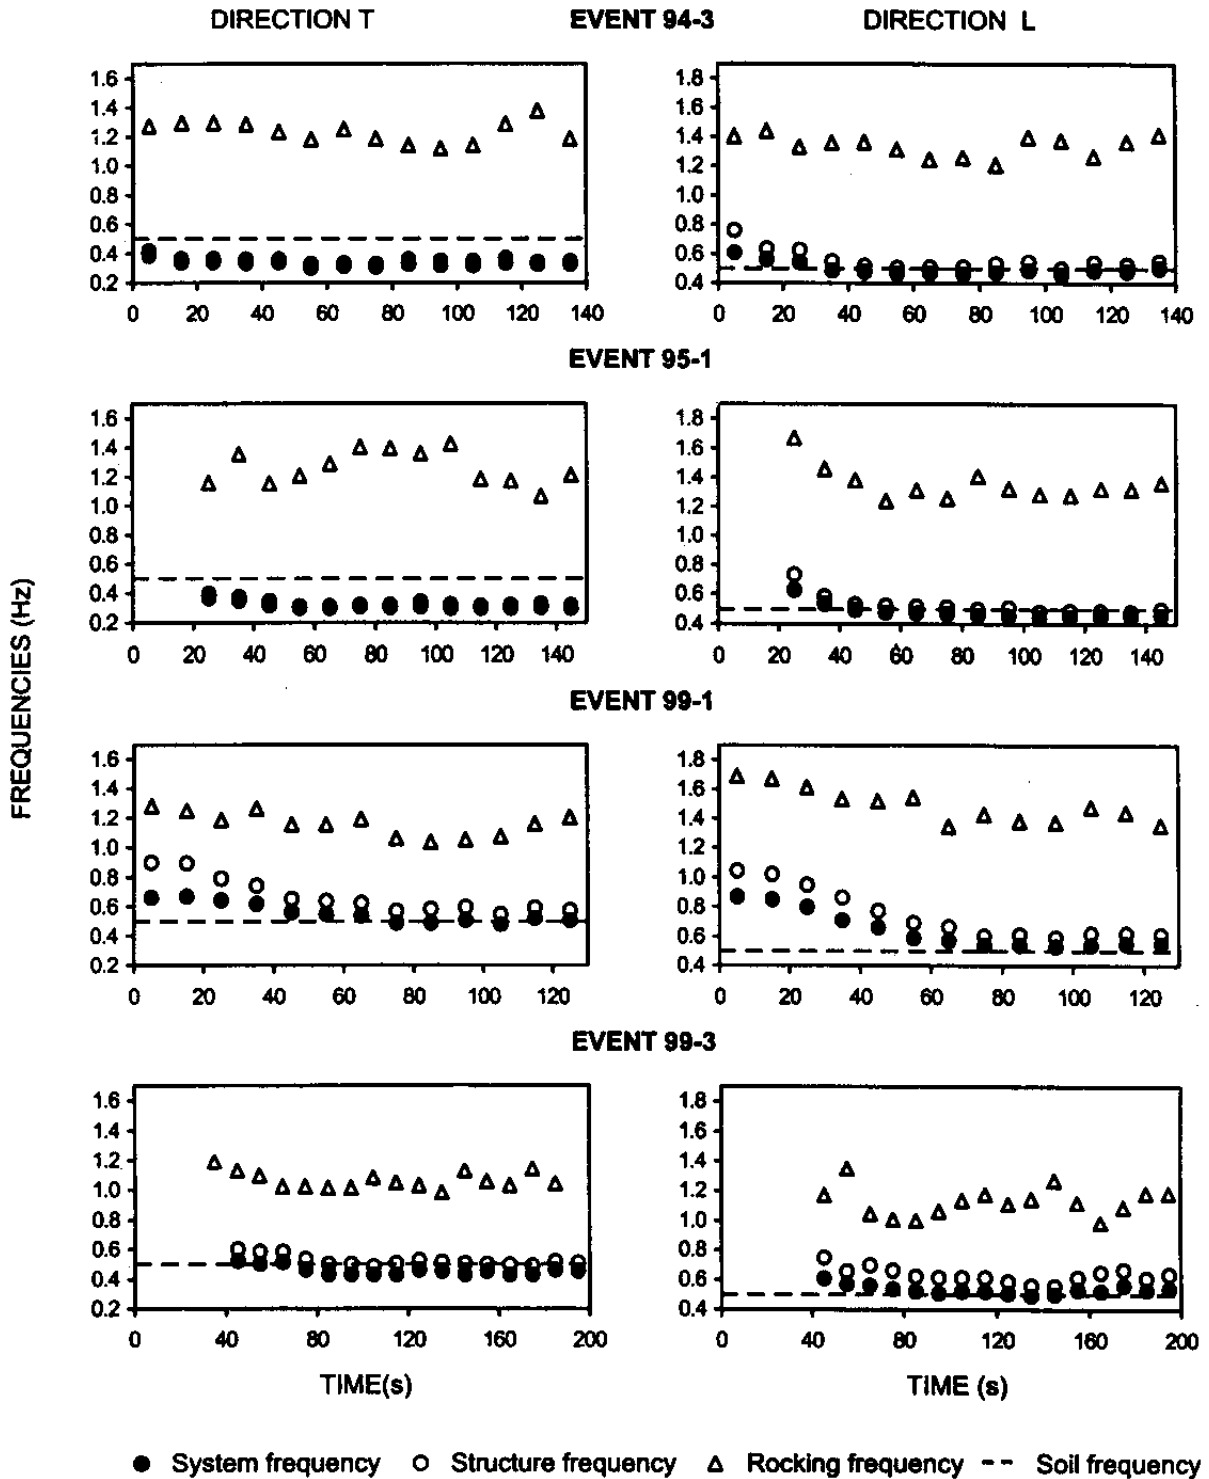
Fig. 16 Time variations of frequencies, before second rehabilitation (94-3 and 95-1 events) and after second rehabilitation (99-1 and 99-3 events)
