Case study on the performance of reinforced soil slopes

Abstract:

The term paper deals with the performance of reinforced soil slopes in various locations and using various techniques for reinforcement. The four case studies showcase different reinforcement methods like use of soil nailing, geogrids and geo-synthetic sheets. Also the locations of the four slopes are very different from one another as one slope fails due to water pressure, other is an earthen dam. One case study deals with the effect of seismic motions on reinforced soil slopes.

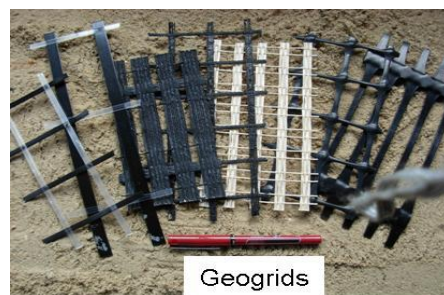
Geogrids are commonly made of polymer materials, such as polyester, polyethylene or polypropylene.

Figure 3: Geogrids made from different materials

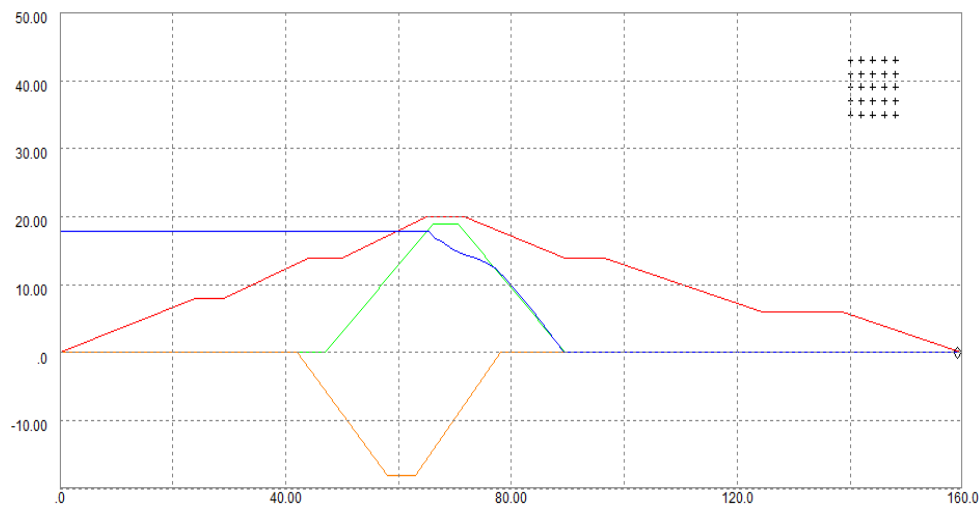
Fig 4 shows the model of the Wasani dam developed in Slope Module of Oasys software. The properties assigned to the dam material are presented in Table 2.

Figure 8: Model of Wasani Dam

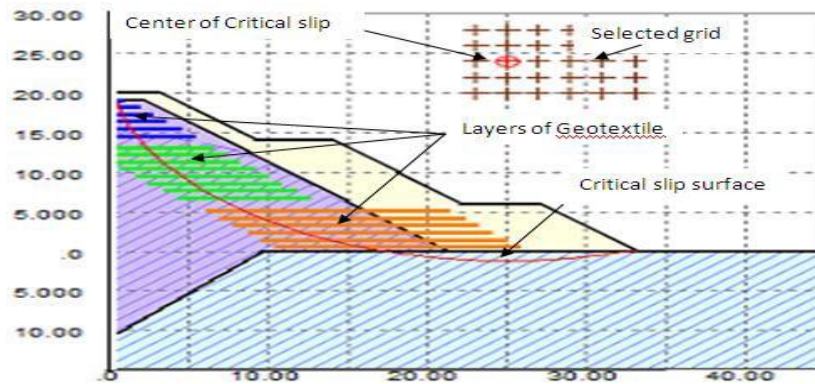
The downstream slope of the Wasani dam was considered to be reinforced with horizontal layers of geotextile in anticipation of increased factor of safety. As a result, steeper slopes may be provided to the downstream direction of dam. The d/s slope of the dam was reduced in increments by 0.25 H: 1V. The spacing between layers (z) was varied from 0.9 to 3 m for each case. Analysis was then carried out for each case separately. During analysis of each case the length of reinforcing layer (L) and their offset (x) from the d/s face of dam was varied in such a way that the reinforcing layers remains activated i.e. they intersected the potential failure surface and governing criteria of failure for the reinforcing layers remained as tensile. This ensured the maximum utilization of reinforcing layers and resulted in solutions that were economical. Typical graphical output obtained from software is presented in figure.

Figure 9: Typical graphical output of d/s slope

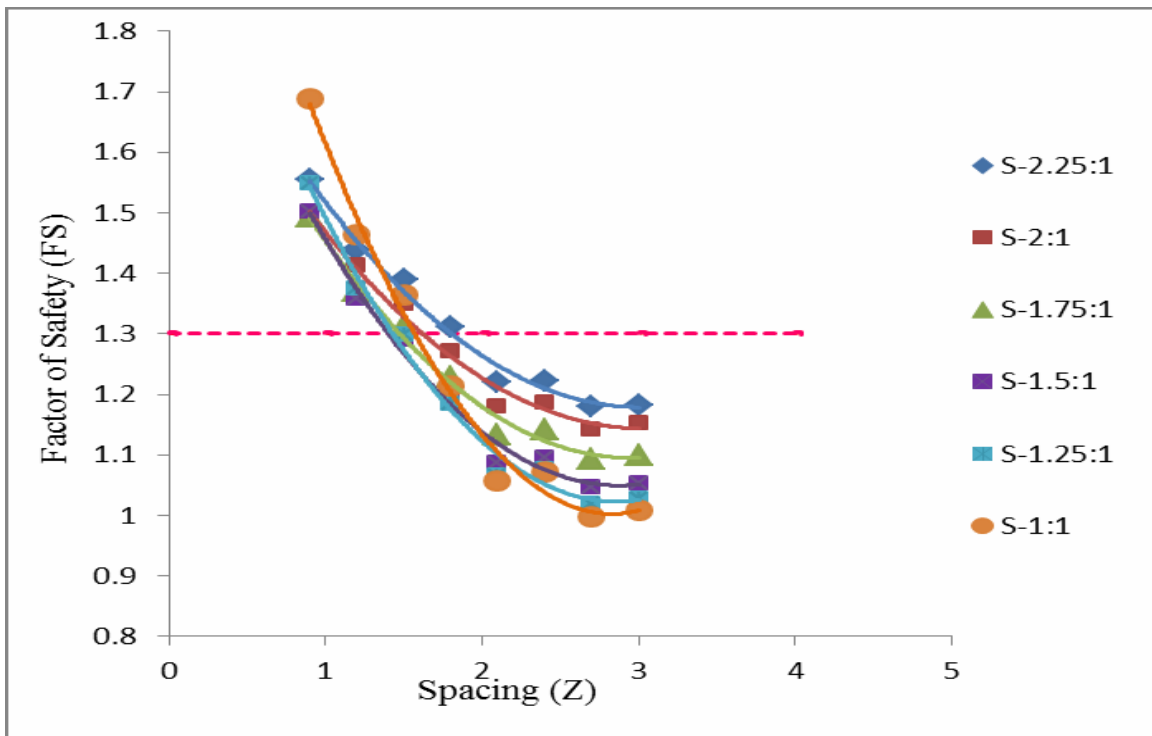
Figure 12: Variation of factor of safety with respect to spacing between geotextile layers for sudden drawdown condition

Similar to the previous case, factory of safety decreased as the spacing between the reinforcement layers was increased. It was also observed that by providing geotextile layers at spacing of 1.5 m, the u/s slope can be made as steep as 1:1. The length of the geotextile layers required for reinforcing the u/s slopes were found to be in the range of 4 m to 27 m and offset from u/s slope were found to be in the range of 3 m to 18 m depending upon the location of geotextile layers.

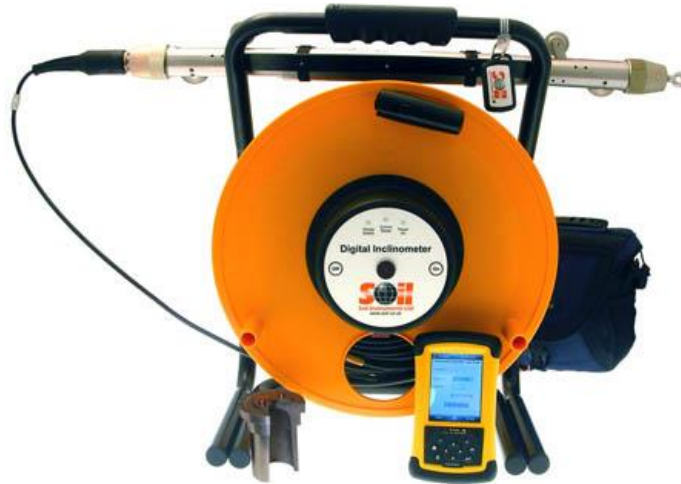
They are also used to measure deflections in the walls of excavations, shafts, tunnels and in caissons, piles and sheet piling.

Ground movement causes the casing to move away from its initial position. The rate, depth, and magnitude of this movement is calculated by comparing data from the initial readings to data from subsequent readings.

Figure 13: Inclinometer System

The inclinometer readings coupled with that of rain gauge showed that the major slope movements occurred after significant rainfall in the area. Surprisingly, the piezometer readings were significantly below the river water level even after significant storms.

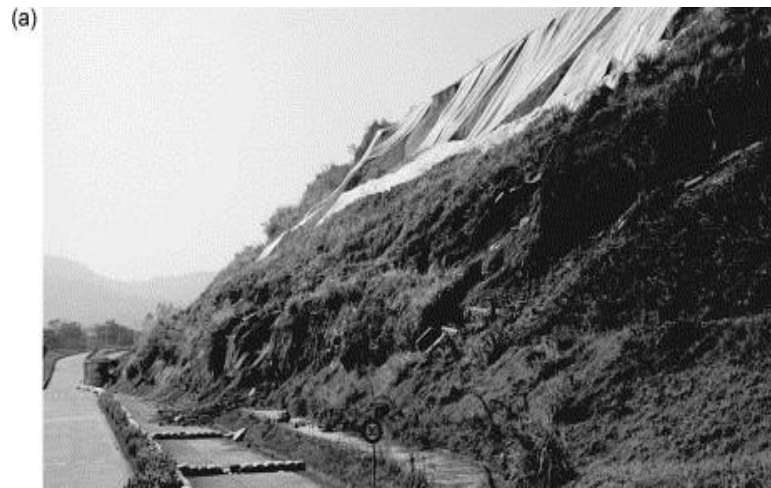
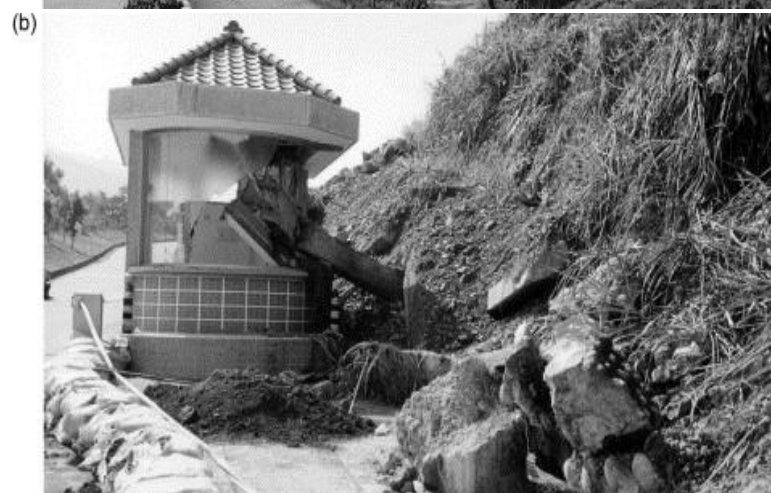
The geogrids were used as reinforcement and the slope was backfilled by on-site soil, which was silty-clay. The slope had a wrap-around facing. The reinforced structure was constructed by stacking a series of reinforced slopes, with a reinforcement spacing of 1 m. The images of failure slope are shown thus:

Figure 17: Chi-Nan University geo-synthetic-reinforced slope: (a) side view of failure, (b) damaged security office, (c) front view of failure, (d) close view of failure showing the reinforcement and backfill soil, (e) settlement of concrete pavement along the foot of the slope

The backfill soils and concrete structures from the slope moved for more than 10 m and buried the road. The security office was damaged. A close view of the slope shows that the reinforcements are seen to pull out of the slope. Note that the concrete pavement around the site, at the foot and crest of the slope, deformed excessively.

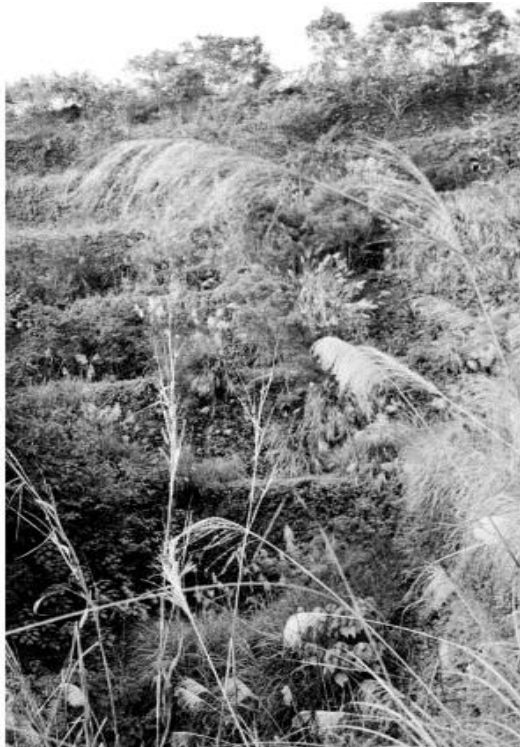
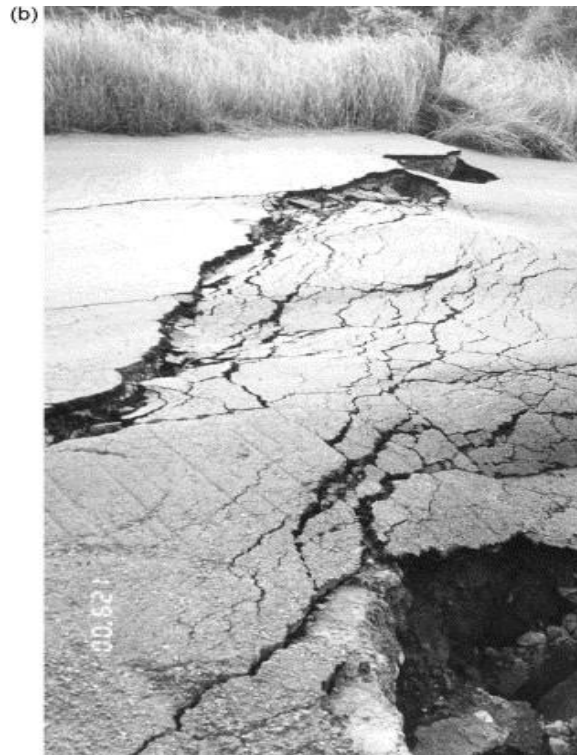
According to paper solution of this problem is another case study of Nai Lu housing development site, Chung Hsin New Village. A 35 m high reinforced structure, located near Chung Hsin New Village, remains stable after the earthquake. The structure was composed of six multiple reinforced slopes, facing south-west. The slope has a wrap-around facing and was fully vegetated. It was the tallest reinforced soil structures at the time of completion of construction. Note that the road pavement along the slope suffered significant damage.

Figure 19: Nai Lu housing development site: (a) stable geo-synthetic-reinforced slope with vegetated facing, (b) severely cracked pavement along the road to the slope
